# Fire Risk Assessment

**48 – 50 Hawfield Road**

**Hawfield Rd, Tividale, Oldbury, B69 1LD**

**Date Completed: 5<sup>th</sup> February 2026**

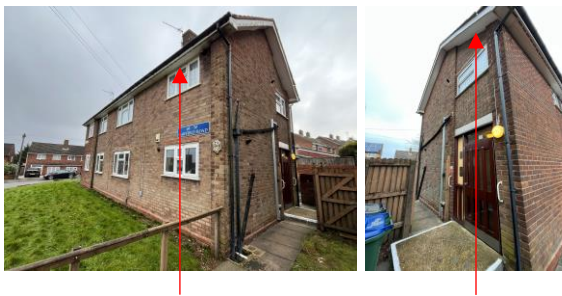
- 1)The exterior of the building is primarily traditional brick construction with a pitched roof design. The roof features concrete tiles and laminated fascia boards along the roofline and underside

Laminated boards on the underside & fascia

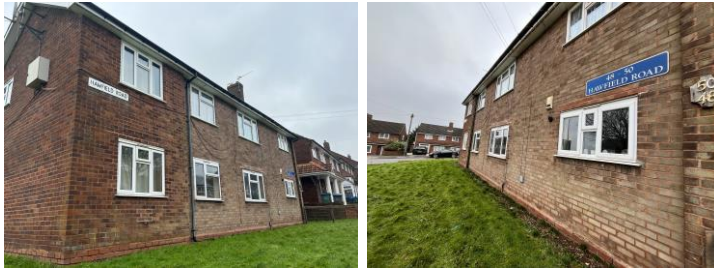
- 3) UPVC double-glazed window units have been installed in each flat and in the communal areas within the block.

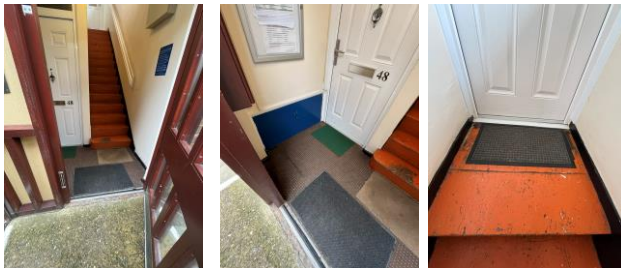
- 1) Each flat is equipped with, as a minimum LD3 fire detection to facilitate means of escape and provide sufficient response time.
- 2) The small section of the entrance hallway floor is installed with carpet, however there are floor mats of various sizing placed over. The sizing and condition of the mats are acceptable. This area is kept clear of any obstruction and combustibles promote maintain safe exit in an event of fire.

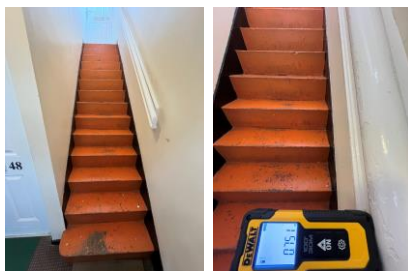
- 3) 48 -50 Hawfield Road contains a single concrete staircase, positioned at the entrance of the block, which provides an adequate means of escape. The width of the staircases, measured from handrail to wall, is 751 mm respectively. This staircase is kept clear to ensure a safe means of escape.

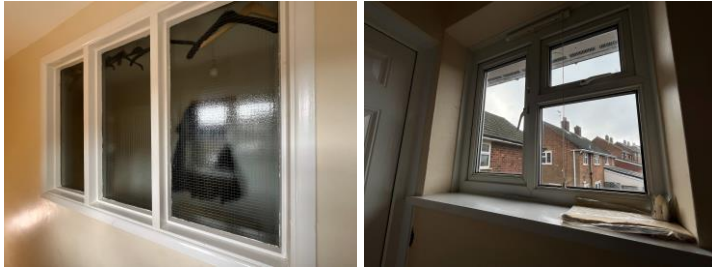
- 4) A UPVC window unit has been installed on the staircase landing which is openable without the use of key. This installation provides sufficient borrowed lighting and ventilation, while an incorporated Georgian wired glazing unit has been installed on the flat side to protect the means of escape and prevent the spread of fire and smoke. It should be noted that there is currently no automatic smoke ventilation system installed on the premises.

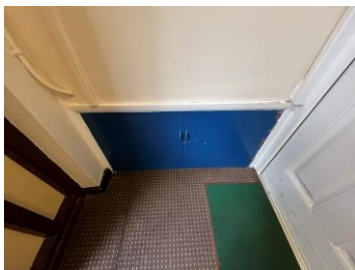
- 6) The ground floor entrance houses a gas service cupboard near to the entrance of flat 48, this is secured by a push-button lock. *Action regarding the location of gas meter has been noted in section 10, Compartmentation.*

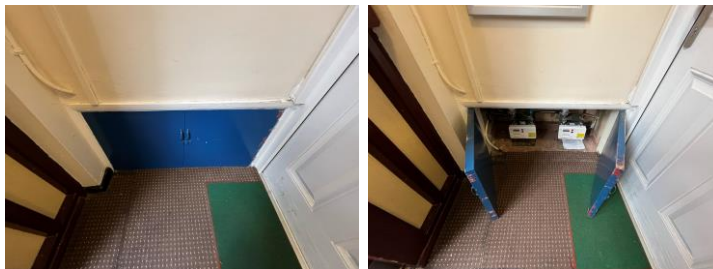
- 3) The residents' gas meters are located within a service cupboard on the ground floor, adjacent to the entrance to Flat 4. Recommended that the meters to be relocated outside or the present location made to vent externally. *A collective email regarding this and neighbouring blocks has been sent to the Gas Safety team on 03/02/2026 to liaise with Cadent regarding the relocation on 03/02/2026. See below for reply from Cadent.*

- 4) It is recommended that the service cupboard is upgraded to provide an appropriate level of fire resistance. The cupboard should be fitted with lockable fire-rated doors incorporating intumescent strips and smoke seals to help prevent the spread of fire and smoke

As no future works are planned with Cadent to relocate the gas meters, suitable permanent ventilation must be provided. This should include the installation of a ventilation brick or equivalent arrangement to ensure compliant airflow to the exterior of the property. *Noted in Observations*

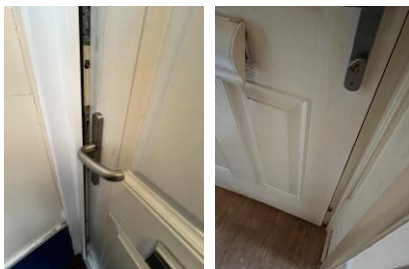
- 7) Access was gained to Flat 48 to assess the operation of the self-closing device and the condition of the fire and smoke seals to the flat entrance door.

Upon testing, the self-closing device did not enable the door to fully close into the frame. The security latch engages prematurely, preventing the door from achieving full and effective self-closure.

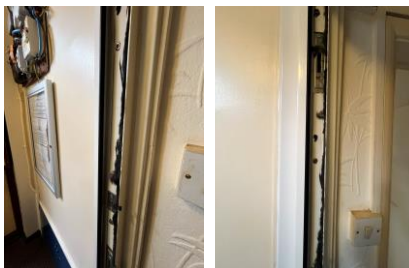
- 8) Flat 48, The cold smoke seals are severely frayed at certain parts of the installation and require replacement of both the smoke and intumescent seals where damaged.

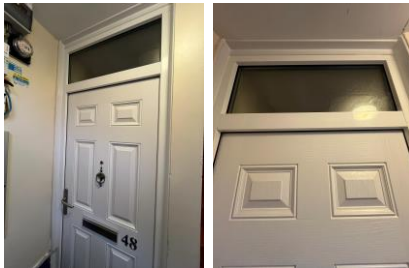
- 9) The transom glazing installed in Flat 48 does not display any permanent marking or stamp to confirm that it is certified as fire-rated glazing. Instead, the only visible marking on the glass is **EN 14449**, which relates to laminated safety glass in accordance with European standards. *This has been noted in observations for clarification.*

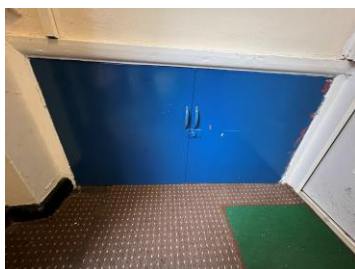
- 4) Gas service cupboard in entrance hallway will require appropriate signage once upgraded

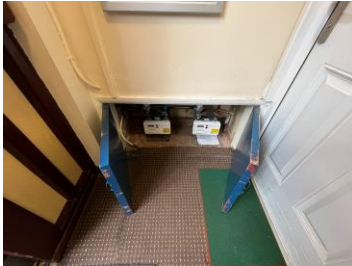
- 5) The residents' gas meter is located within a service cupboard on the ground floor, adjacent to the entrance to Flat 48. Recommended that the meters to be relocated externally or the present location made to vent outwards. *A collective email regarding this and neighbouring blocks has been sent to the Gas Safety team on 03/02/2026.*

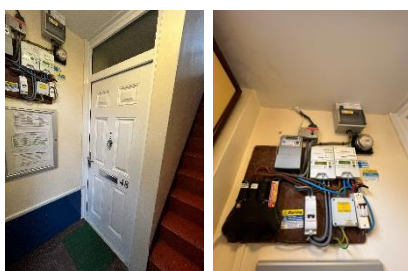
- 7) At present, appropriate control measures are in place to mitigate any potential risks associated with the exposed electrical switching located within the communal area of the block. However, electrical switching and metering installations will be required to be enclosed within a suitably fire-resisting enclosure in accordance with current fire safety standards as part of any future refurbishment works.

The design and installation of the enclosure must not impede access to Flat 48 or cause undue disruption to the resident. *Noted in Observations*

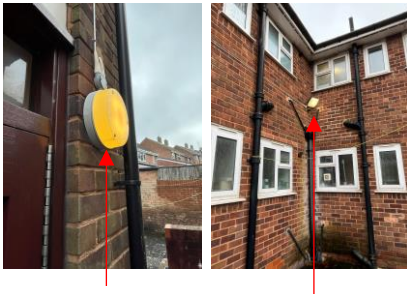
- 1) There is no current evidence of arson.
- 2) The perimeter of the premises is well illuminated with the installation of external lighting.

Front and rear external lighting

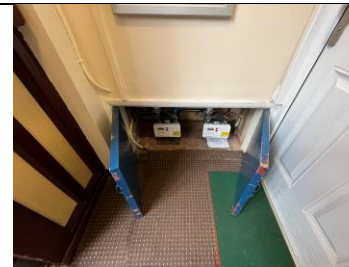
The residents' gas meter is located within a service cupboard on the ground floor, adjacent to the entrance to Flat 48. Recommended that the meters to be relocated externally or the present location made to vent outwards. *A collective email regarding this and neighbouring blocks has been sent to the Gas Safety team on 03/02/2026*

- *Meeting held on the 23/02/2026 with electrical and gas safety team concluded that the gas service cupboards would be surveyed for the addition of ventilation being added to the outside of the building.*

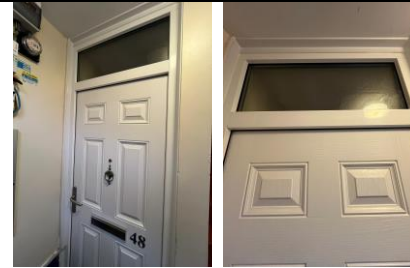
The transom glazing installed in Flat 48 does not display any permanent marking or stamp to confirm that it is certified as fire-rated glazing. Instead, the only visible marking on the glass is **EN 14449**, which relates to laminated safety glass in accordance with European standards.

**EN 14449** certification indicates that the glazing is classified as laminated safety glass designed to reduce the risk of injury upon breakage. However, this marking does not confirm that the glass has been tested or approved for fire-resistance performance.
