# Fire Risk Assessment

**49 – 51 Hawfield Road**

**Hawfield Rd, Tividale, Oldbury, B69 1LD**

**Date Completed: 5<sup>th</sup> February 2026**

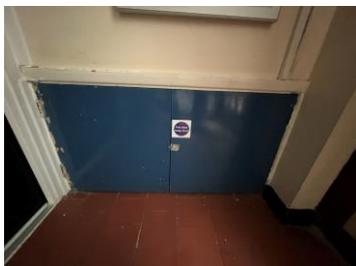
- 6) The ground floor entrance houses a gas service cupboard near to the entrance of flat 49, this is secured by a push-button lock. *Action regarding the location of gas meter has been noted in section 10, Compartmentation.*

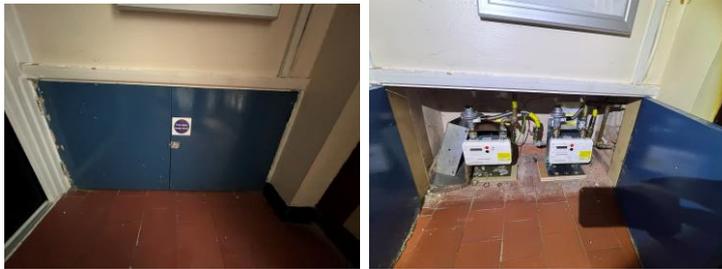
- 3) The residents' gas meters are located within a service cupboard on the ground floor, adjacent to the entrance to Flat 49. Recommended that the meters to be relocated outside or the present location made to vent externally. *A collective email regarding this and neighbouring blocks has been sent to the Gas Safety team on 03/02/2026 to liaise with Cadent regarding the relocation on 03/02/2026. See below for reply from Cadent.*

- 4) It is recommended that the service cupboard is upgraded to provide an appropriate level of fire resistance. The cupboard should be fitted with lockable fire-rated doors incorporating intumescent strips and smoke seals to help prevent the spread of fire and smoke

As no future works are planned with Cadent to relocate the gas meters, suitable permanent ventilation must be provided. This should include the installation of a ventilation brick or equivalent arrangement to ensure compliant airflow to the exterior of the property. *Noted in Observations*

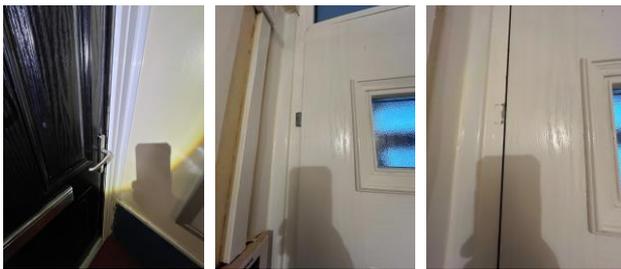
- 8) **Access was gained to Flat 49 to assess the operation of the self-closing device and the condition of the fire and smoke seals to the flat entrance door.**

**Upon testing, the self-closing device did not enable the door to fully close into the frame. The security latch engages prematurely, preventing the door from achieving full and effective self-closure.**

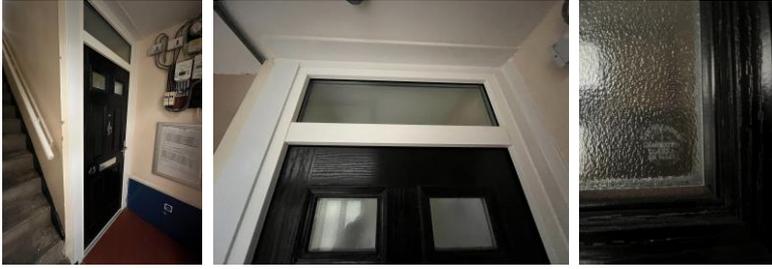
- 10) The transom glazing and glazing installed within the fire rated door in Flat 49 does not display any permanent marking or stamp to confirm that it is certified as fire-rated glazing. Instead, the only visible marking on the glass is ClearTherm laminated glass, Class 1 **EN 14449**, which relates to laminated safety glass in accordance with European standards. *This has been noted in observations.*
-

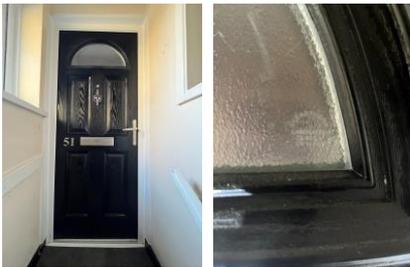
- 11) The glazing within the fire rated flat entrance door to flat 51 does not display any permanent marking or stamp to confirm that it is certified as fire-rated glazing. Instead, the only visible marking on the glass is ClearTherm laminated glass, Class 1 **EN 14449**, which relates to laminated safety glass in accordance with European standards. *This has been noted in observations.*

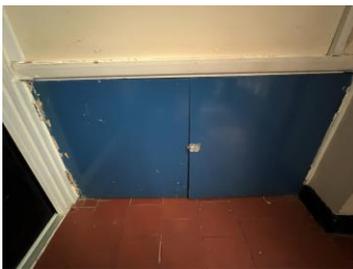
- 4) Gas service cupboard in entrance hallway will require appropriate signage once upgraded.

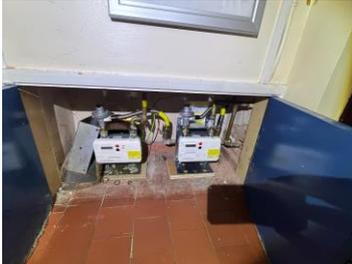
- 6) Gas appliances and pipework (where installed) are subject to annual testing and certification. This contract is managed by the in-house Gas team. Gas supply to these premises is internal. This cupboard is kept clear of any combustible items.

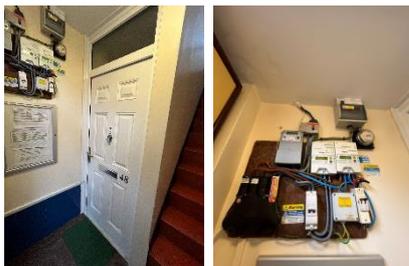
- 7) At present, appropriate control measures are in place to mitigate any potential risks associated with the exposed electrical switching located within the communal area of the block. However, electrical switching and metering installations will be required to be enclosed within a suitably fire-resisting enclosure in accordance with current fire safety standards as part of any future refurbishment works.

The design and installation of the enclosure must not impede access to Flat 49 or cause undue disruption to the resident. *Noted in Observations*

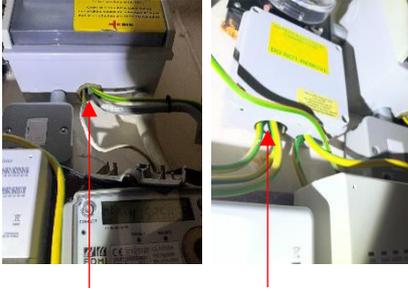
Missing grommets on installations

- 8) Electrical installation on the ground floor communal area has missing grommets to the communal distribution board and earth bonding unit. Requires assessment from electrical team to ensure that the installation is within electrical regulations.**

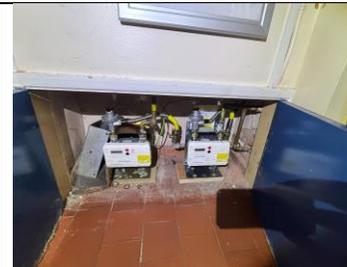
The residents' gas meter is located within a service cupboard on the ground floor, adjacent to the entrance to Flat 49. Recommended that the meters to be relocated externally or the present location made to vent externally. *A collective email regarding this and neighbouring blocks has been sent to the Gas Safety team on 03/02/2026*

- *Meeting held on the 23/02/2026 with electrical and gas safety team concluded that the gas service cupboards would be surveyed for the addition of ventilation being added to the outside of the building*

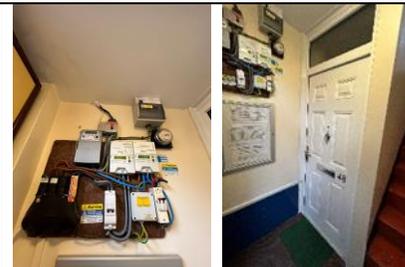
At present, appropriate control measures are in place to mitigate any potential risks associated with the exposed electrical switching located within the communal area of the block. However, electrical switching and metering installations will be required to be enclosed within a suitably fire-resisting enclosure in accordance with current fire safety standards as part of any future refurbishment works.

The design and installation of the enclosure must not impede access to Flat 49 or cause undue disruption to the resident.

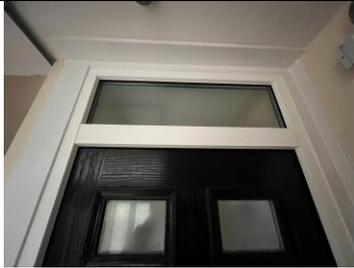
<p>The transom glazing installed in Flat 49 does not display any permanent marking or stamp to confirm that it is certified as fire-rated glazing. Instead, the only visible marking on the glass is <b>EN 14449</b>, which relates to laminated safety glass in accordance with European standards.</p> <p><b>EN 14449</b> certification indicates that the glazing is classified as laminated safety glass designed to reduce the risk of injury upon breakage. However, this marking does not confirm that the glass has been tested or approved for fire-resistance performance</p>
