Fire Risk Assessment

1-3

**Hawfield Close,
Tividale,
B69 1LH**

Date Completed: 11/02/2026

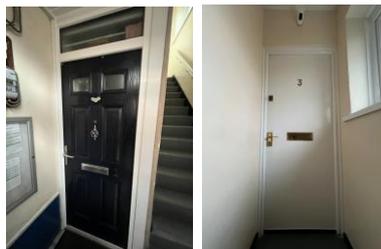
- 4) None of the corridors that form part of the means of escape are dead ends.
- 5) Two flats within the block, both doors are FD30 doors, one is a timber notional door

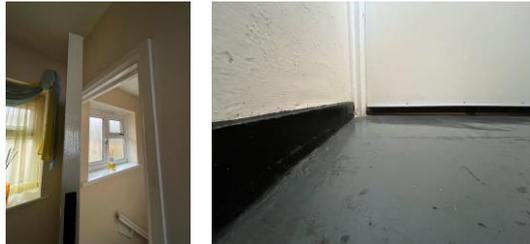
a) Flat 3: No self-closer is fitted to the door. Intumescent strip and cold smoke seal need fitting. Large gap at the base of the door, fit drop seal (Leasehold). Due to required works I will be putting adding to the actions that a new door is fitted.

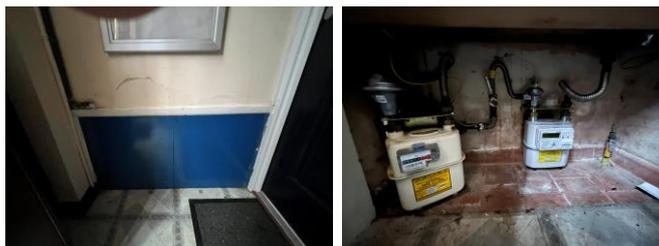
14) Gas meters: Gas meters are located outside flat 1 within the communal area of the block and are housed in small service cupboards that lack ventilation to the exterior. The cupboard doors are not fire-rated, are not fitted with appropriate lockable hardware to prevent unauthorised access, and do not display signage indicating the presence of gas installations (see Section 10/6), it is also recommended that an upgrade is carried out during future refurbishment works See Section 10.

“Fire Door – Keep Shut” also “Gas meter” signage should be affixed to the current door. Refer to Section 12 for the associated action.

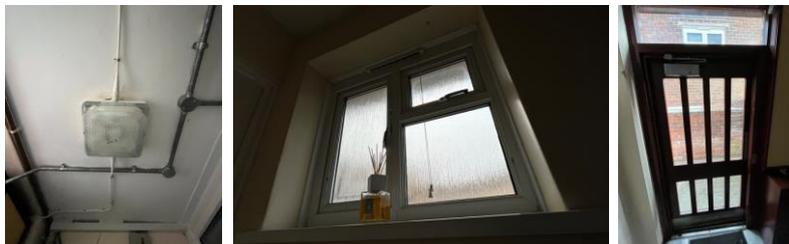
17) No emergency lighting is provided to communal landings and stairs. Adequate lighting comes from standard lighting also from the door and window areas.

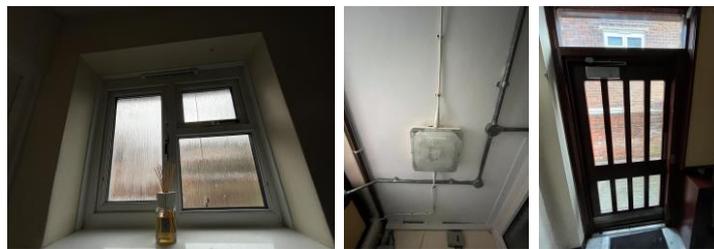
- 1) The premise is not fitted with emergency lighting
- 2) There is standard lighting within the communal area also a landing window and final exit door to assist in lighting the communal areas from outside

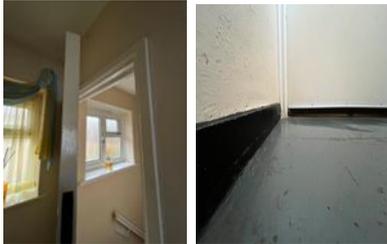
Question/ Ref No	Required Action	Supporting photograph	Priority	Timescale and Person Responsible	Date Completed
7/6a	Flat 3: New door required due to a number of issues ie no self closer, no intumescent strips and a large gap under the door

P3	Within 3-6 months Leasehold Management
