Fire Risk Assessment

**104-104a
Tower Road,
Oldbury,
B69 1PE**

Date Completed: 02/03/2026

Current Risk Rating = Tolerable

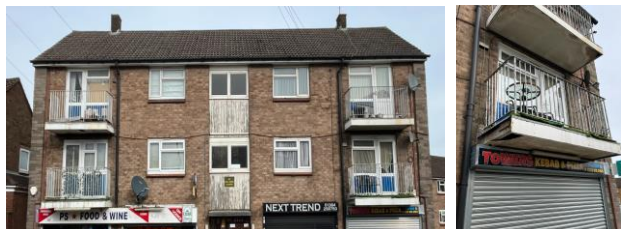
3) On the first and second floors at the front of the building, there are balconies fitted with steel balustrades. Each balcony consists of a concrete base and is accessed directly from the individual flats.

a) The underside of the balconies is boarded over with Amosite panels. Several of these boards are in a deteriorated condition. This issue has been reported to the line manager for further action.

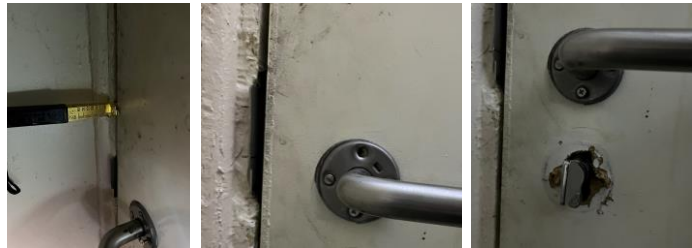
a) Flat 148: No self-closer was fitted. Damage on the inside of the door frame and around the thumb lock. The inside door handle is missing screws. Gaps in between the door and frame: Top of the door 5mm, slam side 6mm. Would recommend a new door set.

b) Flat 148: Artificial grass lay inside the property preventing the door from closing. This needs removing from within the doorway. *Email sent to housing manager 22/02/2026*

Question/ Ref No	Required Action	Supporting photograph	Priority	Timescale and Person Responsible	Date Completed
7/6a	Flat 148: Replace flat entrance fire door set

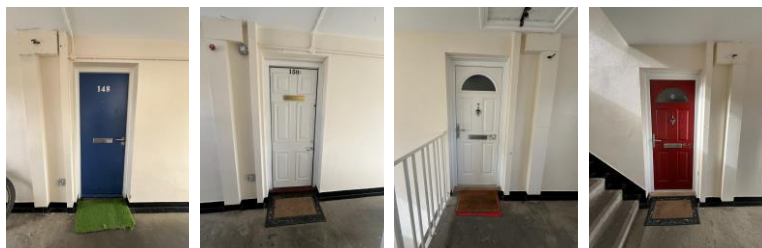
7) Outside each flat entrance a door mat is present; the fire rating is not known of the door mats, whilst most mats are deemed to be low risk as in good condition, the one outside flat 148, this is a trip hazard and would need removing from the communal area. *Email sent to housing manager 22/02/2026*

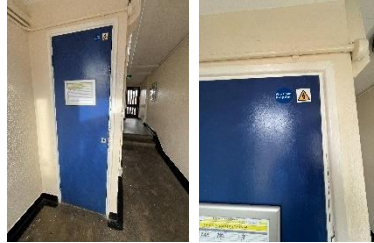
- 6) The electrical service cupboard on the ground floor in the communal area is fitted with a lockable 138-key lock and an upgraded notional FD30 timber door, complete with “Fire Door Keep Locked” and electrical hazard signage.

- a) **The framework surrounding the electrical service cupboard is in need of a repair because the deadlock is currently visible through the frame. The frame should be securely refixed to the wall, and the affected section filled.**

<p>10/6a</p>	<p>Service Cupboard: Ground floor electric service cupboard door frame requires repair / splice. Large gap within frame showing the deadlock, and frame coming away from the wall.</p>

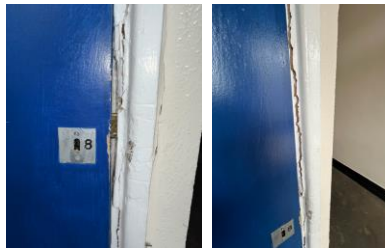
- b) **The wall pillar inside the service cupboard that supports the hinged side of the door requires replastering, as its current condition reduces the fire resistance of the wall. Replastering is needed to restore the necessary level of fire protection.**

<p>P3</p>	<p>3-6 Months Fire Rapid Response</p>	
<p>10/6b</p>	<p>Service Cupboard: The wall pillar inside the service cupboard that supports the hinged side of the door requires replastering</p>

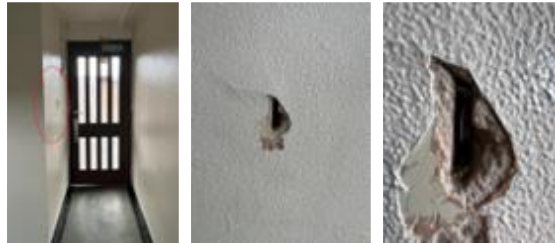
- 7) **The left-hand wall beside the internal rear final exit door contains a hole that opens through to the bin room. This breach requires filling to maintain the fire resistance of the escape route.**

<p>P3</p>	<p>3-6 Months Repairs Plastering</p>	
<p>10/7</p>	<p>Interior wall next to the rear final exit requires a repair due to a hole that goes through into the bin room. Plaster the hole fully through the wall.</p>

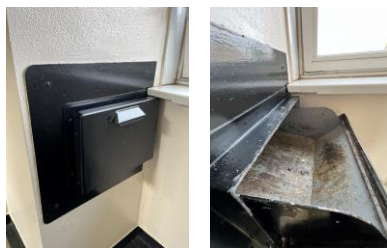
- 8) There is a mixture of notional timber, uPVC, and composite door sets. These should meet a minimum standard of notional timber FD30. Access to all properties was not possible at the time of the fire risk assessment. See section 7/5.
- 9) On the first and second floors, residents dispose of refuse via hopper openings connected to the main bin chute, which leads to the refuse container at ground level. These hoppers were inspected during the fire risk assessment and were found to be in full working order, with all seals intact and operating correctly. The integrity of these seals is essential, as they help prevent the spread of smoke and fire through the chute system. Continued routine inspection and maintenance of the hoppers and their seals are recommended to ensure they remain effective as part of the building's fire-resisting strategy.

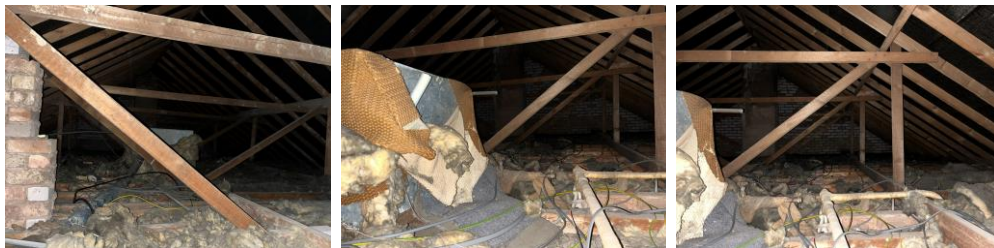
a) Within the roof void, there is no compartmentation separating the areas above the flats from the communal spaces. This has been included as a recommendation for future refurbishment works, as compartment walls must extend through the roof void to separate flats from each other and from the common parts. This is essential to prevent a fire in one flat from spreading through the roof void and affecting neighbouring flats or communal areas. *Added to observations to be carried out in future refurbishment.*

- Within the roof void, there is no compartmentation separating the areas above the flats from the communal spaces. This has been included as a recommendation for future refurbishment works, as compartment walls must extend through the roof void to separate flats from each other and from the common parts. This is essential to prevent a fire in one flat from spreading through the roof void and affecting neighbouring flats or communal areas.
-

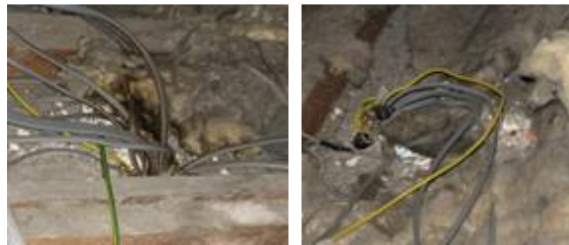
- 7) A number of potential concerns were observed within the roof void during the assessment. Signs of historic burning were present around cable penetrations from the flats below, with corresponding marks on the insulation. A council electrician has inspected this area following the FRA visit and confirmed it to be safe. Additionally, cables from a flat had been brought into the roof void to supply a light fitting, connected using block connectors and electrical tape. Light was visible from the flat below, indicating a breach in the compartment line. Remedial works have been scheduled to ensure the wiring is made safe and that appropriate compartmentation is reinstated. *Email on 26/02/2026 joint visit with our trade or supervisor as we require access equipment and torches, looking at the 12/03/2026 to carry out the inspection.*

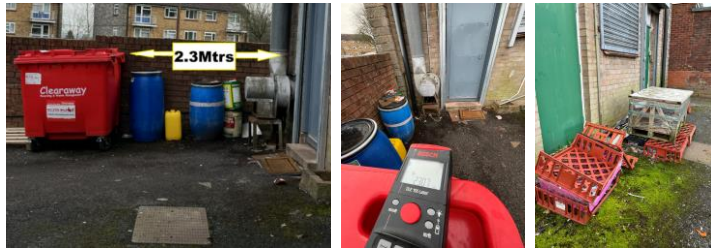
- 6) At the rear of the premises, a large waste bin and other discarded materials are currently sited within 2.3 metres from the building. Property Services has been contacted to work with the shop owner to relocate them to a safer location. Under CFPA-E Guideline No. 7:2022 F, plastic waste containers must be stored at least 4 metres away to limit the risk of fire exposure to the building. Maintaining this clearance also supports good housekeeping and reduces potential ignition sources.
