Fire Risk Assessment

**102-102a
Tower Road,
Oldbury,
B69 1NF**

Date Completed: 09/03/2026

Current Risk Rating = Tolerable

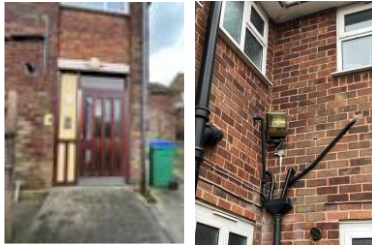
Above the front entrance door and within the rear courtyard there is a safety/security light installed.

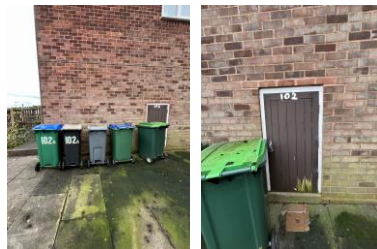
At the rear of the premises the courtyard is shared with 85-87 Hawfield Road. Within the building at the rear there is a small storage cupboard which is kept locked with a residential key.

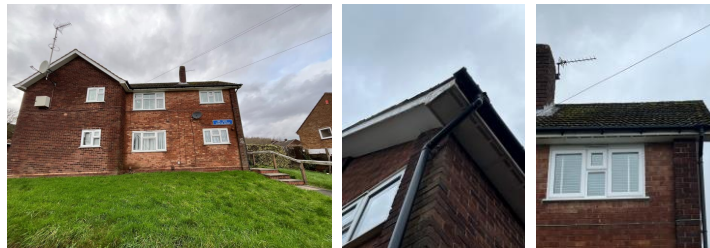
- 1) The external surface of the building is predominantly brick structure with uPVC facia and asbestos cement undercloaking soffits. The roof is pitched and fitted with concrete interlocking roof tiles on the roof.

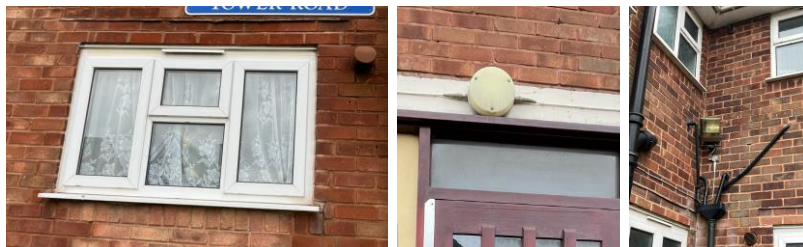
- 2) uPVC double-glazed units have been installed in each flat and one at the top of the communal stairway. A security/safety light is fitted above the entrance door and one at the rear of the property. The entrance door is timber construction with glazed panels.

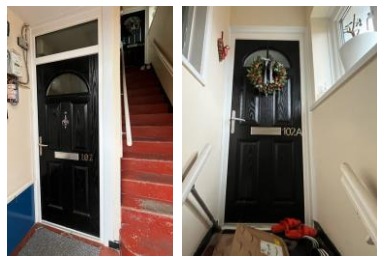
- 4) None of the corridors that form part of the means of escape are dead ends.
- 5) Two flats within the block, both doors are FD30s doors

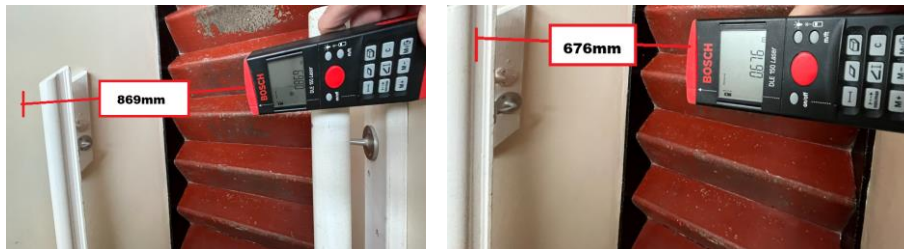
10) Within this block the first floor is accessed via a single staircase that provides a means of escape for flat 102a and has a width of a minimum of 676mm between the handrails, and 869mm wall to wall.

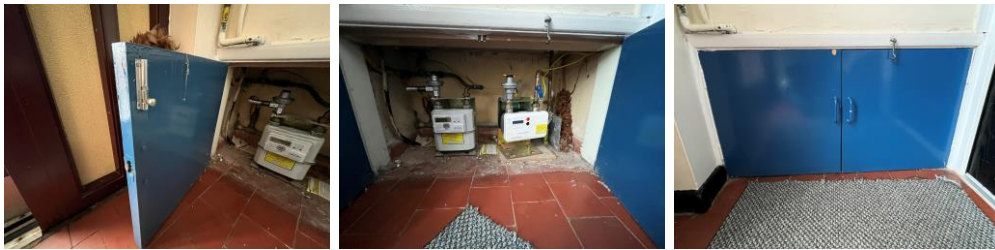
- 14) In the communal area on the ground floor outside flat 102 is situated the gas service cupboard see required actions under section 10/6
- 15) Gas meters: Gas meters are located outside flat 102 within the communal area of the block and are housed in small service cupboards that lack ventilation to the exterior. The cupboard doors are not fire-rated, are not fitted with appropriate lockable hardware to prevent unauthorised access, and do not display signage indicating the presence of gas installations (see Section 10/6), it is also recommended that an upgrade is carried out during future refurbishment works See Section 10.
“Fire Door – Keep Shut” also “Gas meter” signage should be affixed to the current door. Refer to Section 12 for the associated action.

- 7) The presence of gas meters within the communal escape route introduces a potential source of ignition due to the increased fire loading associated with gas infrastructure. Although the primary concern relates to gas accumulation and interference, the lack of external ventilation, non-fire-rated cupboard construction, and absence of appropriate protective measures heightens the risk that an electrical fault, accidental damage, or deliberate tampering could act as an ignition source in the event of a gas leak.

6) Gas Service Cupboard located ground floor outside flat 102: Gas meters should be relocated to an external position to remove the hazard from the communal escape route. SMBC Gas team have contacted Cadent to explore this option 19/01/2026; however, Cadent have confirmed that they have no planned works to relocate the meters within the next 12 months. As such, interim measures are required, including:

- a) As no future works are planned with Cadent to relocate the gas meters, suitable permanent ventilation must be provided. This should include the installation of a ventilation brick or equivalent arrangement to ensure compliant airflow to the exterior of the property. This has been added to recommendations to be undertaken at a future refurb date. Meeting held on the 23/02/2026 concluded that the service cupboards would be surveyed for the addition of ventilation being added to the outside of the building.

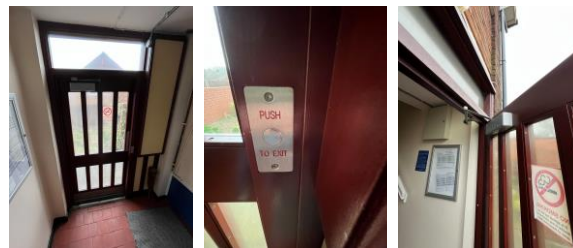
- 16) The final exit doors are fitted with a push button to egress the building and are also fitted with automatic closing devices that are checked on a regular basis by caretaking teams as part of their checks. Defective closing devices are replaced either by the Caretaking Team(s) or the in-house repairs team(s). The final exit doors have door entry systems installed. These systems are designed to fail safe i.e. door unlocked in the event of a power failure. This prevents residents being locked in or out of the building.

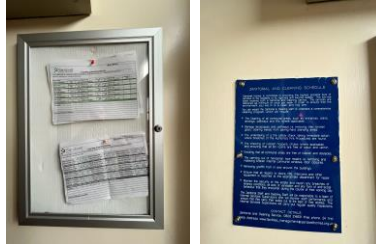
17) Communal areas are kept free of flammable items. The communal areas are checked on a regular basis by Caretaking / Cleaning teams 365 days per year and all items of rubbish are immediately removed. There is also an out of hour's service that allows combustible items of furniture / rubbish to be removed.

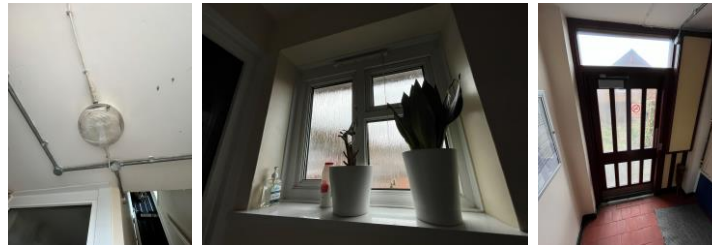
18) No emergency lighting is provided to communal landings and stairs. Adequate lighting comes from standard lighting also from the door and window areas.

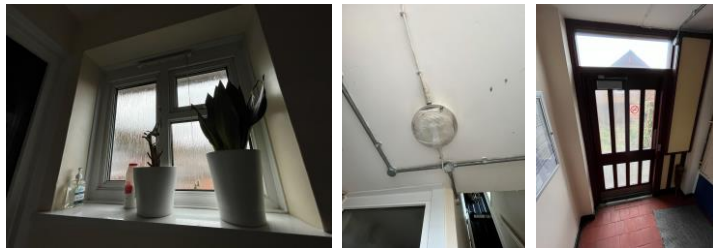
- 1) The premise is not fitted with emergency lighting
- 2) There is standard lighting within the communal area also a landing window and final exit door to assist in lighting the communal areas from outside

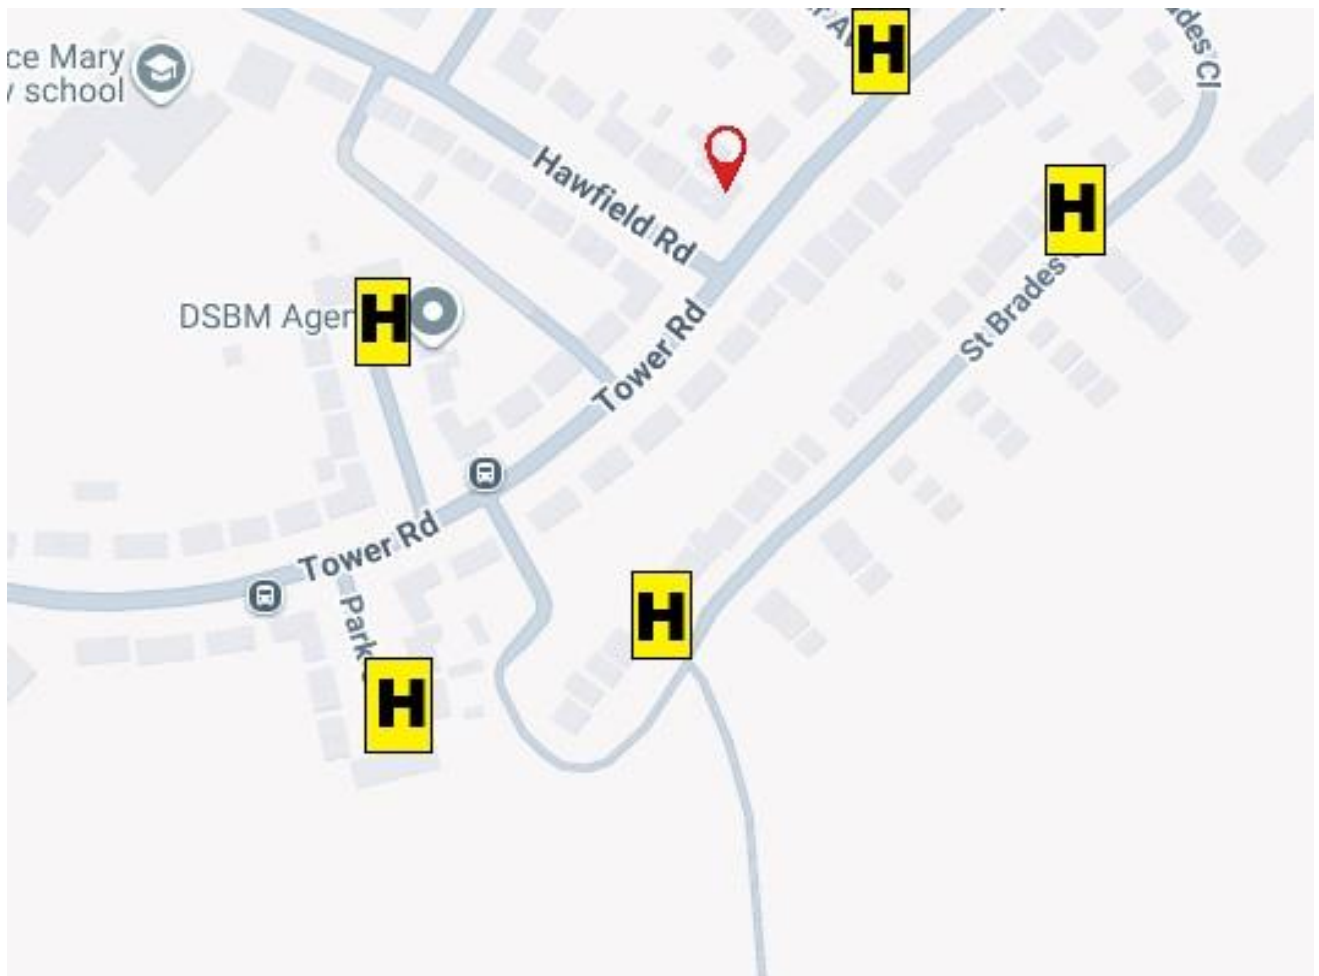
- 1) There is no firefighting equipment on this premises.
- 2) Nearest fire hydrant is indicated within the attached plan. Information from <https://dataservices.riscauthority.co.uk/map/index>

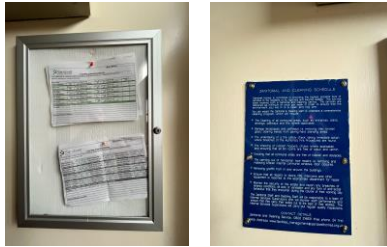
- 1) There is a regular Cleaning Service to the premises.

- 2) The refuse bins for 102-102a Tower Road are stored at the rear of the premises. These are emptied with the regular waste collections. Email sent to the caretaker and housing manager to relocate the bins away from the building.

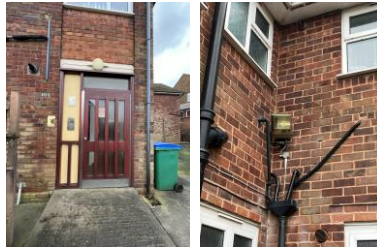
- 1) Regular checks are undertaken by Caretakers / Cleaning Team(s) 365 days per year which helps reduce the risk of arson.
- 2) Access to the premises is by means of a key, fob that only residents or using a fire fighters drop key.
- 3) Perimeter is covered by external lighting

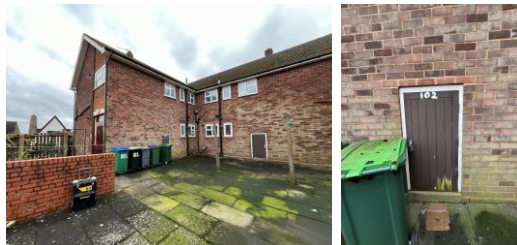
- 1) Residents instructed not to bring L.P.G cylinders into block.
- 2) The tenancy conditions, Section 7 – Condition 5.6 stipulates “If you live in a flat or maisonette, you, people living with you and any visitors to your property must not keep or use paraffin oil, petrol, bottled gas appliances or any other explosive, FLAMMABLE or dangerous material in the property. This restriction also applies to any storage facility situated in or attached to the block, which has been provided for your use.”
- 3) Residents should not store flammable liquids or gas cylinders on site.
- 4) No Flammable liquids stored on site by Caretakers / Cleaners.
- 5) There is one storage cupboard in the rear courtyard, which is built within the building and is locked by a tenant only key.
