Fire Risk Assessment

94-94A Tower Road

Tower Road, Tividale, Oldbury, B69 1LD

Date Completed: 5th February 2026

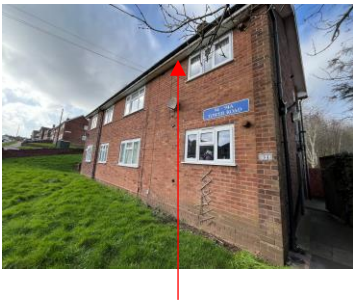
- 1)The exterior of the building is primarily traditional brick construction with a pitched roof design. The roof features concrete tiles and laminated fascia boards along the roofline and underside

Laminated boards on the underside & fascia

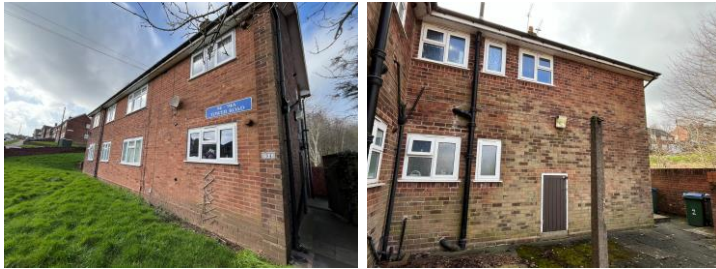
- 3) UPVC double-glazed window units have been installed in each flat and in the communal areas within the block.

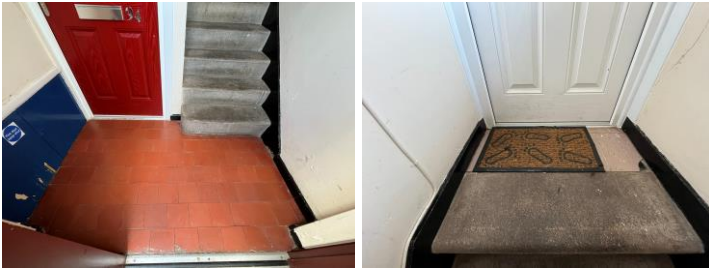
- 1) Each flat is equipped with, as a minimum LD3 fire detection to facilitate means of escape and provide sufficient response time.
- 2) The small section of the entrance hallway floor is installed with clay tiles. There is a small door mat placed at the entrance of 94A, the sizing and condition of the mat is acceptable. This area is kept clear of any obstruction and combustibles promote maintain safe exit in an event of fire.

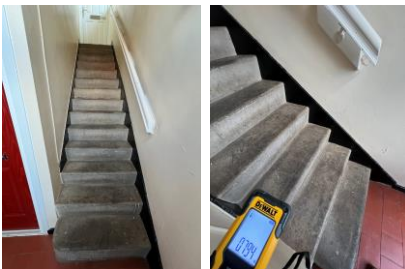
- 3) 94 -94A Tower Road contains a single concrete staircase, positioned at the entrance of the block, which provides an adequate means of escape. The width of the staircases, measured from wall to handrail, is 794 mm respectively, this is acceptable as the staircase serves a single flat. This staircase is kept clear to ensure a safe means of escape.

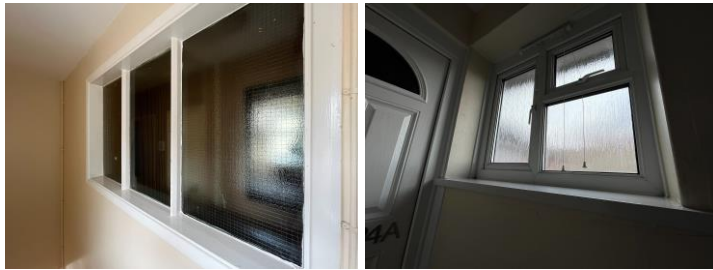
- 4) A UPVC window unit has been installed on the staircase landing which is openable without the use of key. This installation provides sufficient borrowed lighting and ventilation, while an incorporated Georgian wired glazing unit has been installed on the flat side to protect the means of escape and prevent the spread of fire and smoke. It should be noted that there is currently no automatic smoke ventilation system installed on the premises.

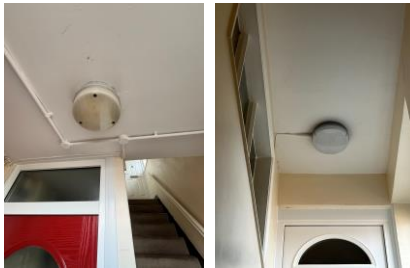
- 5) Sufficient lighting installed over the staircase and over the small hallway by the final exit door.

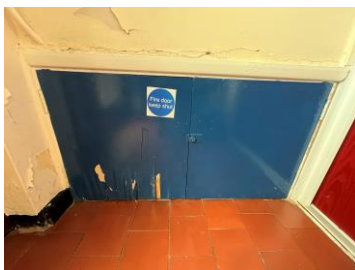
- 6) The ground floor entrance houses a gas service cupboard near to the entrance of flat 94, this is secured by a push-button lock. *Action regarding the location of gas meter has been noted in section 10, Compartmentation.*

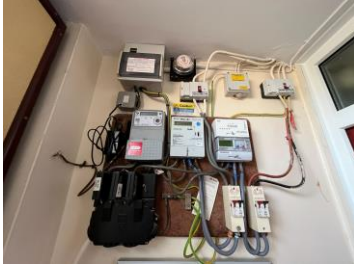
- 7) Residential electrical meters and associated switch gear are installed on an open board without a suitable fire-resistant enclosure. The installation is positioned within a designated means of escape and immediately adjacent to the entrance of Flat 94 which may present a fire safety concern. *This has been noted in the section 14 Source of Ignition.*

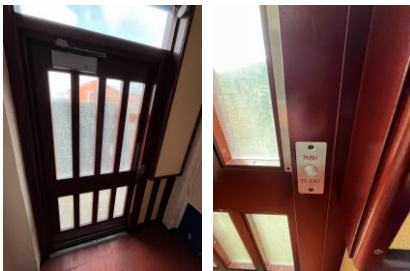
- 9) The final exit door is installed with a push button system; this is made to fail safe in an emergency which aids easy and safe evacuation out of the building in an event of a fire.

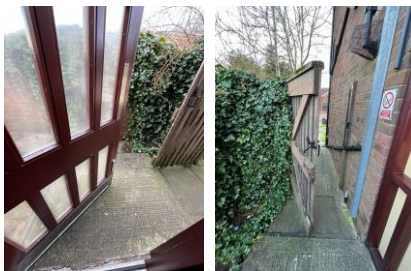
- 10) Ultimate safety is ensured through access via a timber gate. The gate is intentionally left without a key lock mechanism, allowing for immediate, unobstructed egress.

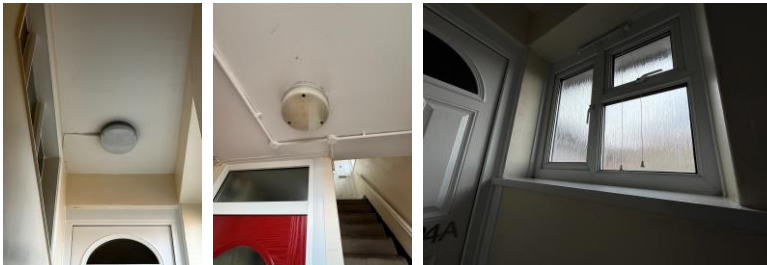
- 1) While dedicated emergency lighting has not been installed on the premises, the existing illumination is deemed adequate. This is due to the strategic placement of lighting units above the stairs and by the final exit, supplemented by sufficient borrowed lighting from the externally facing window on the staircase landing.

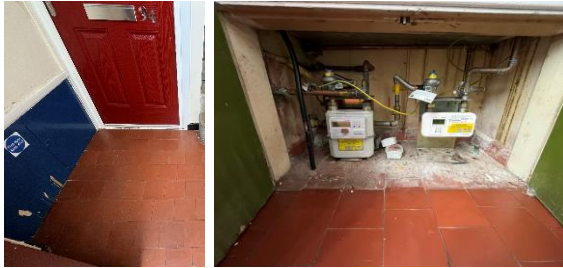
- 3) The residents' gas meters are located within a service cupboard on the ground floor, adjacent to the entrance to Flat 94. Recommended that the meters to be relocated outside or the present location made to vent externally. *A collective email regarding this and neighbouring blocks has been sent to the Gas Safety team on 03/02/2026 to liaise with Cadent regarding the relocation of meters. See below for reply from Cadent.*

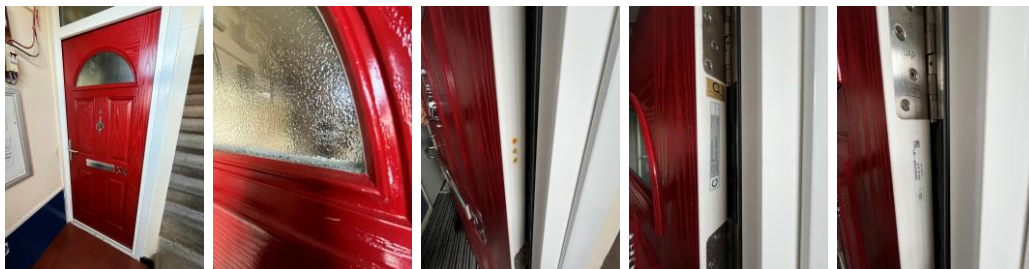
6) Flats 94 & 94A have been fitted with a certified composite FD30s fire door assembly. There is also laminated glazing installed within the section of the flat entrance door. Could not gain access to inspect flat entrance door to flat 94A.

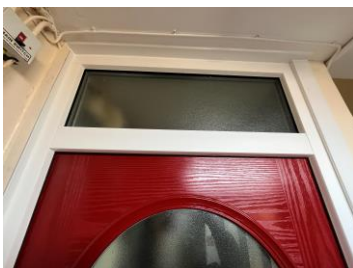
- 8) Transome glazing to flat 94 does not have fire rated glazing installed within the frame. There is no evidence of fire rated glazing marking etched on to the glazing.

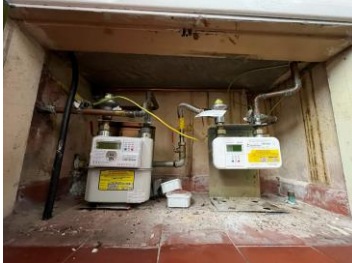
- 5) Gas appliances and pipework (where installed) are subject to annual testing and certification. This contract is managed by the in-house Gas team. Gas supply to these premises is internal. This cupboard is kept clear of any combustible items.

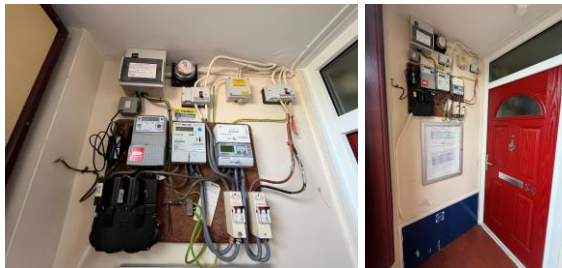
- 6) At present, appropriate control measures are in place to mitigate any potential risks associated with the exposed electrical switching located within the communal area of the block. However, electrical switching and metering installations will be required to be enclosed within a suitably fire-resisting enclosure in accordance with current fire safety standards as part of any future refurbishment works.

The design and installation of the enclosure must not impede access to Flat 94 or cause undue disruption to the resident. *Noted in Observations*

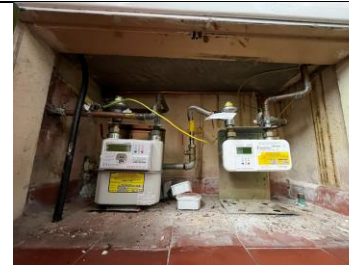
The residents' gas meter is located within a service cupboard on the ground floor, adjacent to the entrance to Flat 94. Recommended that the meters to be relocated externally or the present location made to vent externally. *A collective email regarding this and neighbouring blocks has been sent to the Gas Safety team on 03/02/2026*

- *Meeting held on the 23/02/2026 with electrical and gas safety team concluded that the gas service cupboards would be surveyed for the addition of ventilation being added to the outside of the build*

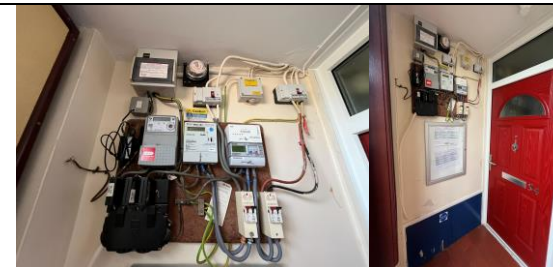
At present, appropriate control measures are in place to mitigate any potential risks associated with the exposed electrical switching located within the communal area of the block. However, electrical switching and metering installations will be required to be enclosed within a suitably fire-resisting enclosure in accordance with current fire safety standards as part of any future refurbishment works.

The design and installation of the enclosure must not impede access to Flat 94 or cause undue disruption to the resident.
