Fire Risk Assessment

96-96A Tower Road

Tower Road, Tividale, Oldbury, B69 1LD

Date Completed: 5th February 2026

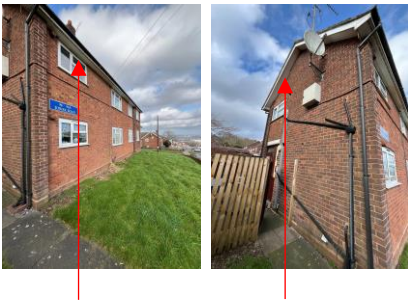
- 1)The exterior of the building is primarily traditional brick construction with a pitched roof design. The roof features concrete tiles and laminated fascia boards along the roofline and underside

Laminated boards on the underside & fascia

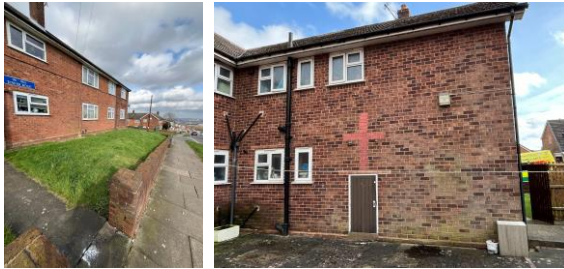
- 3) UPVC double-glazed window units have been installed in each flat and in the communal areas within the block.

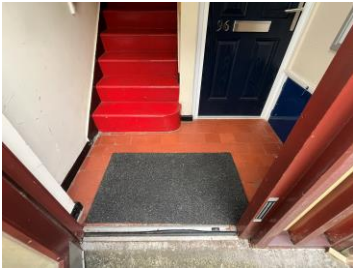
- 1) Each flat is equipped with, as a minimum LD3 fire detection to facilitate means of escape and provide sufficient response time.
- 2) The small section of the entrance hallway floor is installed with clay tiles. There is a small door mat placed at the entrance of the block, the sizing and condition of the mat is acceptable. This area is kept clear of any obstruction and combustibles promote maintain safe exit in an event of fire.

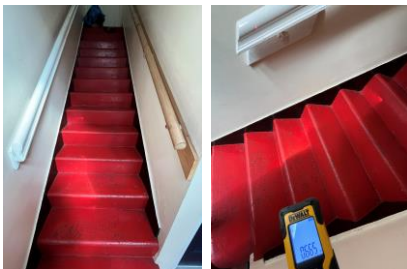
- 3) 96-96A Tower Road contains a single concrete staircase, positioned at the entrance of the block, which provides an adequate means of escape. The width of the staircases, measured from handrail to handrail, is 665 mm respectively, this is acceptable as the staircase serves a single flat. This staircase is kept clear to ensure a safe means of escape.

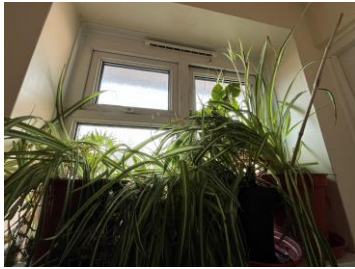
- 4) A UPVC window unit has been installed on the staircase landing which is openable without the use of key. This installation provides sufficient borrowed lighting and ventilation. Resident has placed live plants on the windowsill; these items pose a low fire risk and no obstruction to safe evacuation.

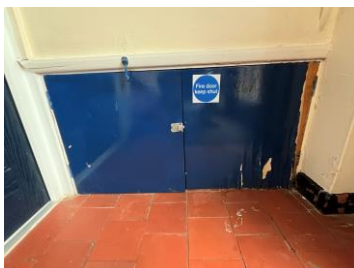
- 6) The ground floor entrance houses a gas service cupboard near to the entrance of flat 96, this is secured by a push-button lock. *Action regarding the location of gas meter has been noted in section 10, Compartmentation.*

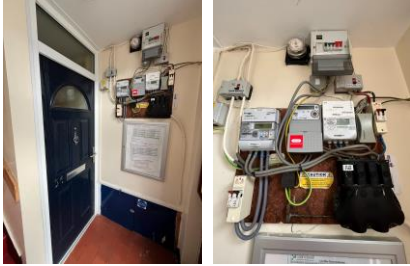
- 7) Residential electrical meters and associated switch gear are installed on an open board without a suitable fire-resistant enclosure. The installation is positioned within a designated means of escape and immediately adjacent to the entrance of Flat 96 which may present a fire safety concern. *This has been noted in the section 14 Source of Ignition.*

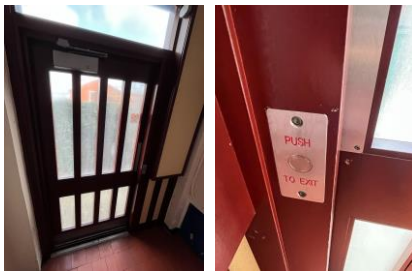
- 8) The final exit door is installed with a push button system; this is made to fail safe in an emergency which aids easy and safe evacuation out of the building in an event of a fire.

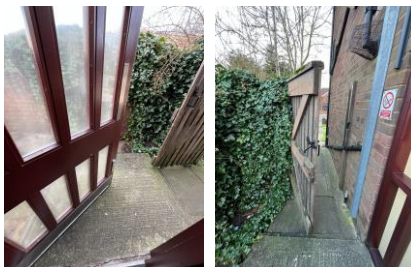
- 9) Ultimate safety is ensured through access via a timber gate. The gate is intentionally left without a key lock mechanism, allowing for immediate, unobstructed egress.

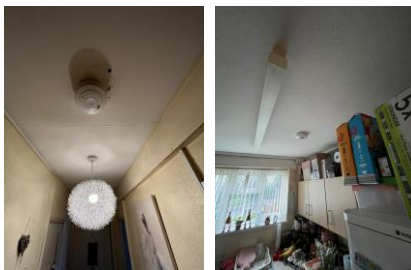
- 1) Early warning is limited to hard wire or battery smoke alarms within each of the resident's flats, this is installed to a minimum of LD3 as standard, the equipment is subjected to a cyclical test.
- 2) There is no effective means for detecting an outbreak of fire to communal areas. The reason for this is:
 - I. Such systems may get vandalised.
 - II. False alarms would occur.
 - III. A Stay Put - Unless policy is in place
- 4) Access was obtained to flat 96 to check for confirmation of detection.

Flat 96 – Detection in hallway, kitchen, living room, LD2
Flat 96A– No access gained.

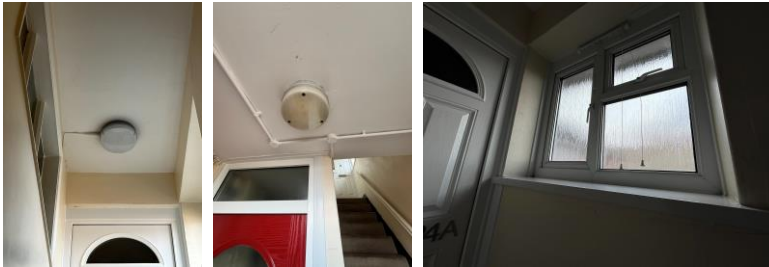
- 1) While dedicated emergency lighting has not been installed on the premises, the existing illumination is deemed adequate. This is due to the strategic placement of lighting units above the stairs and by the final exit, supplemented by sufficient borrowed lighting from the externally facing window on the staircase landing.

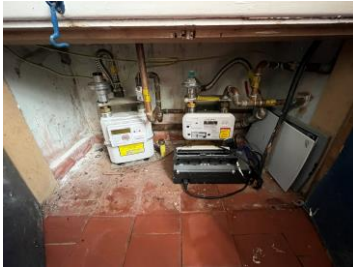
- 3) The residents' gas meters are located within a service cupboard on the ground floor, adjacent to the entrance to Flat 96. Recommended that the meters to be relocated outside or the present location made to vent externally. *A collective email regarding this and neighbouring blocks has been sent to the Gas Safety team on 03/02/2026 to liaise with Cadent regarding the relocation of meters. See below for reply from Cadent.*

- 4) It is recommended that the service cupboard is upgraded to provide an appropriate level of fire resistance. The cupboard should be fitted with lockable fire-rated doors incorporating intumescent strips and smoke seals to help prevent the spread of fire and smoke

As no future works are planned with Cadent to relocate the gas meters, suitable permanent ventilation must be provided. This should include the installation of a ventilation brick or equivalent arrangement to ensure compliant airflow to the exterior of the property. *Noted in Observations*

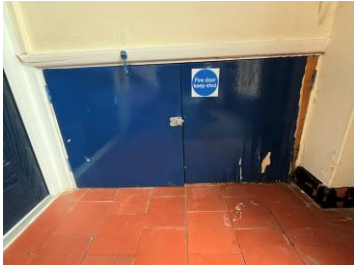
5) To ensure the gas service cupboard remains securely closed and continues to comply with the required fire safety standards, an appropriate bolt lock should be installed on the gas service cupboard serving Flats 96-96A.

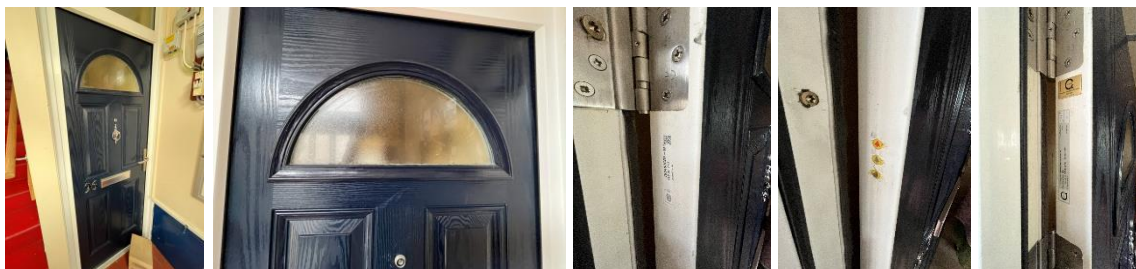
Flat 96

6) Flats 96 has been fitted with a certified composite FD30s fire door assembly. There is also laminated glazing installed within the section of the flat entrance door. Entry to flat 96A could not be gained to inspect the condition of the door and function of the self-closing device.

| 10/8 | Adjust self-closing device to flat 96 | | P2 | 1 -3 Months Fire Rapid Response | |

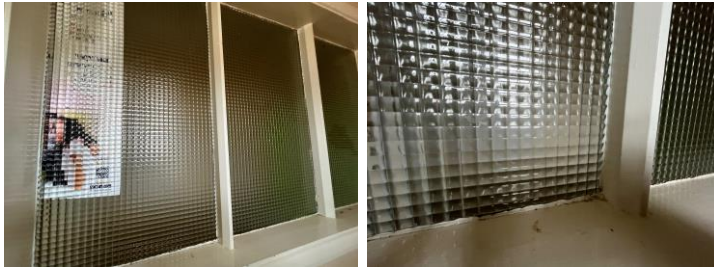
7)The glazing installed within the resident's window in the communal stairwell does not provide adequate fire resistance between the flat and stairs

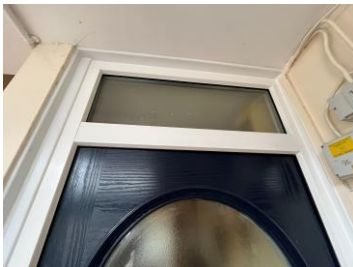
- 9) Transome glazing to flat 96 does not have fire rated glazing installed within the frame. There is no evidence of fire rated glazing marking etched on to the glazing.

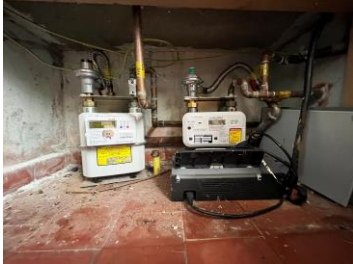
- 6) Gas appliances and pipework (where installed) are subject to annual testing and certification. This contract is managed by the in-house Gas team. Gas supply to these premises is internal. This cupboard is expected to be kept clear of any combustible items. Resident advised on the day to remove items stored within.

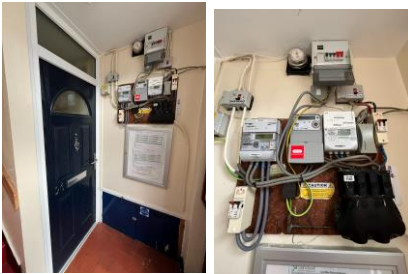
- 7) At present, appropriate control measures are in place to mitigate any potential risks associated with the exposed electrical switching located within the communal area of the block. However, electrical switching and metering installations will be required to be enclosed within a suitably fire-resisting enclosure in accordance with current fire safety standards as part of any future refurbishment works.

The design and installation of the enclosure must not impede access to Flat 96 or cause undue disruption to the resident. *Noted in Observations*

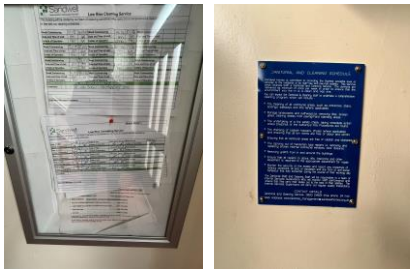
- 1) Sandwell Cleaning services and caretaking teams are employed at this block; there is a scheduled plan in place for cleaning teams to attend site.

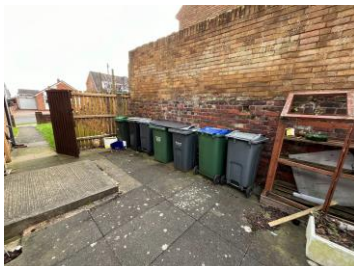
- 2) Refuse bins are located at side of the building, away from the envelope of the block.

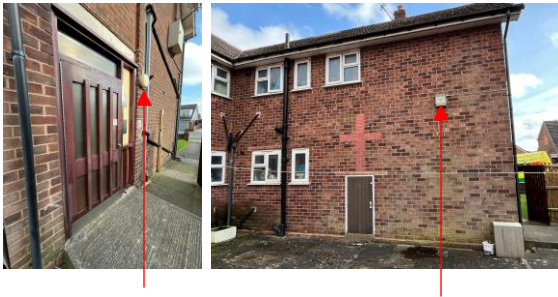
Front and rear external lighting

- 1) There is no current evidence of arson.
- 2) The perimeter of the premises is well illuminated with the installation of external lighting.

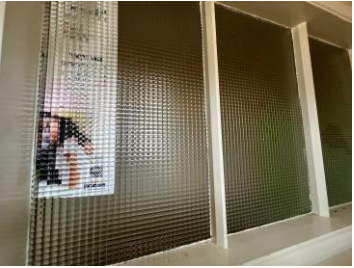
| 10/7 | Glazing in flat 96A window overlooking communal stairs does not have fire rated glazing, replace with fire rated glazing. | | P2 | 1-3 Months Repairs Glazing Team | |

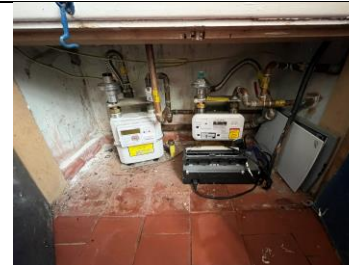
The residents' gas meter is located within a service cupboard on the ground floor, adjacent to the entrance to Flat 94. Recommended that the meters to be relocated externally or the present location made to vent externally. *A collective email regarding this and neighbouring blocks has been sent to the Gas Safety team on 03/02/2026*

- *Meeting held on the 23/02/2026 with electrical and gas safety team concluded that the gas service cupboards would be surveyed for the addition of ventilation being added to the outside of the build*

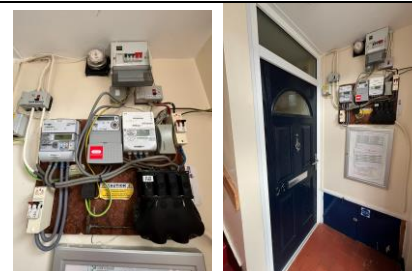
At present, appropriate control measures are in place to mitigate any potential risks associated with the exposed electrical switching located within the communal area of the block. However, electrical switching and metering installations will be required to be enclosed within a suitably fire-resisting enclosure in accordance with current fire safety standards as part of any future refurbishment works.

The design and installation of the enclosure must not impede access to Flat 96 or cause undue disruption to the resident.
