# Fire Risk Assessment

**118-118A  
Tower Road,  
Tividale,  
Oldbury,  
B69 1NE.**

**Date Completed: 02/03/2026**

**Current Risk Rating = Tolerable**

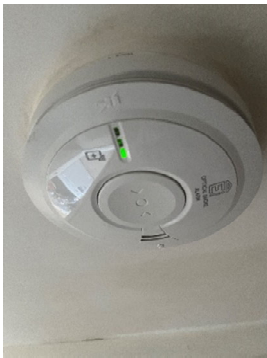
Flat 118A was accessed and was seen to be LD1 standard.

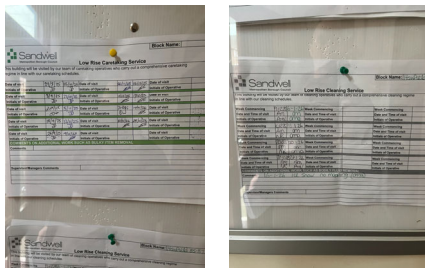
3. Regular checks by Caretakers minimise risk of waste accumulation.
