# Fire Risk Assessment

**165-166A  
Tower Road,  
Tividale,  
Oldbury,  
B69 1PA.**

**Date Completed: 02/03/2026**

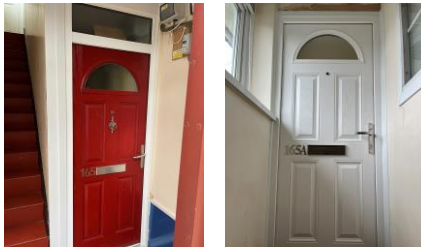
- 1) Flat 165 and 165A have FD30s rated composite fire doors which are glazed with 165 having a transom above the door.

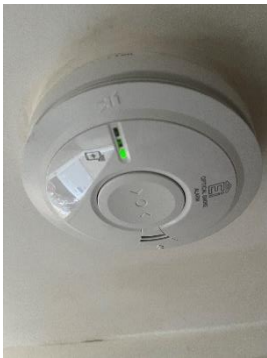
Flat 165 was accessed and was seen to be LD1 standard.

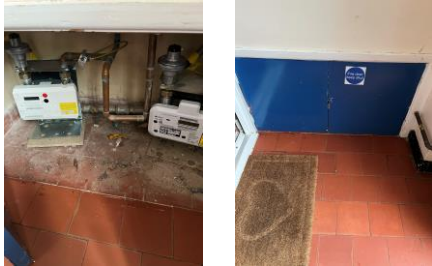
- 7) The gas meter is in a service cupboard in the communal entrance Just below the electrical installation. This is not to current regulations it has no ventilation to outside and no lockable fire rated doors. An email has been sent to the gas team to contact cadent about relocating the gas meters to outside. See observations.

*An email was sent to the Gas Compliance Manager on 19/01/2026 requesting that a job be raised with Cadent to progress this work, and the recommendation has been recorded under observations. Relevant legal and technical guidance supporting this recommendation can be found within the Gas Safety (Installation and Use) Regulations 1998*

- a) As no future works are planned with Cadent to relocate the gas meters, recommend permanent ventilation being provided. This should include the installation of a ventilation brick or equivalent arrangement to ensure compliant airflow to the exterior of the property. This has been added to recommendations to be undertaken at a future refurb date. Meeting held on the 13/02/2026 concluded that the service cupboards would be surveyed for the addition of ventilation being added to the outside of the building.

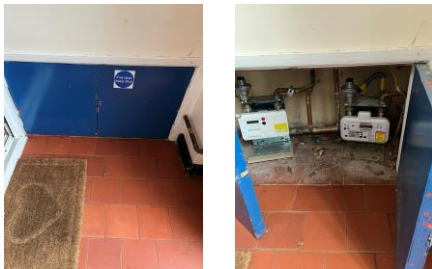
- 8) **The left-hand door bottom hinge has come loose this requires repair or replacement. See action 7/8.**

10/8	The left-hand door bottom hinge has come loose this requires repair or replacement.

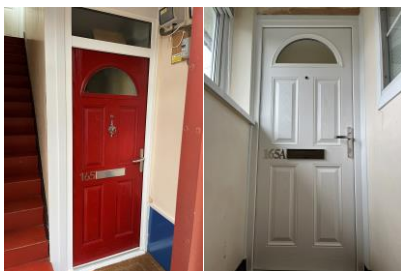
- 9) Flat 165 and 165A have a composite FD30s rated fire door fitted which protects the means of escape.

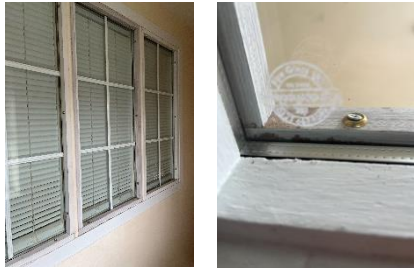
- 10) Although the flat entrance doors are FD30s composite doors no evidence could be seen on any of the glass to prove the fire rating of the glass.

11) Flat 165A is a lease holder flat and has had some work carried out to replace glazing to a sufficient fire rated standard, this is now completed and meets the standard for fire resistance.
