Fire Risk Assessment

Sampson Close 7-12

Sampson Close Tividale, B69 1NL

Date Completed: 1st April 2026

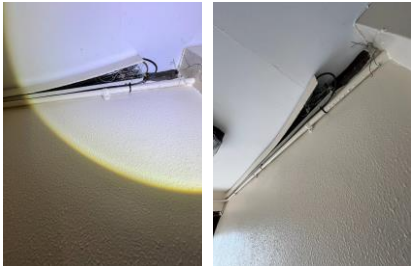
- 10) Electrical trunking located along the ground floor communal corridor is damaged, resulting in the lid becoming dislodged and leaving the internal cabling exposed. It is recommended that the damaged trunking be replaced or repaired, and that the lid be securely refitted to ensure all cabling is fully enclosed and adequately protected.

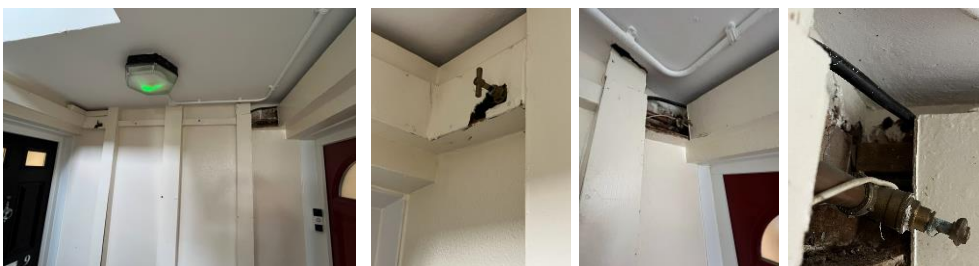
- 7) On the second-floor communal landing, section of timber boxed trunking has been removed to access the water shut off valve, leaving opening that exposes internal cable run. There are also, within this section penetrated holes into the brick work where previous pipes or cabling were channelled through.

It is recommended that the trunking be repaired or reinstated to fully enclose the cabling without reducing the access to the water shut of valve.

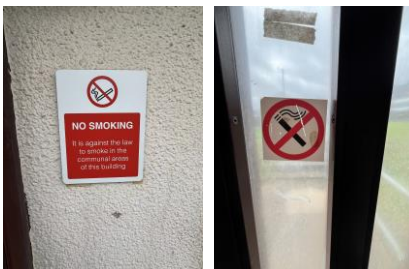
- 4) No smoking signage on the rear needs to be replaced with a new sign due to being damaged

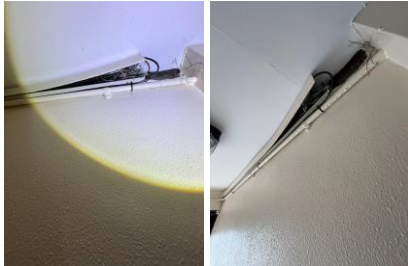
Question/ Ref No	Required Action	Supporting photograph	Priority	Timescale and Person Responsible	Date Completed
7/10	Ground floor communal corridor, electrical trunking damaged exposing cables, Replace and make secure.

P2	1-3 Months Electrical Team

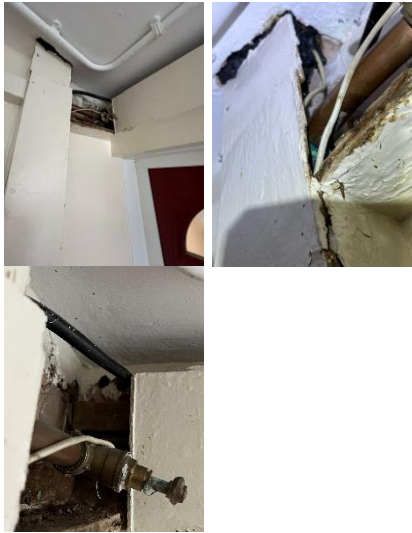
10/8	<p>2nd floor landing, timber box trunking around water shut off valve removed and exposing cable run, requires adequate fire stopping on brickwork behind and section of trunking replaced without reducing access to the water shut of valve</p>

P2	1-3 Months Fire Rapid Response	
12/4	<p>External No Smoking signage to the rear is damaged. Replace with new signage.</p>
