Fire Risk Assessment

Sampson Close 13 -18

Sampson Close Tividale, B69 1NL

Date Completed: 3rd April 2026

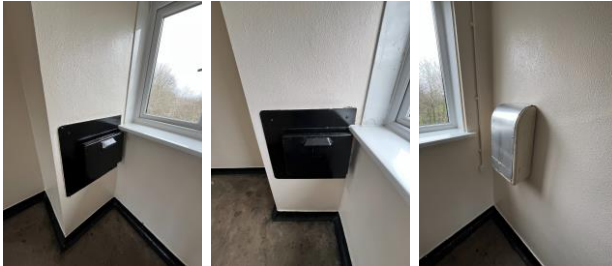
- 8) On both 1st floor and 2nd floor landings, there are bin chute hoppers within the means of escape, they do not present any obstruction in the event of safe evacuation. There is also a decommissioned incinerator installed on the 1st floor landing, this has been sealed shut with the use of aluminium metal sheeting.

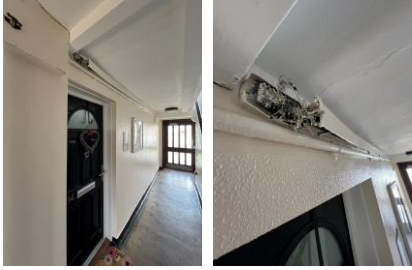
- 11) Electrical trunking located along the ground floor communal corridor is damage, resulting in the lid becoming dislodged and leaving the internal cabling exposed. It is recommended that the damaged trunking be replaced or repaired, and that the lid be securely refitted to ensure all cabling is fully enclosed and adequately protected.**
-

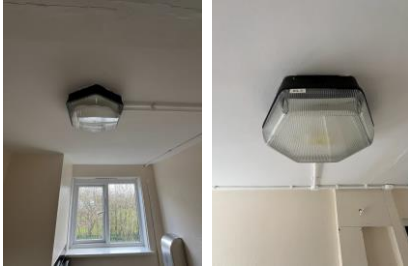
5) Emergency light on the 1st floor landing is not functioning, *email sent to the electrical team on the 31/03/2026. Repair has been scheduled.*

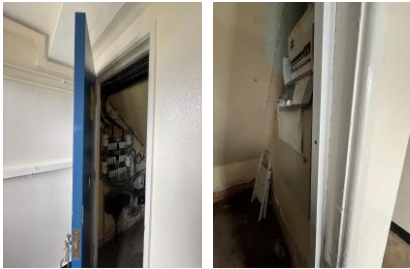
- 4) **Electrical cupboard does not have the required combined smoke and intumescent seals installed.**

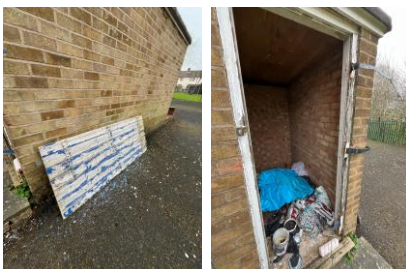
- 6) Resident external storage cupboard to the rear has a door removed, leaving stored combustibles easily accessible to arson.
Email sent to repairs on 13/04/2026.

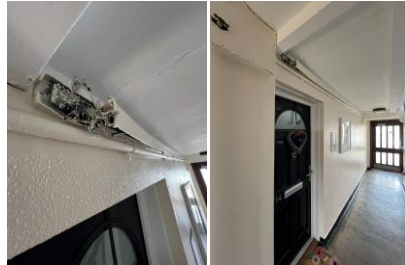
Question/ Ref No	Required Action	Supporting photograph	Priority	Timescale and Person Responsible	Date Completed
7/11	Ground floor communal corridor, electrical trunking damaged exposing cables, Replace and make secure.

P2	1-3 Months Electrical Team
