Fire Risk Assessment

Sampson Close 19-24

Sampson Close Tividale, B69 1NL

Date Completed: 3rd April 2026

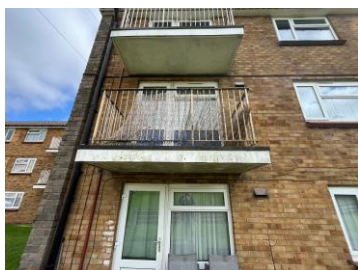
- 5) Flat 21 has wicker screening attached to the balcony railings. This will be required to be removed of the balcony.

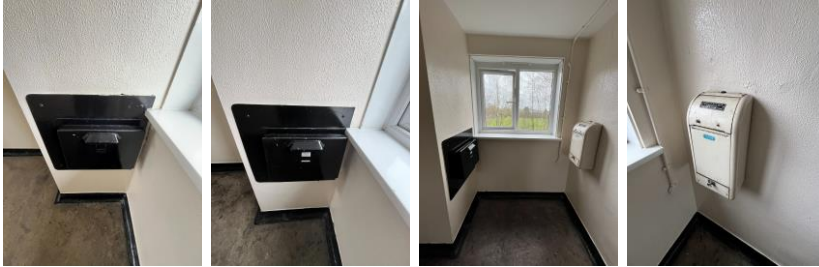
- 8) On both 1st floor and 2nd floor landings, there are bin chute hoppers within the means of escape, they do not present any obstruction in the event of safe evacuation. There is also a decommissioned incinerator on the 1st floor landing.

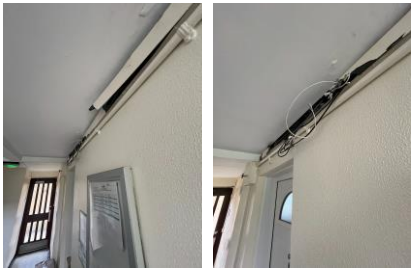
- 11) **Electrical trunking located along the ground floor communal corridor is damage, resulting in the lid becoming dislodged and leaving the internal cabling exposed. It is recommended that the damaged trunking be replaced or repaired, and that the lid be securely refitted to ensure all cabling is fully enclosed and adequately protected.**

7/11	Ground floor communal corridor, electrical trunking damaged exposing cables, Replace and make secure.	 	P2	1-3 Months Electrical Team	
------	-------------------------------------------------------------------------------------------------------	-------------------------------------------------------------------------------------	----	-------------------------------	--

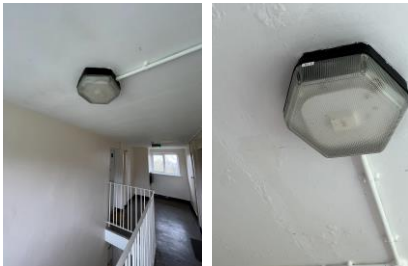
5) Emergency light on the 2nd floor landing is not functioning, *email sent to the electrical team on the 31/03/2026. Repair has been scheduled.*

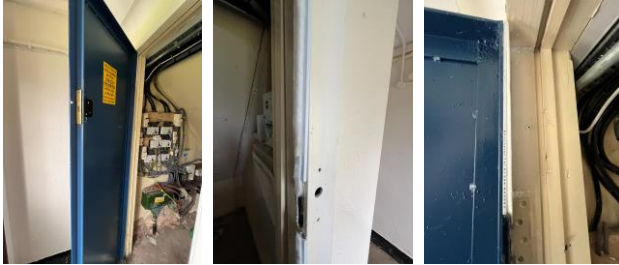
- 4) Electrical cupboard does have brush smoke seals installed to the frame of the door, however its is recommended that on any future works programme to the block that this door be replaced with a certified FD30s fire door.

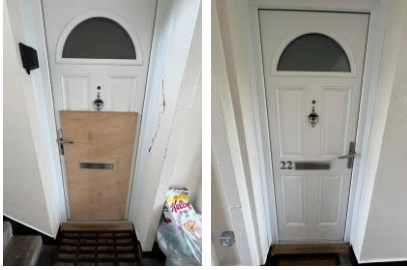
1st floor flats 21,22

Flat 21, has a damaged front entrance door which has had a temporary plyboard fixed to the leaf of the door, a replacement door and frame set have been ordered for this flat. Confirmation is on Sandwell Council's door management portal.

7) Flat 21 front entrance door is damaged and has been fitted with a temporary plywood board to the leaf of the door. Confirmation of new door set has been recorded on the Sandwell door management system for this flat.

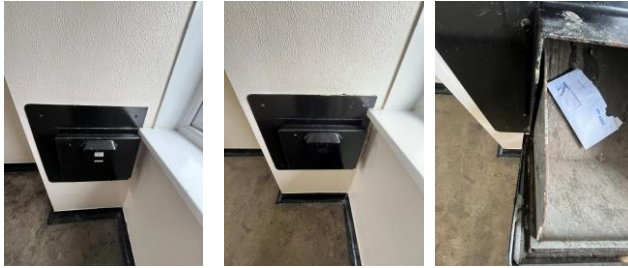
6) Intumescent seals have been installed within the chute hoppers on the 1st and 2nd landing
