# Fire Risk Assessment

**2-4 Tower Rise,  
Tividale,  
B69 1NP**

**Date Completed: 02/04/2026**

**Officer: S. Henley Fire Risk Assessor**

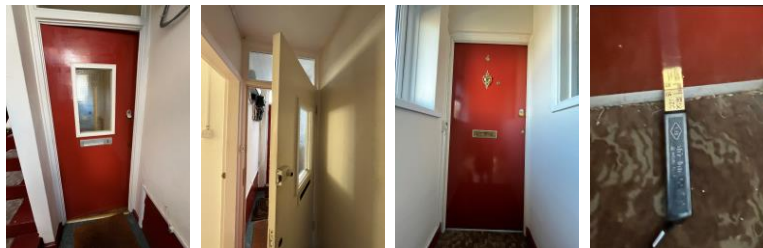
6) Access was attempted to the properties as part of the risk assessment. This was to ensure the doors have not been tampered with by residents. Access was gained to the following

**a) Flat 2 (Leasehold): No Self closer in place. Notional fire door, no intumescent strips or smoke seals/brushes. *Email sent to the leasehold manager 20/03/2026***

**b) Flat 4 (Leasehold): No answer. Notional timber door fitted. The door has a large gap at almost 15mm, *this has been emailed to the leasehold manager 20/03/2026***

Question/ Ref No	Required Action	Supporting photograph	Priority	Timescale and Person Responsible	Date Completed
7/6a	<b>Flat (Leasehold):</b> Fit self closer, intumescent strips and smoke seals – or replace the door for an FD30s fire door

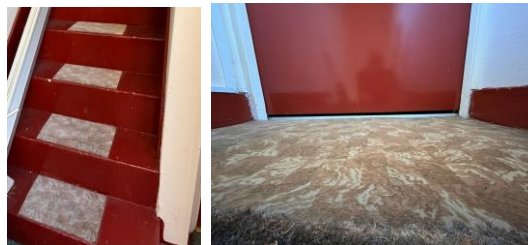
7) Upon the stairs small carpet pads are fitted, full section of carpet is fitted outside flat 4; the fire rating is not known of the carpet it is deemed to be low risk as in good condition.

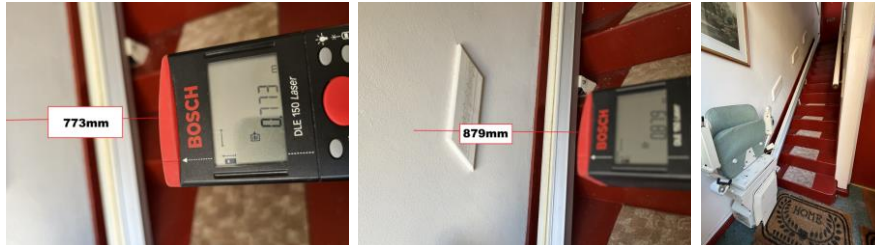
9) Within this block the first floor is accessed via a single staircase that provides a means of escape for flat 4 and has a width of a minimum of 773mm between the handrails, and 879mm wall to wall. At the time of the fire risk assessment there was a stairlift fitted which reduces the stairway down. I was informed that this is to be removed soon.

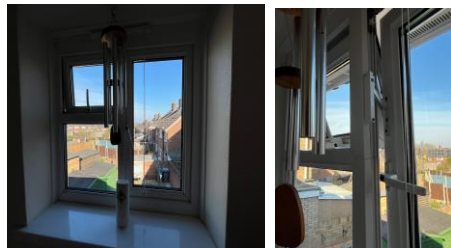
11) Automatic smoke ventilation is not employed. Window at the top of the stairway outside flat 4 is fitted with a manual opener; the window will assist in additional lighting and any ventilation required.

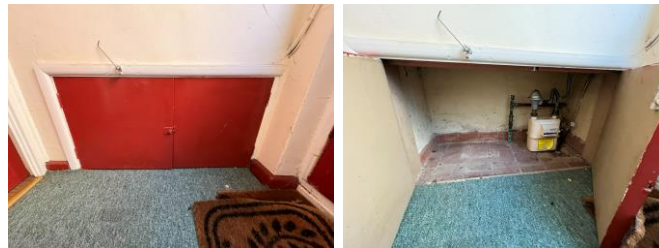
14) Gas meter: Gas meter serving flat 4 is located outside flat 2 within the communal area of the block and are housed in small service cupboard that lacks ventilation to the exterior. The cupboard doors are not fire-rated, are not fitted with appropriate lockable hardware to prevent unauthorised access, and do not display signage indicating the presence of gas installations (see Section 10/6), it is also recommended that an upgrade is carried out during future refurbishment works See Section 10.

“Fire Door – Keep Shut” also “Gas meter” signage requires to be affixed to the current door. Refer to Section 12 for the associated action.

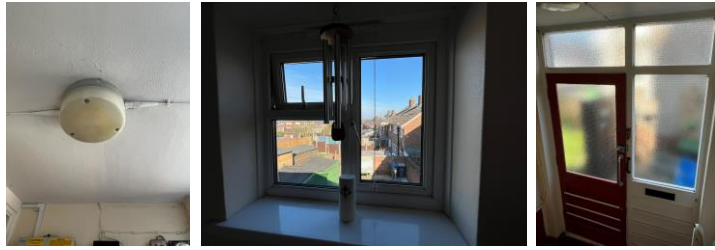
18) No emergency lighting is provided to communal landings and stairs. Adequate lighting comes from standard lighting also from the door and window areas.

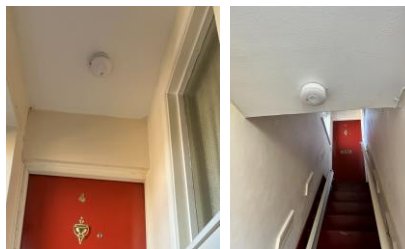
19) Within the communal area on the ground floor and first floor smoke detection has been installed.

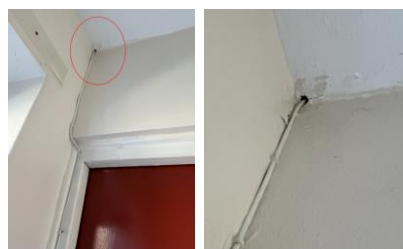
- 5) A variety of methods / materials have been used to achieve fire-stopping such as intumescent mastic around penetrations.
- 6) **Flat 4: Outside flat 4 to the top left-hand side a cable runs through to the roof void area. This requires fire stopping**

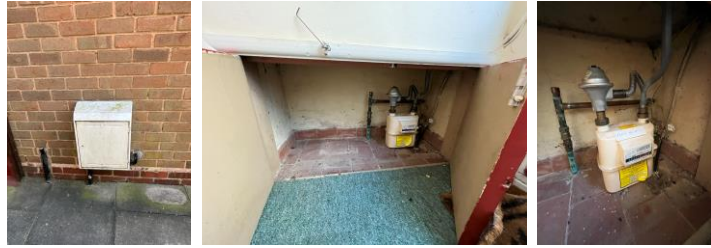
- b) Flat 2's gas meter is located on the outside of the property within a locked protective protected service cupboard. Flat 4's is within a small service cupboard within the communal area.

- 8) The electrical switching apparatus and resident metering equipment are currently mounted on an exposed distribution board within the communal hallway adjacent to Flat 2. Although the installation is historic, it benefits from up-to-date Electrical Installation Condition Reports (EICRs), and the existing wiring and fixings are therefore deemed safe at present.

However, the equipment remains unenclosed, leaving live electrical components accessible to residents and visitors. This arrangement does not align with modern expectations under BS 7671 (IET Wiring Regulations), which require electrical equipment in publicly accessible areas to be suitably enclosed, protected against unauthorised access, and housed within non-combustible or fire-resistant enclosures. While compliant at the time of original construction, the open distribution board presents a foreseeable ignition risk through accidental contact, deliberate interference, or electrical fault, any of which could lead to arcing, overheating, or fire. The lack of containment also increases the potential for flames or hot gases to spread directly into the communal escape route in the event of a fault.

In line with contemporary fire-safety legislation, including the Fire Safety Act 2021 and the Fire Safety (England) Regulations 2022, it is recommended that during future refurbishment works the metering and switching equipment be relocated either into suitable external protective cabinets or into each individual flat. This approach would provide improved physical protection, reduce the risk of tampering, and enhance fire containment.

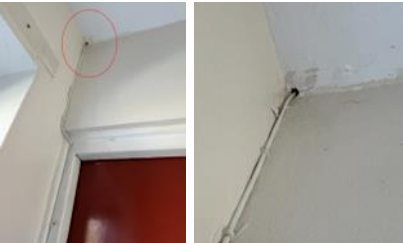
<p>P2</p>	<p>Within 1-3 months Leasehold Manager</p>	
<p>10/6</p>	<p><b>Flat 4:</b> Outside flat 4 to the top left-hand side a cable runs through to the roof void area. This requires fire stopping</p>
