Fire Risk Assessment

**Tower Rise,
1-3,
Tividale,
Oldbury,
B69 1NJ.**

Date Completed:02/04/2026

Officer: C. Hudson Fire Risk Assessor

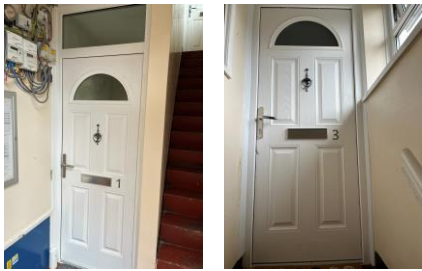
- 1) Flat 1 has a FD30s rated composite fire doors which is glazed with a transom and Flat 3 has a FD30s rated composite fire doors which is glazed.

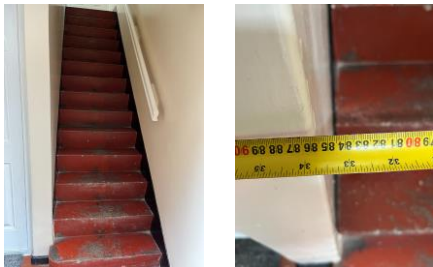
- 9) The block has a single staircase that provides a means of escape and is 865mm in width.

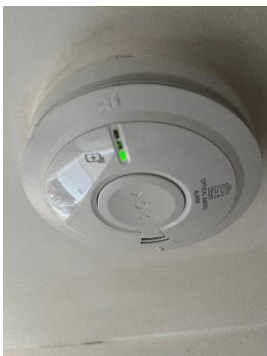
- 1) Early warning is limited to hard wire or battery smoke alarms within each of the resident's flats the equipment is subjected to a cyclical test.
- 2) Based on samples taken, the previous fire risk assessment and information kept on file (JM) the smoke alarms within resident's flats are installed to a minimum of an LD3 Standard.

I was unable to gain access after 4 attempts at the property, so looking at the previous risk assessment Flat 1 was accessed and was seen to be LD3 standard and Flat 3 accessed previously and was seen to be of an LD3 standard.

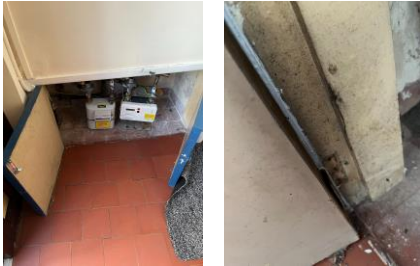
- 8) **Left hand door of gas cupboard bottom hinge is not connected to the frame this requires repair. See Action 10/8.**

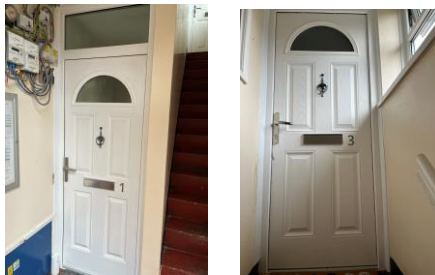
- 9) Flat 1 and 3 have a composite FD30s rated fire door fitted which protects the means of escape.

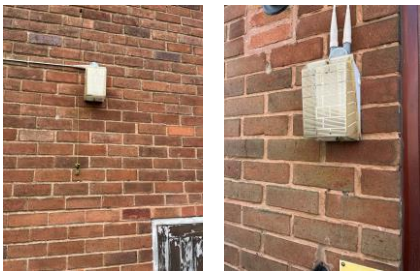
1. Regular checks are undertaken by Caretakers / Cleaning Team(s) 365 days per year which helps reduce the risk of arson.
2. Restricted access to the premises.
3. No CCTV is present at the block.
4. There is no current evidence of arson.
5. The perimeter of the premises is well illuminated.

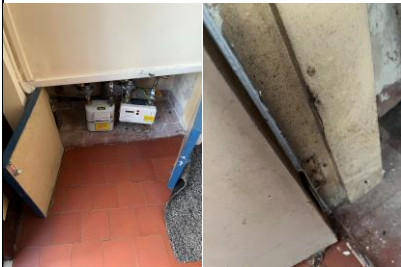
Question/ Ref No	Required Action	Supporting photograph	Priority	Timescale and Person Responsible	Date Completed
10/8	Left hand door of gas cupboard bottom hinge is not connected to the frame this requires repair.

P3	Fire Rapid Response 3-6 Months
