# Fire Risk Assessment

**Walker Avenue,  
Tividale,  
B69 1NP**

**Date Completed: 13/04/2026**

**Current Risk Rating = Tolerable**

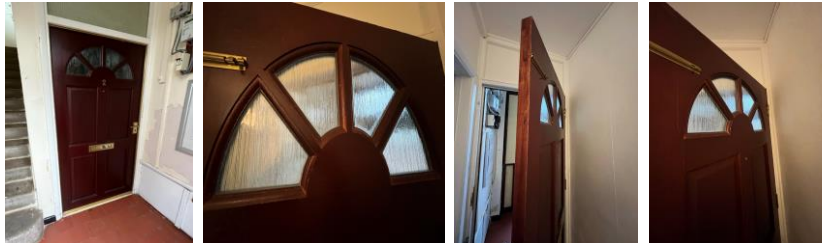
a) **Flat 2: fitted with a timber, non–fire-rated entrance door and is not equipped with any fire-resistant door furniture.**

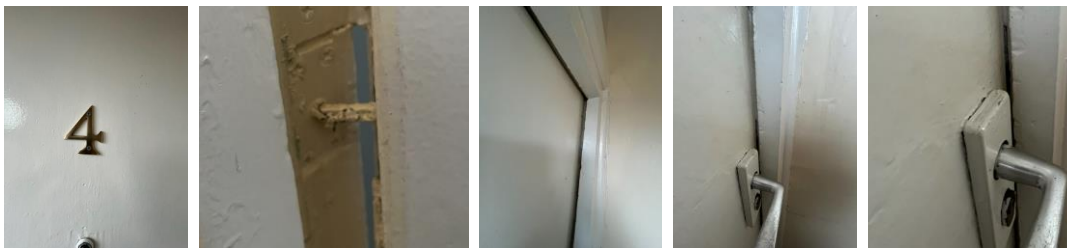
b) **Flat 4 (leasehold): A notional timber door with a concealed chain door closer fitted which did not fully close the door, there were also gaps around the door at the head and strike jamb areas.**

<p>7/6b</p>	<p><b>Flat 4 (leasehold):</b> A chain door closer fitted does not fully close the door, there are also gaps around the door at the head and strike jamb areas. Repair or replace the door.</p>

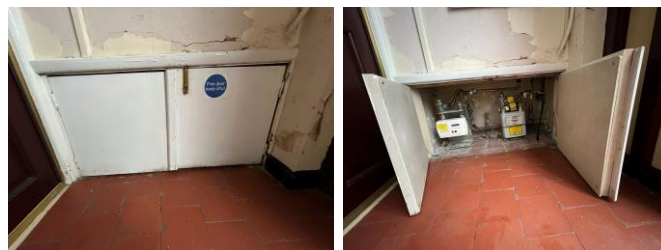
- 13) In the communal area on the ground floor outside flat 2 is situated the gas service cupboard see required actions under section 10/6
- 14) Gas meters: Gas meters are located outside flat 2 within the communal area of the block and are housed in small service cupboards that lack ventilation to the exterior. The cupboard doors are not fire-rated but do have Supalux panels installed on the inside of the doors, and do not display signage indicating the presence of gas installations (see Section 10/6), it is also recommended that an upgrade is carried out during future refurbishment works See Section 10. “Fire Door – Keep Shut” also “Gas meter” signage is affixed to the current door. Refer to Section 12 for the associated action.

6) Gas Service Cupboard located ground floor outside flat 2: Gas meters should be relocated to an external position to remove the hazard from the communal escape route. SMBC Gas team have contacted Cadent to explore this option 19/01/2026; however, Cadent have confirmed that they have no planned works to relocate the meters within the next 12 months. As such, interim measures are required, including:

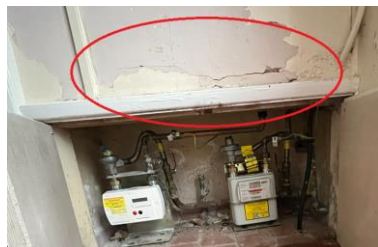
- a) **Around the gas service cabinet outside flat 2, the plaster around this cupboard is in a poor state of repair. This area needs to be replastered.**

<p>P3</p>	<p>Within 3-6 months Leasehold Manager</p>	
<p>7/14a</p>	<p><b>OS Flat 2:</b> Around the gas service cabinet outside flat 2, the plaster around this cupboard is in a poor state of repair. This area needs to be replastered.</p>

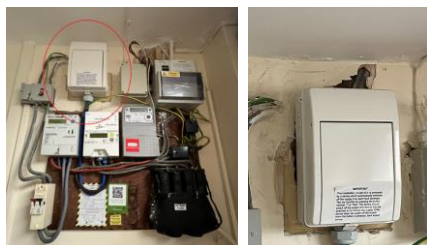
**16) A defect was noted in the vicinity of the electrical consumer unit outside Flat 2, where gaps and missing plaster were present around the enclosure. This breach in the fire-resisting construction compromises the required level of protection and must be fire-stopped. Its location is shown on the accompanying photos and will be included within the action plan of this Fire Risk Assessment for corrective works.**

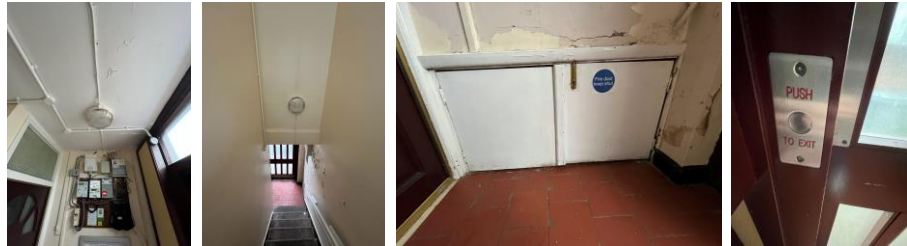
19) No emergency lighting is provided to communal landings and stairs. Adequate lighting comes from standard lighting also from borrowed lighting from the door and window areas.

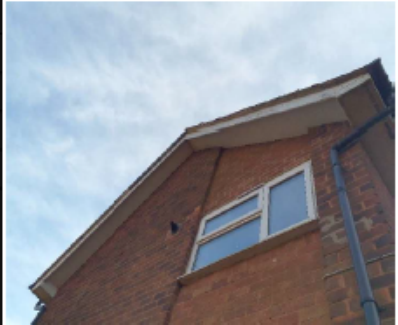
<b>Location:</b>	03 External	<b>Block:</b>	Communal	<b>Floor Level:</b> E - External
<b>Sample No.:</b>	No sample - presumed	<b>Portal Ref No.:</b>	4

<b>Item:</b>	Asbestos Cement underclanking			
<b>Asbestos Content:</b>	<b>Result Based on:</b>			
Crocidolite	Presumed			
<b>Sample Analysed By:</b>	Not applicable	<b>Extent:</b>	14 linear metres	
<b>Comments:</b> Present to gable end of the property.

<b>Material Assessment Total Score: 6</b>		<b>Likelihood of Disturbance Assessment Total Score: 3</b>		<b>Management Assessment</b>  <b>Recommendations:</b> Monitor condition  <b>Reinspection Interval:</b> 12 Months  <b>Overall Risk Category:</b> C9
<b>Product Type:</b>	1 (Asbestos cement)	<b>Location:</b>	0 (Outdoors)	
<b>Condition:</b>	1 (Minor scratches)	<b>Accessibility:</b>	1 (Occasionally likely to be disturbed)	
<b>Surface Treatment:</b>	1 (Unencapsulated asbestos cement)			
<b>Asbestos Type:</b>	3 (Crocidolite)	<b>Extent Score:</b>	2 (>10 - <50 sq m or >10m - <50m pipe run)
