# Fire Risk Assessment

**Blue Rock Place,  
31-39,  
Tividale,  
Oldbury,  
B69 1PD.**

**Date Completed: 08/05/2026**

**Current Risk Rating = Tolerable**

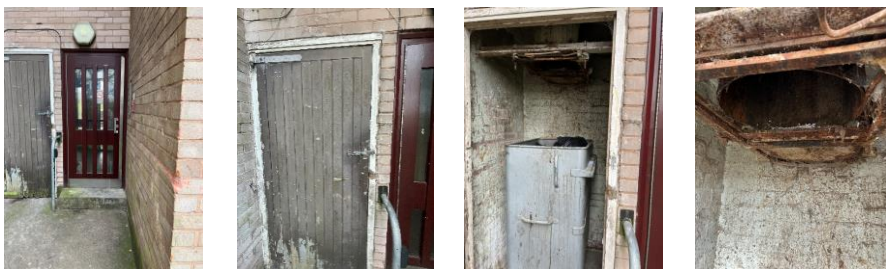
The bin store is located on the ground floor near the rear exit. The bin store is not secured with any type of lock. There is a latch present to keep the bin store door closed.

The bin chute has a manual closing plate

As the refuse hopper is located within a common area, it is recommended that the manual bin chute be upgraded to a fusible link to ensure it will automatically close in the event of a fire, thereby reducing the risk of fire and smoke spread.

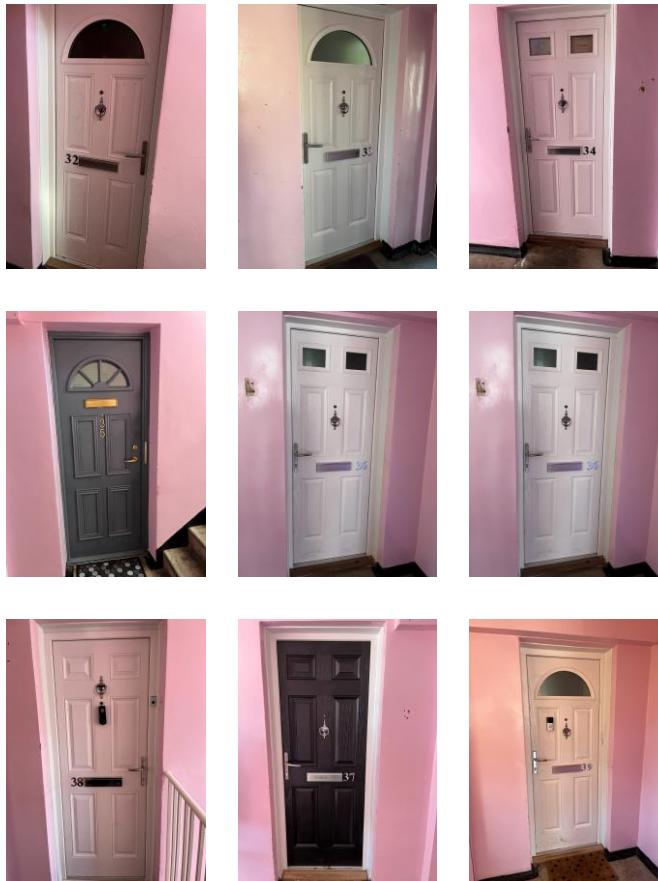
- 1) All Individual flat doors are FD30s rated composite fire doors, with the exception of flat No 35 being a notional timber door.

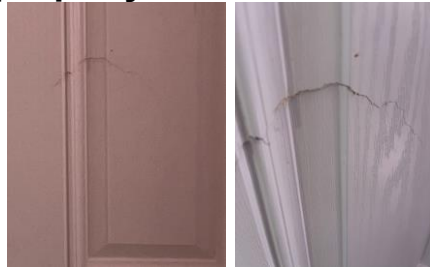
- 5) **Flat 38 Front door has been damaged this requires a repair or replacement door; this flat is a lease hold property.**

Question/ Ref No	Required Action	Supporting photograph	Priority	Timescale and Person Responsible	Date Completed
7/5	Flat 38 Front door has been damaged this requires a repair or replacement door; this flat is a lease hold property.

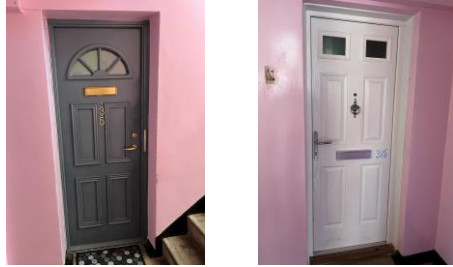
- 7) All Flats have a composite FD30s rated fire door except flat 35 fitted which is a notional timber door that protects the means of escape.

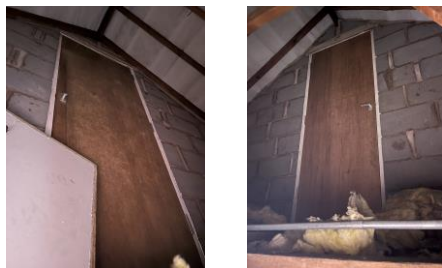
- 9) The loft hatch is of timber construction, recommend replacement to a fire rated loft hatch in future upgrade programme see observations.
- 10) The loft area was inspected visually from the head of a ladder. The solid block wall with a fire door fitted in it appeared to be in good condition, but this assessment was limited and does not constitute a comprehensive compartmentation survey.

The loft hatch is of timber construction, recommend replacement to a fire rated loft hatch in future upgrade programme see observations.

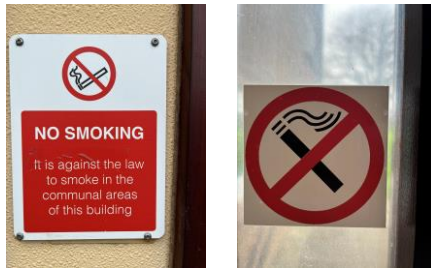
- 1) Appropriate signage is displayed throughout the building.
- 2) No smoking (Smoke Free England) signage is displayed at the front entrance to the premises.
