Fire Risk Assessment

**Falcon Place,
13-18,
Tividale,
Oldbury,
B69 1PB.**

Date Completed: 01/05/2026

Current Risk Rating = Tolerable

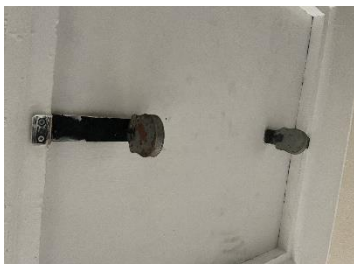
Internal access to the loft space can be gained on the third floor communal area. Residents do not have access to the roof space.

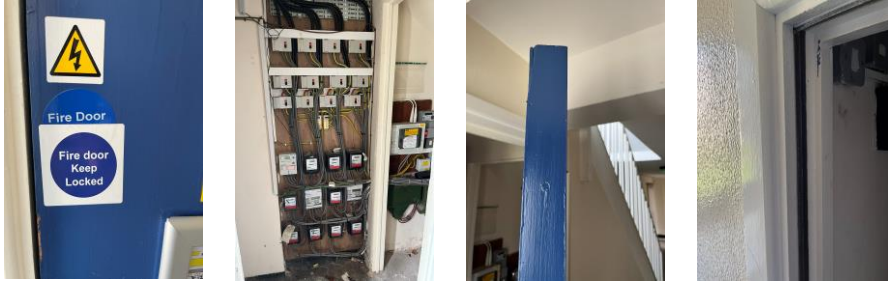
The service cupboard housing electrical intakes is situated at the front of the building behind the staircase; the door is a notional FD60 door, secured with a type 138 suited mortice lock. Residents have been provided with a key for access to their electricity meters.

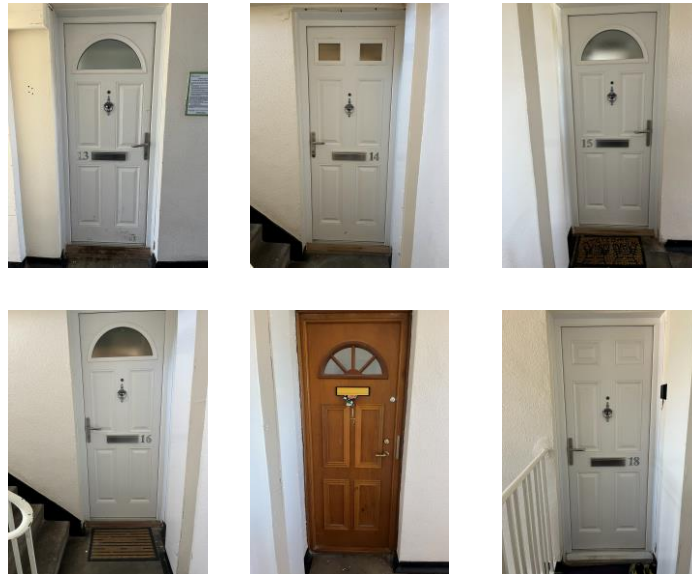
- 1) All Individual flat doors are FD30s rated composite fire doors, with flat No 17 being a notional timber door.

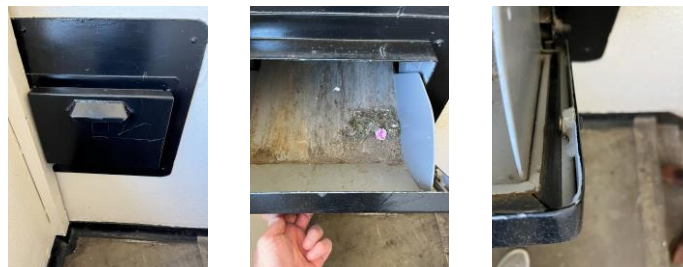
- 12) It was noted that some of the windows in the communal area have damage to them and do not close properly in to the frame, so an email has been sent to repairs on the 19/05/2026
- 13) Refuse chute located within the communal landing areas on 1st and 2nd floor.

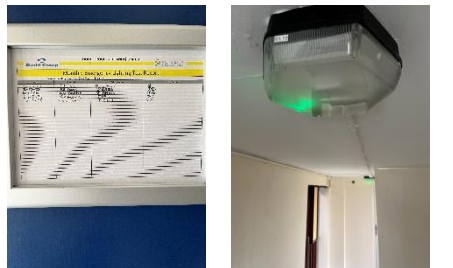
- 1) The premises has a sufficient emergency / escape lighting system in accordance with BS 5266 and has test points strategically located.
- 2) The self-contained units are provided to the communal landings, stairs.
- 3) All installed equipment is checked and tested monthly by Sandwell MBC in house electrical team or approved contractor, in accordance with current standards. The emergency lighting was subject to an in-house test on 10/03/2026.
- 4) **The emergency light outside no7 on the second-floor landing was not working this requires repair. See Action 9/4.**

Question/ Ref No	Required Action	Supporting photograph	Priority	Timescale and Person Responsible	Date Completed
9/4	The emergency light outside no7 on the second-floor landing was not working this requires repair.	N/A	P2 3-6 Months	Electrical 1-3 Months

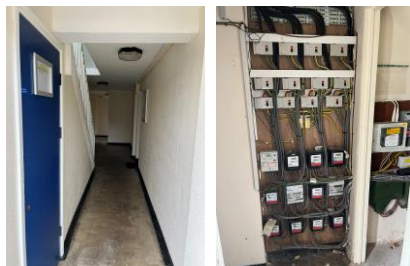
- 6) The service cupboard housing electrical intakes is situated at the front of the building behind the staircase, this is a notional FD60 door, secured with a type 138 suited mortice lock. Residents have been provided with a key for access to their electricity meters.

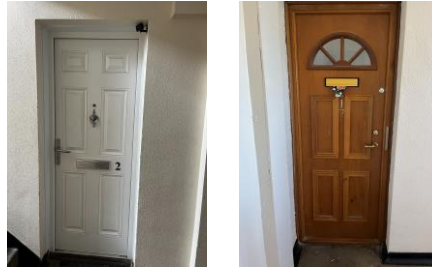
- 7) All Flats have a composite FD30s rated fire doors except flat 17 which has a notional timber door with Georgian wired glass fitted, that protects the means of escape.
