# Fire Risk Assessment

**14-18**

**Bishops Close,  
Smethwick,  
B66 2RD**

**Date Completed: 26/05/2026**

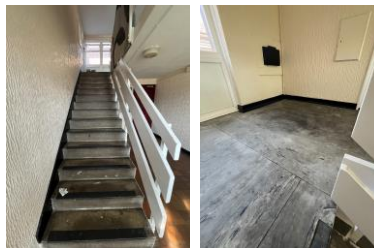
- 8) The flooring and stairway within this property are concrete construction. On the 2<sup>nd</sup> floor there is a vinyl covering. The fire rating of this flooring is not known and should be removed in future refurbishments.

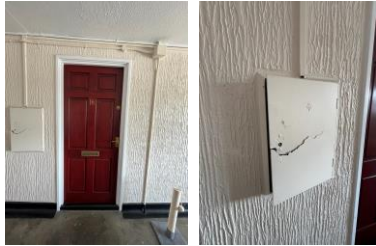
**a) Flat 16: Electrical over cupboard adjacent to flat 16 is damaged and needs replacing.**

Question/ Ref No	Required Action	Supporting photograph	Priority	Timescale and Person Responsible	Date Completed
7/13a	<b>Flat 16:</b> Electrical over cupboard adjacent to flat 16 is damaged and needs replacing.

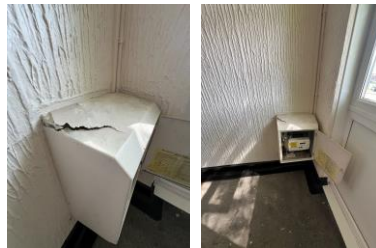
**b) Flat 16: Gas over cupboard adjacent to flat 16 is damaged and needs replacing.**

7/13b	<b>Flat 16:</b> Gas over cupboard adjacent to flat 16 is damaged and needs replacing.

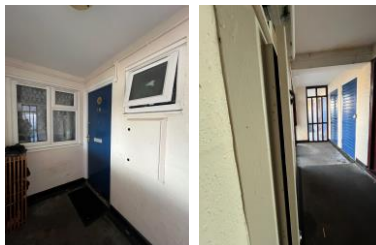
**c) Flat 18: Electrical over cupboard adjacent to flat 18 does not close tightly and requires repairing or replacing.**

P3	Within 3-6 months Gas	
7/13c	<b>Flat 18:</b> Electrical over cupboard adjacent to flat 18 does not close tightly and requires repairing or replacing.

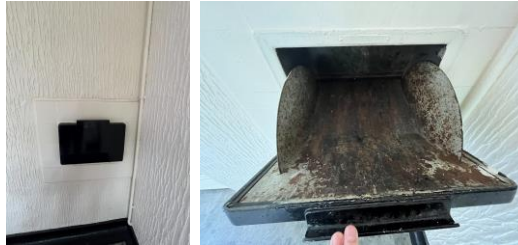
14) On the 1st and 2nd floors, a bin-chute hopper door is located adjacent to the flat entrances for residents to dispose of refuse bags.

a) **The hopper door on the 2<sup>nd</sup> floor requires new seals or replacing.**

P3	Within 3-6 months Electrical	
7/14a	<b>2<sup>nd</sup> Floor:</b> Replace hopper door seals

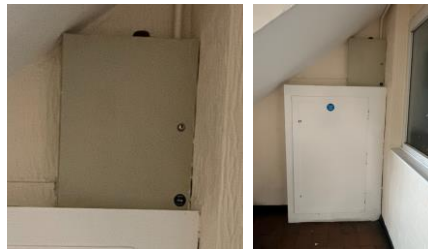
b) Within the communal area on the ground floor next to the final exit the control unit is installed within a steel cupboard that operates the final exit door electronics. Below that there is a large steel door that stores the mains electric supply. No access was gained at the time of the FRA.

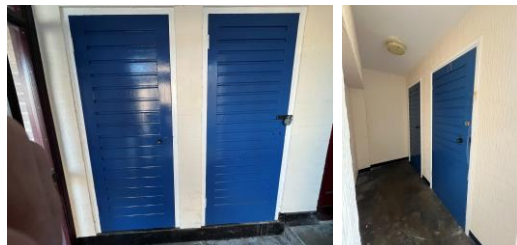
15) Within the ground floor communal areas, there are several resident-accessible storage cupboards; however, these were not accessible at the time of the fire risk assessment as they were locked. As a result, no internal inspection could be carried out, and the condition of the internal compartmentation or the nature of any stored items could not be verified.

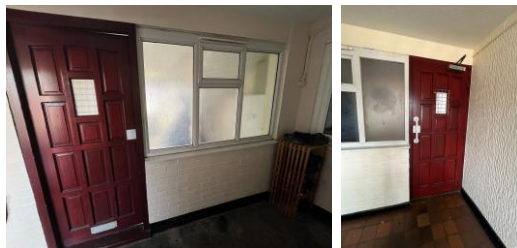
**16) Adjacent to Flat 18 on the ground floor, the door leading into the communal area at the base of the staircase does not close correctly and fails to sit flush within the frame. This needs to be rectified in the short term.**

**This deficiency was also identified during the previous fire-risk assessment and remains outstanding. The issue has been escalated to the Head of Compliance for further action.**

**The existing door is not fire-resisting and must be replaced with a fully compliant FD30s fire door with vision panel, also including certified fire-rated ironmongery, smoke seals, and an effective self-closing device to ensure reliable performance in the event of fire.**

**These items have been formally highlighted for remedial action and will be reviewed again in six months to confirm completion and compliance.**

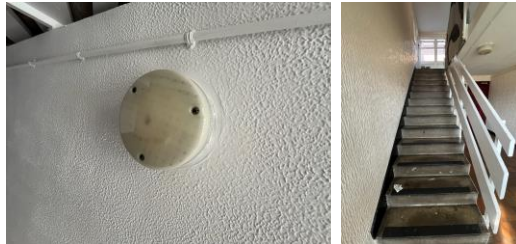
- 1) The premise is not fitted with emergency lighting
- 2) The communal landings and stairways within this three-storey block are not provided with emergency lighting. *Approved Document B, paragraph 3.41* requires that, except for two-storey blocks of flats, all escape routes must have adequate artificial lighting, with escape lighting operating in the event of a mains power failure. To meet this requirement and comply with the *Regulatory Reform (Fire Safety) Order 2005*, it is recommended that emergency lighting is installed throughout the escape routes as part of future upgrade works. At present, illumination is limited to standard luminaires and natural light from the landing window and final exit door.

It is recommended that emergency lighting be installed throughout the communal areas, as the building exceeds two storeys and requires adequate illumination to support safe evacuation in the event of a power failure.
