# Fire Risk Assessment

**1-20**

**Crystal House,  
Smethwick,  
B66 3JT**

**Date Completed: 10/06/2026**

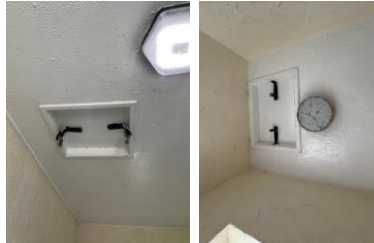
- 3) Within the block, on the top-floor stairways, there were a couple of access points to the roof void provided through timber loft hatches, each secured shut with padlocks. These locations are referenced further in Section 10 of the assessment.

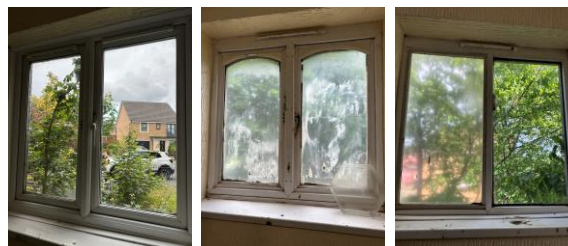
- 5) Windows within the staircase area were fitted with openers, which would assist with ventilation if required during an incident. Several window handles were found to be missing at the time of the Fire Risk Assessment, and some units had been screwed shut. It is recommended that these windows are repaired or replaced as part of future refurbishment works to ensure they remain functional and support effective smoke ventilation.

- Windows within the staircase area were fitted with openers, which would assist with ventilation if required during an incident. Several window handles were found to be missing at the time of the Fire Risk Assessment, and some units had been screwed shut. It is recommended that these windows are repaired or replaced as part of future refurbishment works to ensure they remain functional and support effective smoke ventilation.
- Within the bin chute room and on the stairway are roof void access hatches, these are timber doors and padlocked shut. It is recommended that these are upgraded to fire resistant access doors in future block refurbs.

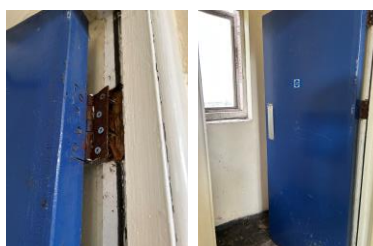
- 7) Off the stairways on either side of the block, a fire door provides access to the bin-chute room. Within the bin chute room towards Oakfield Close, there was evidence of a previous fire.

- a) The hinges to the entrance door of the bin chute room are corroded and require replacement, as they are detaching from the frame. Replace hinges and rehang the door to the bin chute room. Emailed Fire Rapids on 19/06/26.

| Question/<br>Ref No | Required Action | Supporting photograph | Priority | Timescale<br>and Person<br>Responsible | Date<br>Completed |
|---|---|---|---|---|---|
| 7/7 | Replace hinges and rehang door<br>to bin chute room | | P2 | Within 1-3<br>months<br>Fire Rapid<br>Response | |

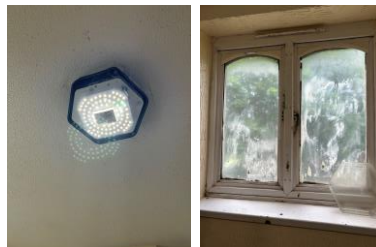
- a) On the second-floor staircase on the left elevation, the casing for the emergency light has become detached and requires reinstallation. Electrical team emailed on 16/06/26.

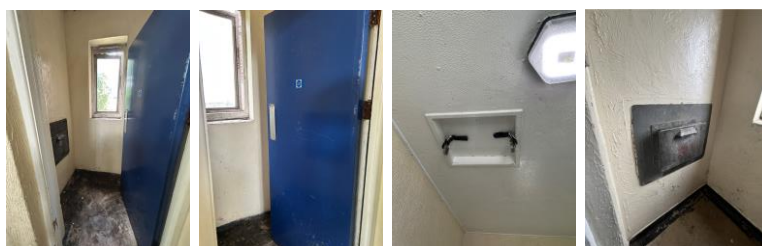
- 5) A variety of methods / materials have been used to achieve fire-stopping such as intumescent mastic around penetrations.
- 6) Bin chute room: There is a notional FD30 timber door with a self-closer and smoke seals to access the room, within the room is a chute hopper door for the disposal of refuse which was fully working at the time of the fire risk assessment, a uPVC glazed openable window unit, also within the room is a loft hatch to access the roof void (padlocked).

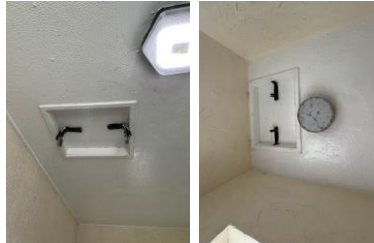
- 7) Flats are fitted with a minimum of timber notional FD30 doors. See section 7/2.
- 8) Within the bin chute room and on the stairway are roof void access hatches, these are timber doors and padlocked shut. It is recommended that these are upgraded to fire resistant access doors in future block refurb.

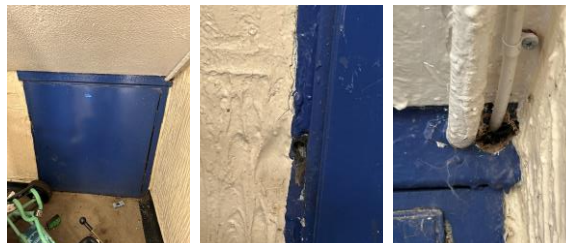
- 9) **Adjacent to the ground-floor entrance door is a steel services cupboard. Access to the cupboard was not possible at the time of the Fire Risk Assessment, therefore the level of internal compartmentation could not be verified. However, small holes were identified to the external face of the cupboard which require appropriate fire stopping. Fire Rapids were notified via email on 16/06/2026.**

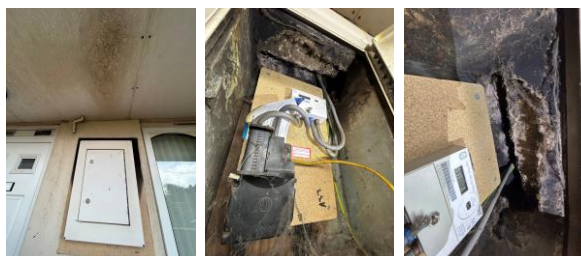
- 10) Outside each flat on the open decked area is situated a fire rated electric meter over box. These are locked with a budget key.
- a) **Located on the open deck of the second-floor landing, adjacent to Flat 15's entrance door, is an electrical over-cupboard. Signs of previous fire damage were observed both externally and within the cupboard. Further investigation is recommended, and appropriate internal fire stopping may be required. Fire Rapids emailed on 16/06/26.**

| 10/10 | Undertake further investigation of the electrical over-cupboard located on the open deck of the second-floor landing adjacent to Flat 15, where signs of previous fire damage were observed both externally and internally. Assess the condition and ensure appropriate internal fire stopping is installed to maintain fire compartmentation. Fire Rapids were notified via email on 16/06/2026. | | P2 | Within 1-3 months<br>Fire Rapids | 17/06/26 |
