# Fire Risk Assessment

## Bridge House1-12

**Oakfield Close, Smethwick  
B66 3JZ.**

**Date Completed:** 9<sup>th</sup> June 2026

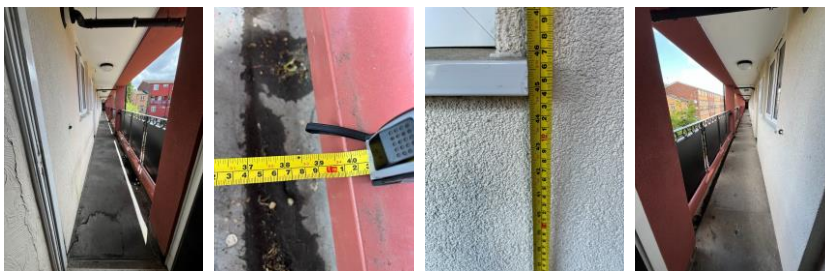
- 3) The open deck is measured at a width 1100mm and are kept clear to promote & maintain safe exit in an event of fire. All windows along the deck access were noted to be over the required measurement of 1100mm above the floor for safe evacuation.

1<sup>st</sup> floor open deck with width and height of windows

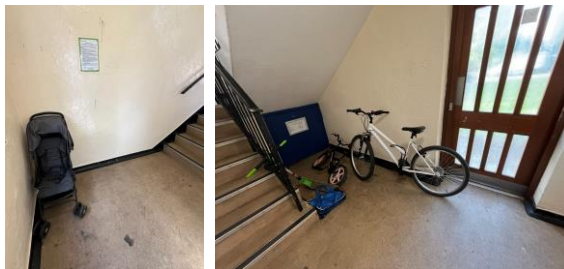
- 6) **On the ground floor under the stairs within the communal entrance, a push chair and bike have been stored in the means of escape**

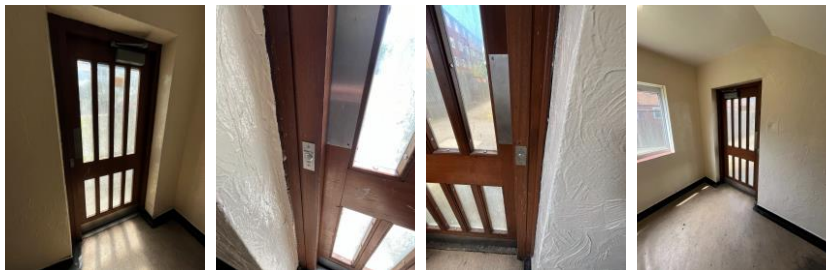
- 11) There is a clear and safe exit out of the building via the ground floor exits. The final front exit doors are made to fail safe in an emergency allowing smooth and safe evacuation.

Final front exit doors and doors exits buttons

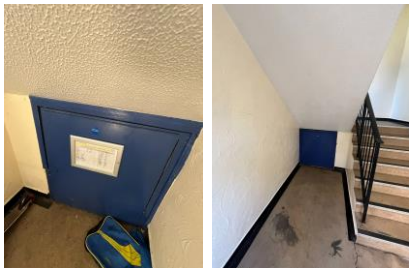
- 7) Electrical service cupboards on the ground floor under the stairs are locked and secured behind a steel door. It was not possible to access these cupboards to check firestopping and compartmentation. *FRA will be required to be updated when access is gained.*

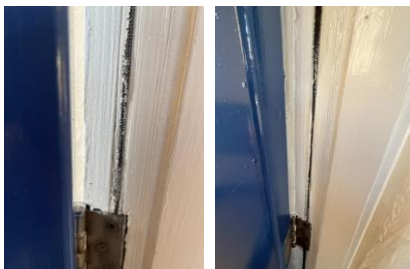
- 10) Refuse chute room on the left stairwell landing has a section of smoke seals damaged by paint fouling and will not perform as it should.

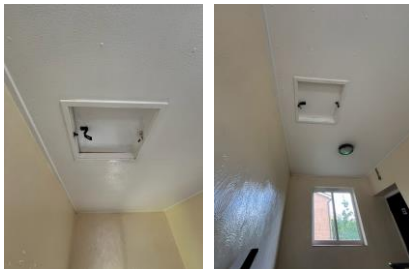
- 12) Roof access located on both 1<sup>st</sup> floor stairwell landings was not possible to gain access, the FRA will need to be updated once access is gained.

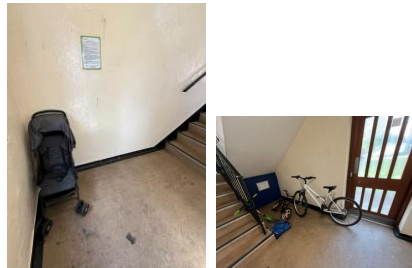
| Question/<br>Ref No | Required Action | Supporting photograph | Priority | Timescale<br>and Person<br>Responsible | Date<br>Completed |
|---|---|---|---|---|---|
| 7/6 | Pushchair, bicycle and toys stored in communal area and within means of escape. Engage with tenant and advise on removal. | | P2 | 1-3 Months<br>Housing<br>Manager | |

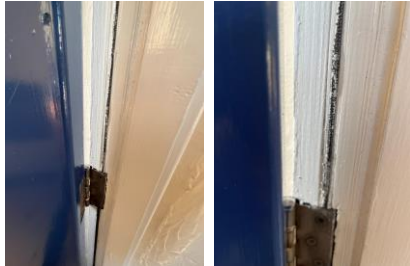
| 10/10 | Paint damaged smoke seal on the bin stores door frame located in the left stairwell. Replace damaged section and make correct. | | P2 | 1-3 Months<br>Fire Rapid Response | |

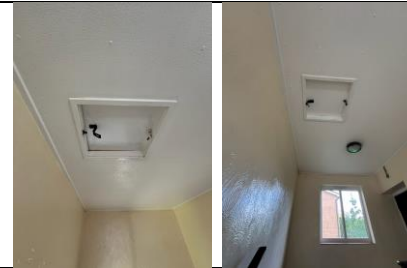
Roof access located on both 1<sup>st</sup> floor stairwell landings was not possible to gain access, the *FRA will need to be updated once access is gained*

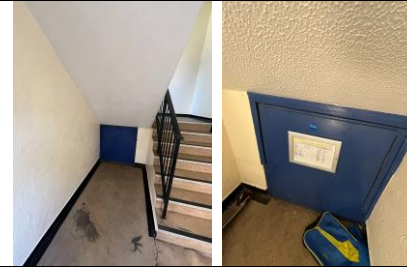
Electrical service cupboards on the ground floor under the stairs are locked and secured behind a steel door. It was not possible to access these cupboards to check firestopping and compartmentation. *FRA will be required to be updated when access is gained*
