# Fire Risk Assessment

## Priory Close 10 - 15

**Priory Close,  
Smethwick  
B66 3SL**

**Date Completed:** June 2026

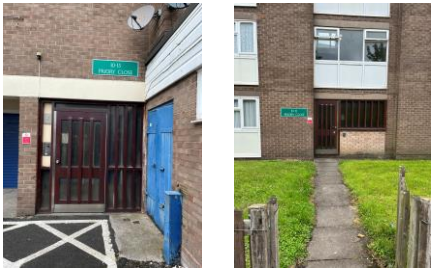
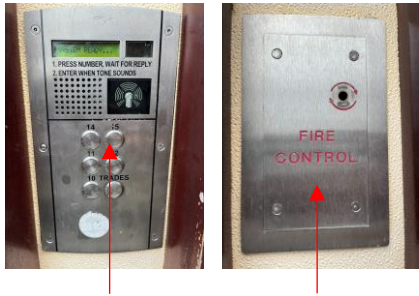
Intercom access and firefighter's switch

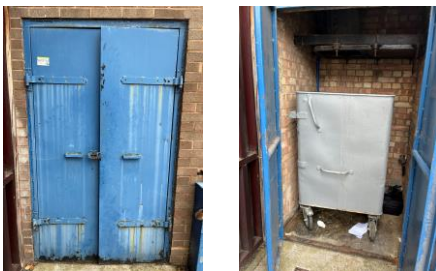
The bin store is located on the ground floor near the front exit. The bin store is secured with a padlock.

The bin chute has a manual closing plate

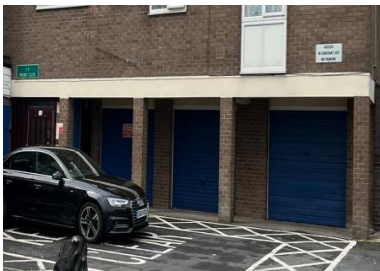
- 5) Front elevation of the building has resident garages; these were not accessed at the time of this FRA.

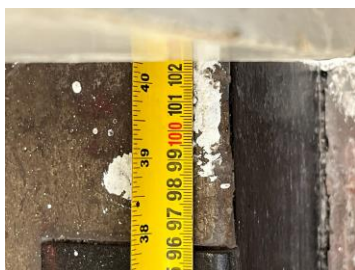
- 10) This premise consists of a single staircase that provides sufficient means of escape, this is located at the rear of the block. The width of the staircases has been measured from handrail to the wall at a measurement of 1020mm. These stairs are kept clear to maintain safe means of escape.

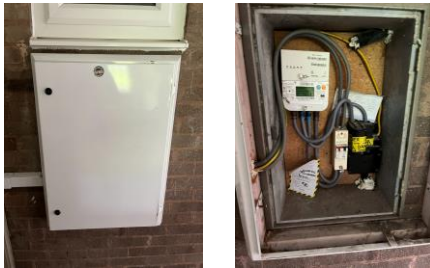
- 16) The communal area is kept free of flammable items. The communal areas should be checked on a regular basis by Caretaking / Cleaning teams and all items of rubbish removed.
- 17) The residential electricity meters are installed within metal enclosures situated in the communal corridors adjacent to the flat entrance doors. Access control to these service boxes is maintained via standard budget lock mechanisms.

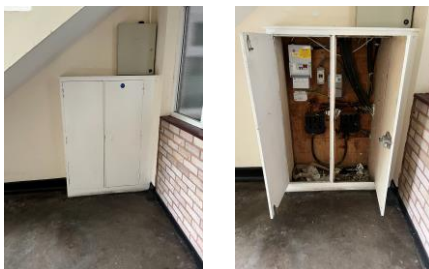
- 19) The mains electrical supply is situated in a timber framed cupboard under the communal concrete staircase. **See Section 10 compartmentation.**

- 6) The incoming electrical installation is enclosed in a timber non fire rated enclosure under the concrete staircase. It is recommended that the timber enclosure be replaced with a metal fire rated enclosure when the next refurbishment takes place See Observations.

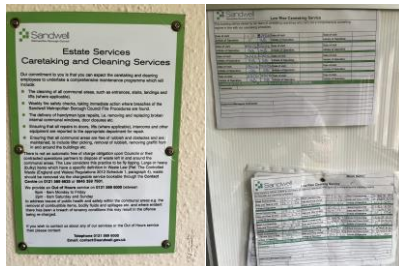
- 1) There is a regular Cleaning Service to the premises. Regular checks by Caretakers minimise risk of waste accumulation. Sandwell Council 'Out of Hours' service is in place to remove bulk items

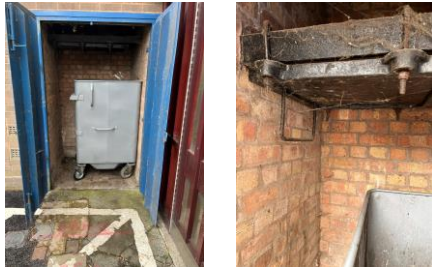
- 4) The refuse chute has a manual sliding plate. Due to the refuse hoppers being in the communal area of the block it is recommended that they are upgraded to a fused link system when the block has any refurbishment. See Observations.

The refuse chute has a manual sliding plate. Due to the refuse choppers being in the communal area of the block it is recommended that they are upgraded to a fused link system when the block has any refurbishment.

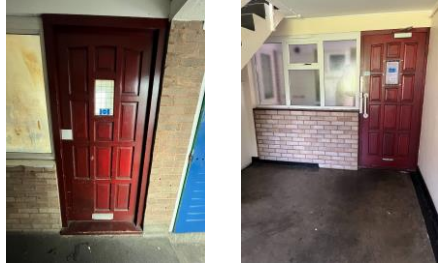
| <p>The communal door on the ground floor is part of a combination frame with a UPVC window frame fitted with Georgian wired double-glazed unit. The timber door has a glazed unit but is not a certified fire door and does not have any smoke seals or intumescent strips fitted so it is recommended that these are replaced with a certified FD30s door and fire rated window frame and glazing when any refurbishment of the block takes place.</p> | |

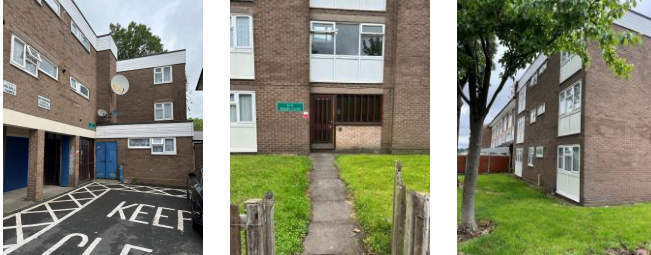
| <p>The front and rear of the perimeter of the premises is not illuminated with external lighting and uses borrowed lighting from the streetlamps. It is recommended to upgrade the external lighting of the building especially to the front and rear final exits.</p> | |
