**FIRNTEC**  
BUILDING COMPLIANCE

# EXTERNAL WALL SURVEY

## ALLEN HOUSE

West Road  
Hamstead  
B43 5PS

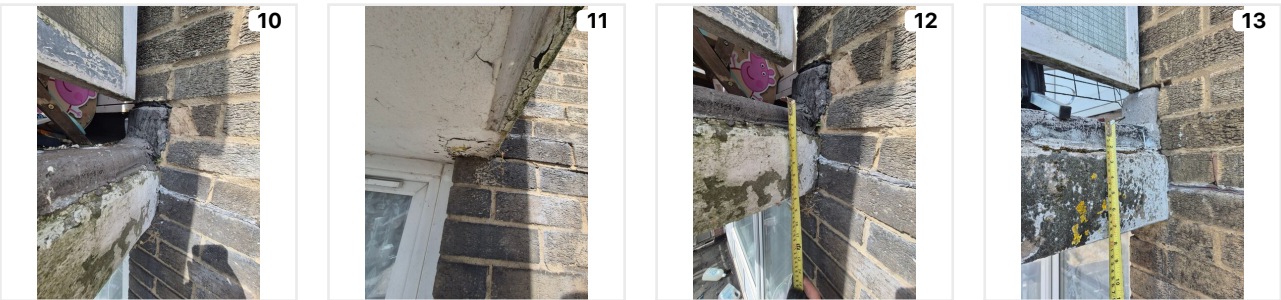
# Inspection: 1B2GAF

loose retrofitted blown mineral fibre found in the cavity

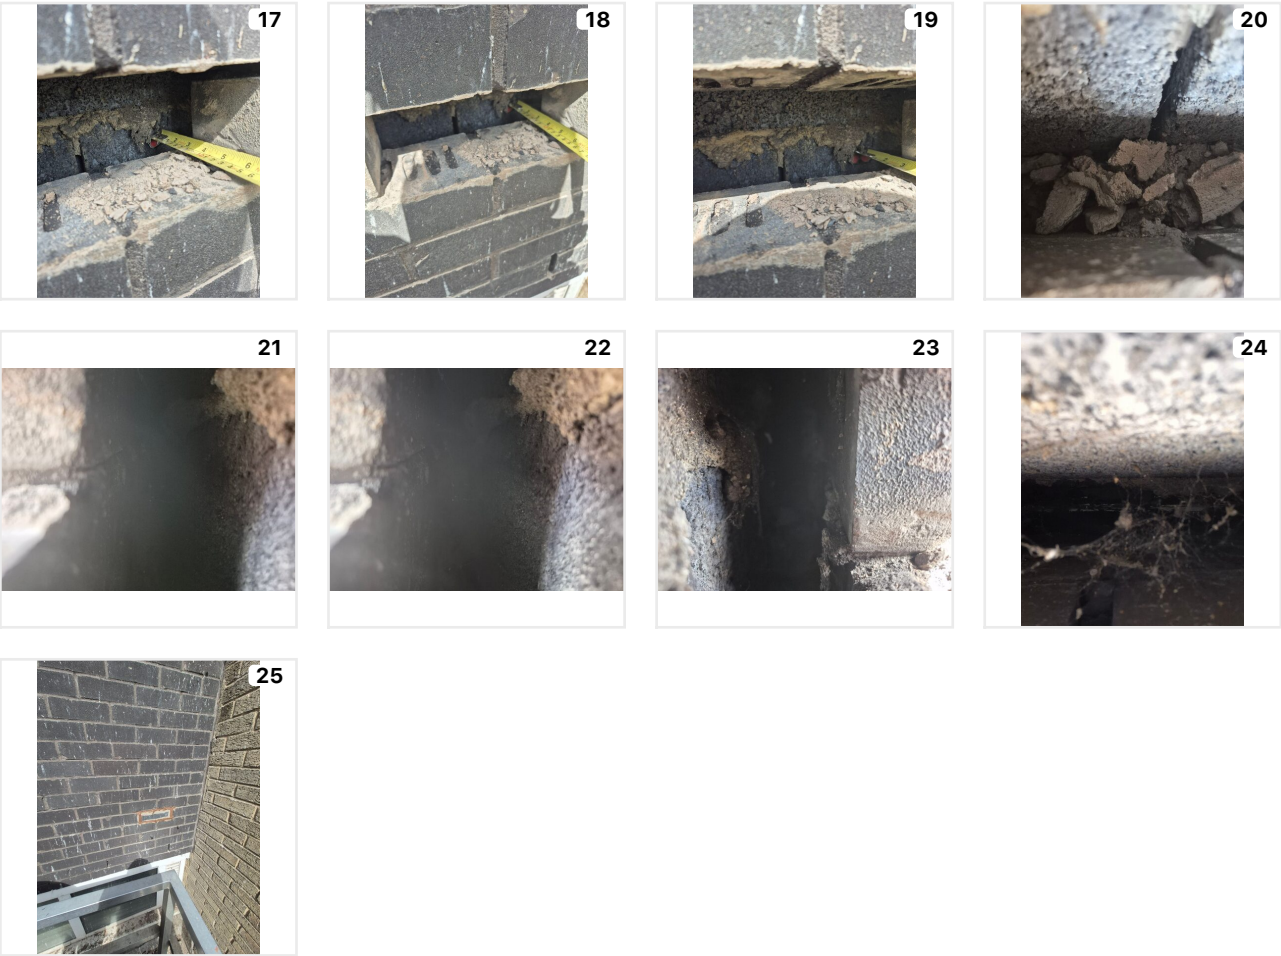
# Inspection: Z1MLVW

Backing Wall Sits On The Floor Slab

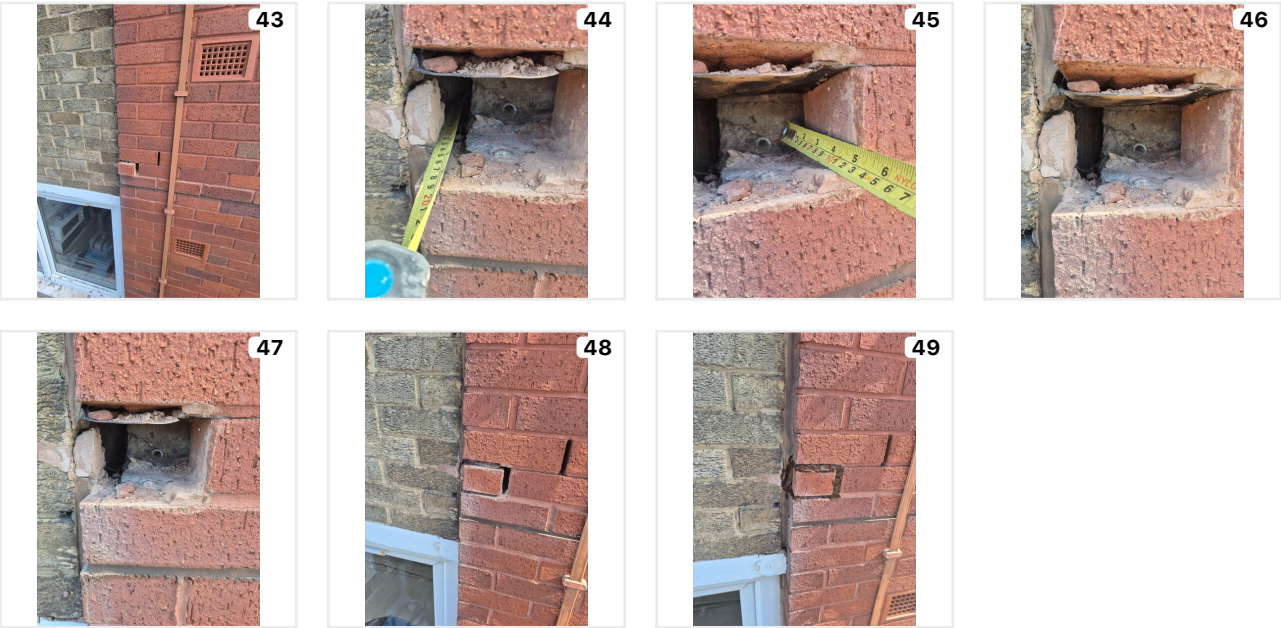
# Inspection: VP6HS2

| 4 Elements | Thickness/Depth | Material | Photo Ref. | Rating (BS EN13501) |
|---|---|---|---|---|
| loose retrofitted blown mineral fibre found in the cavity | | | | |

Backing Wall Sits On The Floor Slab
