**FIRNTEC**  
BUILDING COMPLIANCE

# FIRE RISK APPRAISAL EXTERNAL WALLS

## ALLEN HOUSE

West Road  
Hamstead  
B43 5PS

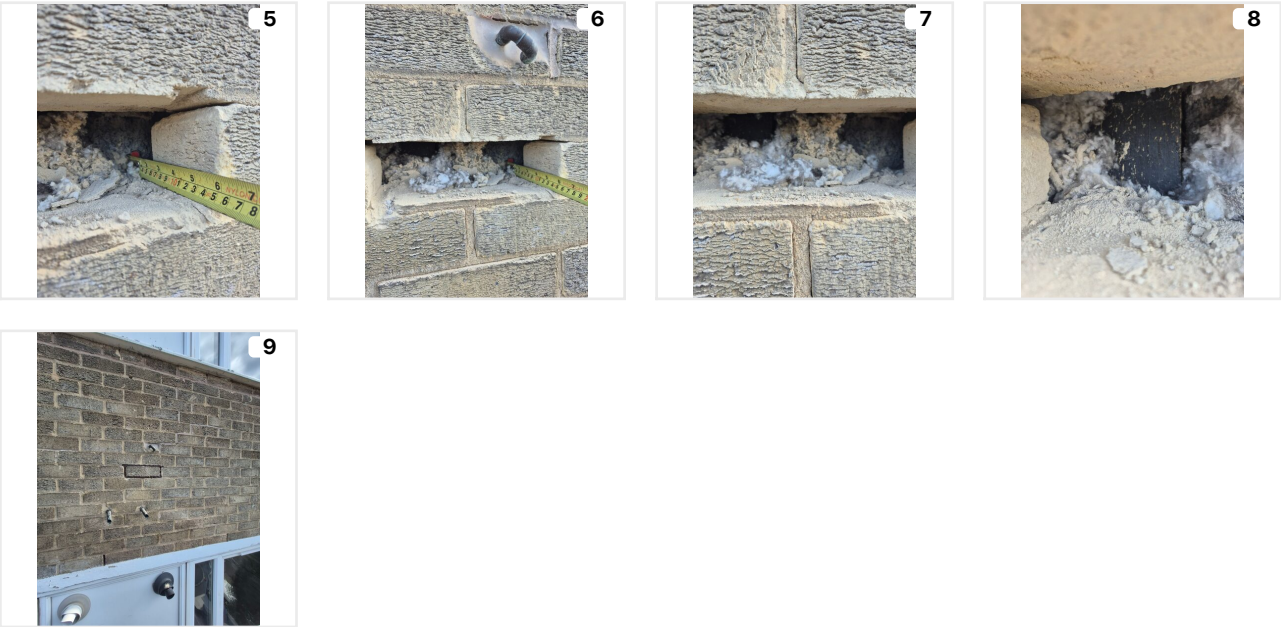
| 4 Elements | Thickness/Depth | Material | Photo Ref. | Rating (BS EN13501) |
|---|---|---|---|---|
| loose retrofitted blown mineral fibre found in the cavity | | | | |

Backing Wall Sits On The Floor Slab

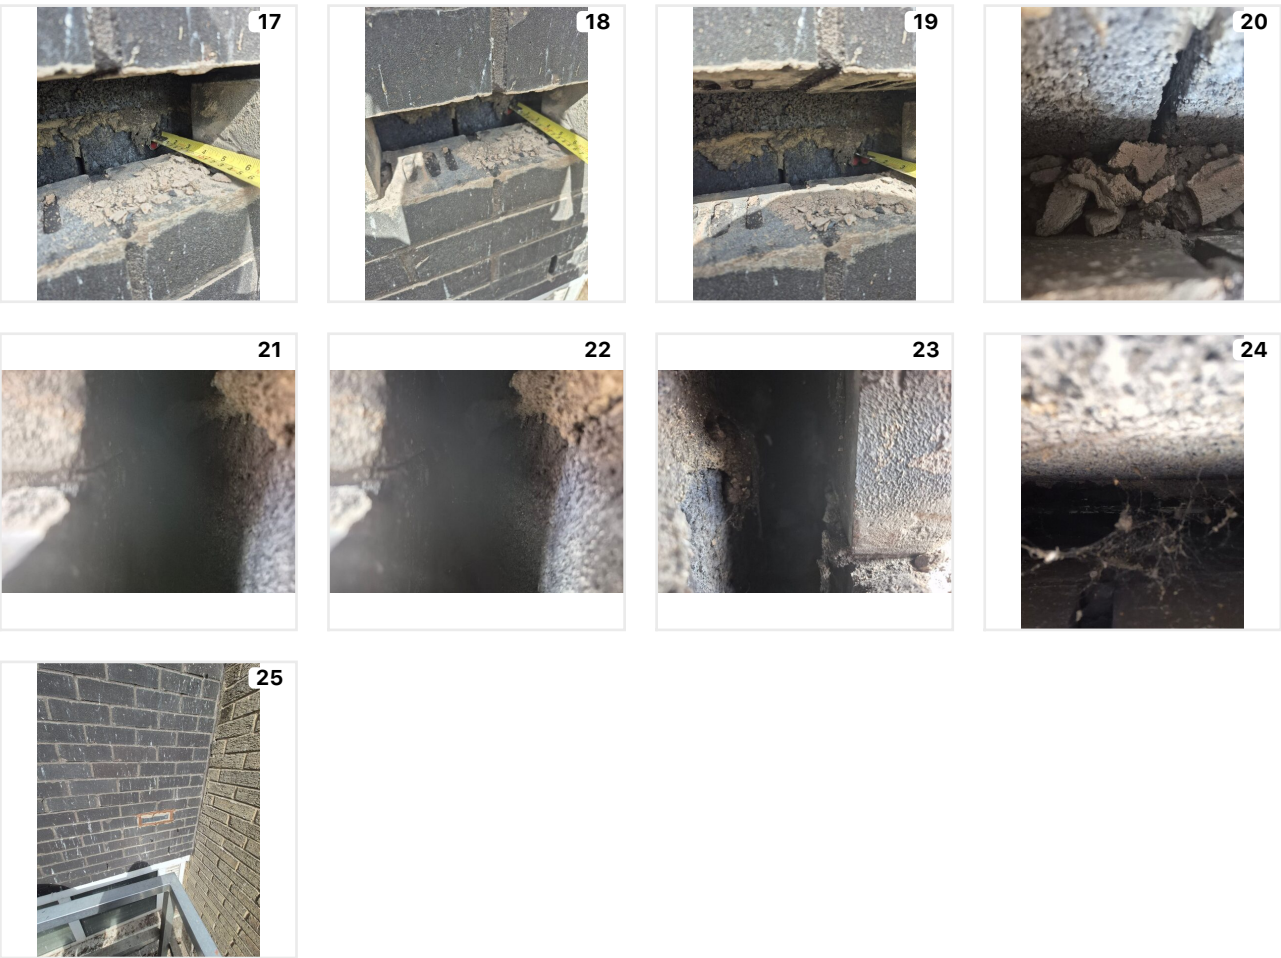
Elevation • Location  
East Elevation • Compartment Floor Junction

Backing Wall Sits On The Floor Slab

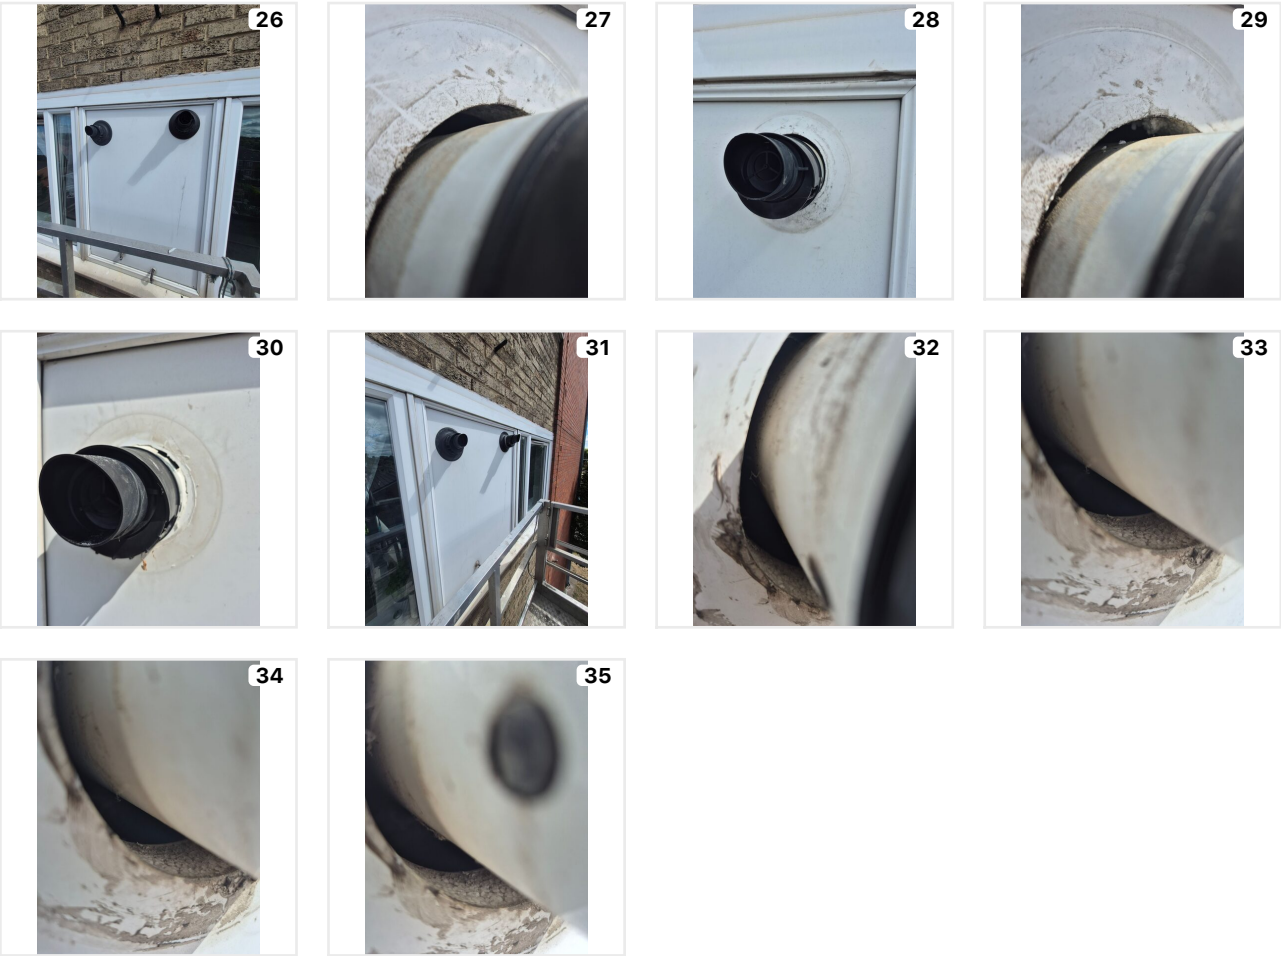
The panel is a composite infill unit, likely PVC-faced board with insulation core, commonly used to replace or infill former window openings. White PVC sheeting, forming the external face of the panel system. Visual inspection via the flue void shows expanded polystyrene (EPS) insulation core present within the panel.

No external cavity

It is our professional opinion that there is no requirement for remediation of this wall type. If at a later date these panels must be removed or replaced due to maintenance or repair they must be replaced with a material that achieves Euroclass A2,s1-d0 or better.

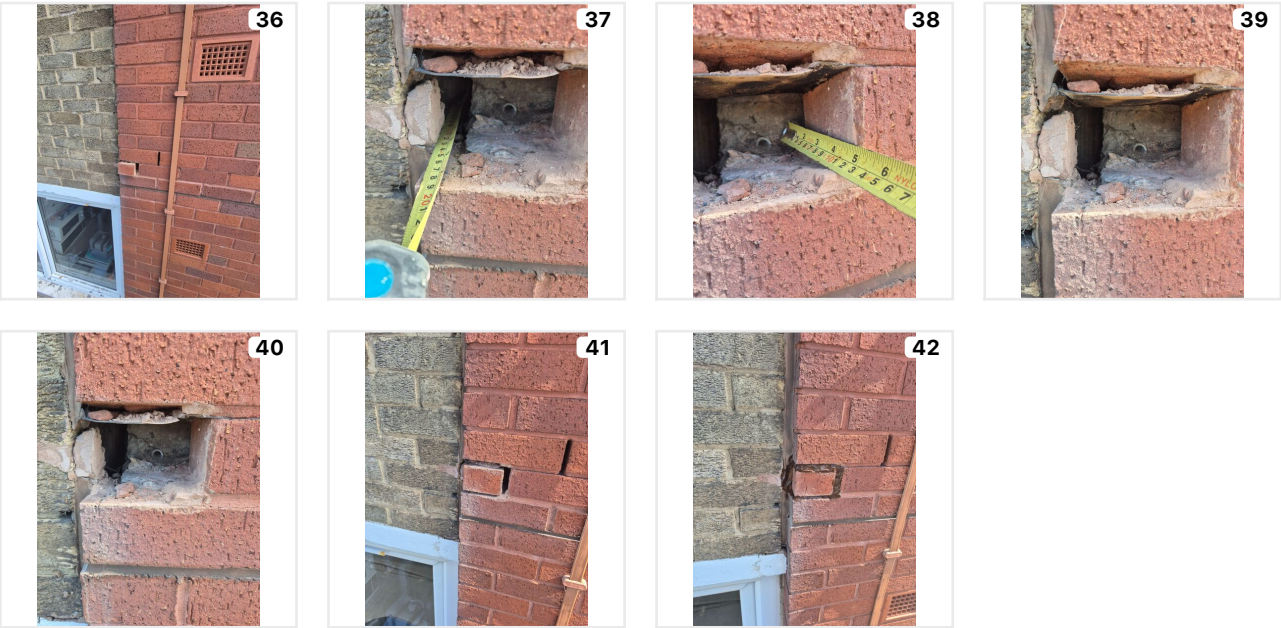
Elevation • Location  
North Elevation • Aperture Opening

| 4 Elements | Thickness/Depth | Material | Photo Ref. | Rating (BS EN13501) |
|---|---|---|---|---|
| loose retrofitted blown mineral fibre found in the cavity | | | | |

Backing Wall Sits On The Floor Slab

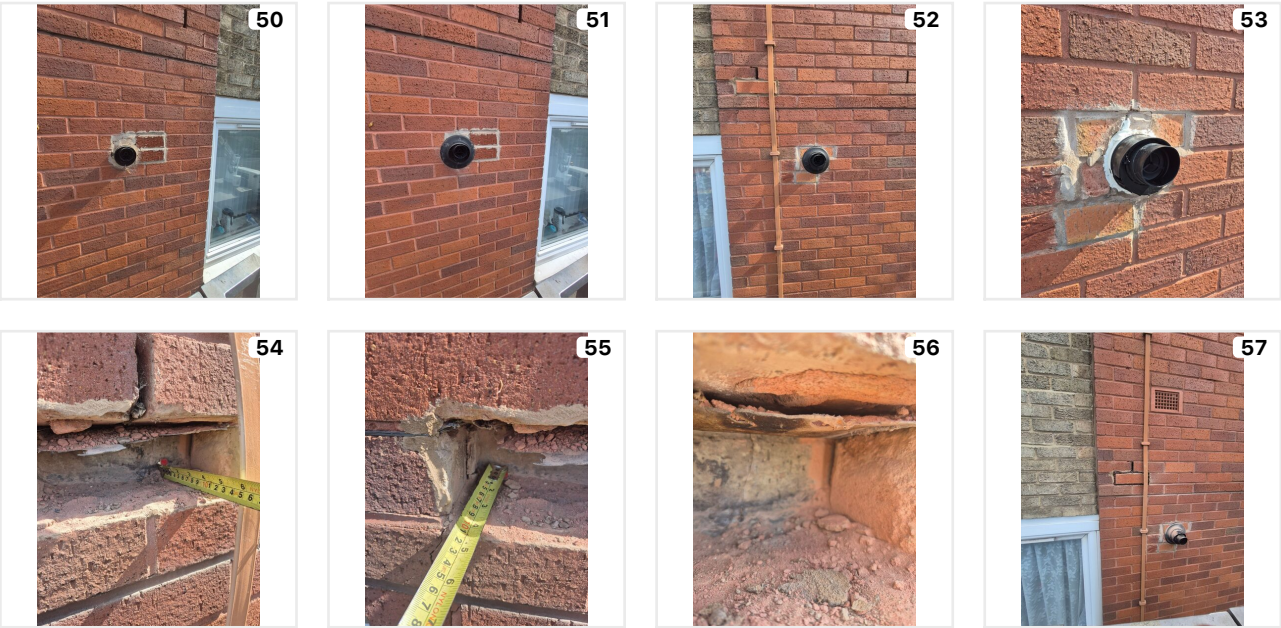
| 4 Elements | Thickness/Depth | Material | Photo Ref. | Rating (BS EN13501) |
|---|---|---|---|---|
| loose retrofitted blown mineral fibre found in the cavity | | | | |

Backing Wall Sits On The Floor Slab

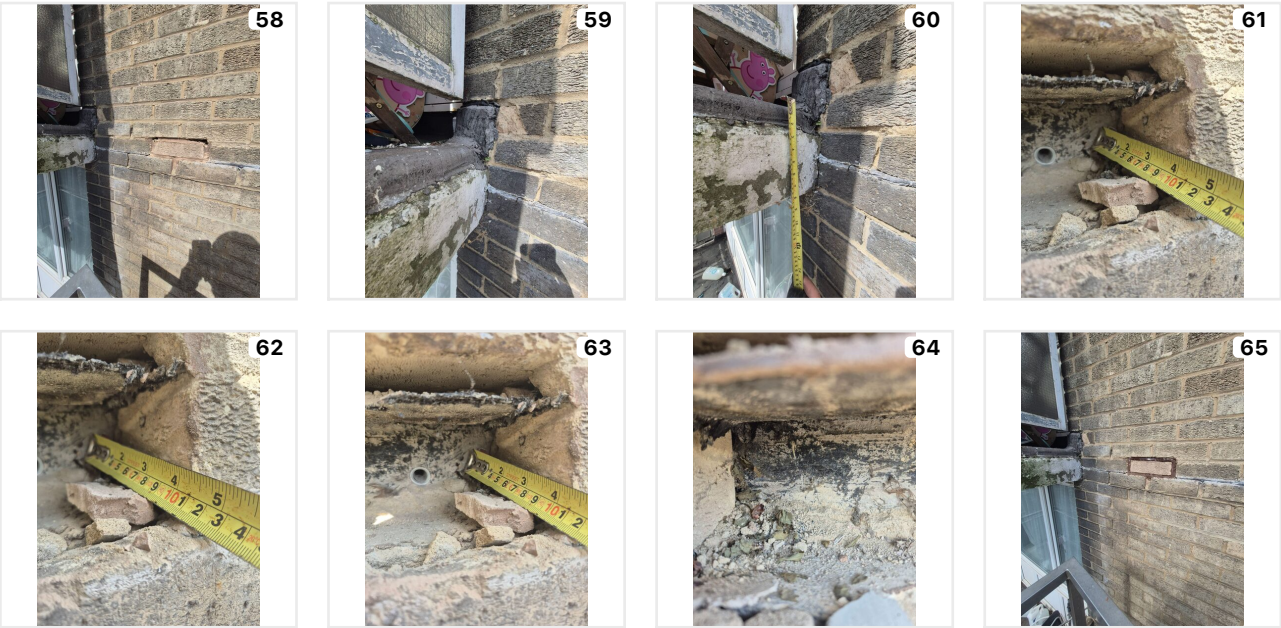
Location  
Compartment Floor and Wall Junction Interface

| 4 Elements | Thickness/Depth | Material | Photo Ref. | Rating (BS EN13501) |
|---|---|---|---|---|
| loose retrofitted blown mineral fibre found in the cavity | | | | |

Backing Wall Sits On The Floor Slab

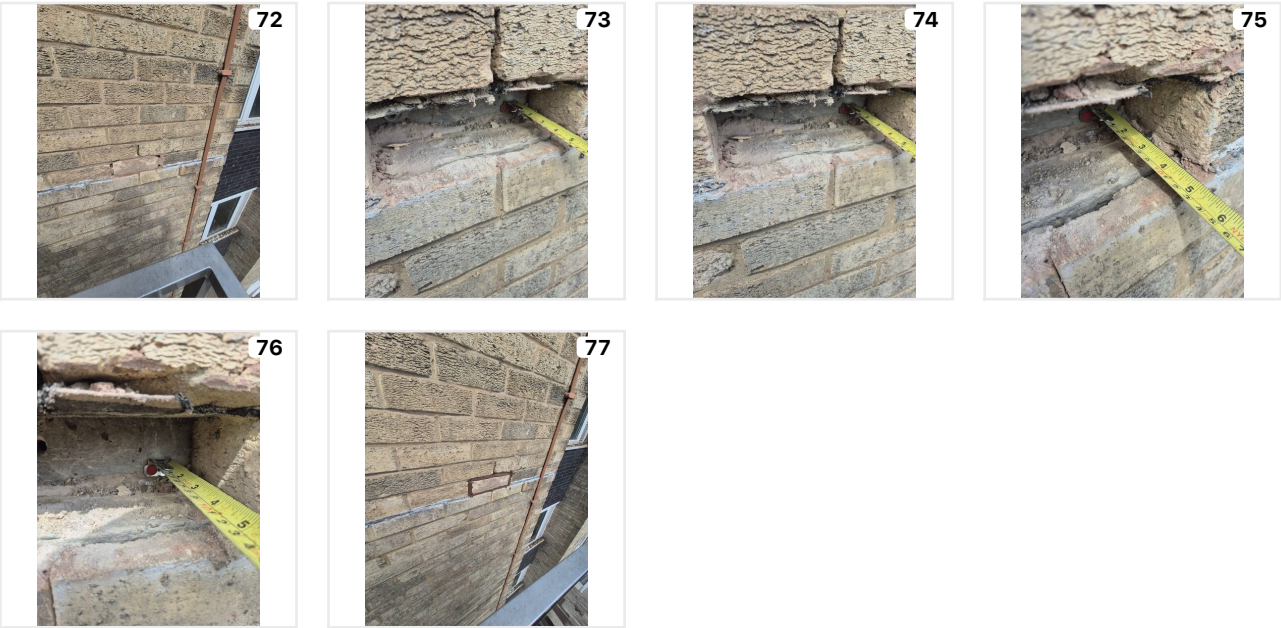
| 4 Elements | Thickness/Depth | Material | Photo Ref. | Rating (BS EN13501) |
|---|---|---|---|---|
| loose retrofitted blown mineral fibre found in the cavity | | | | |

Backing Wall Sits On The Floor Slab

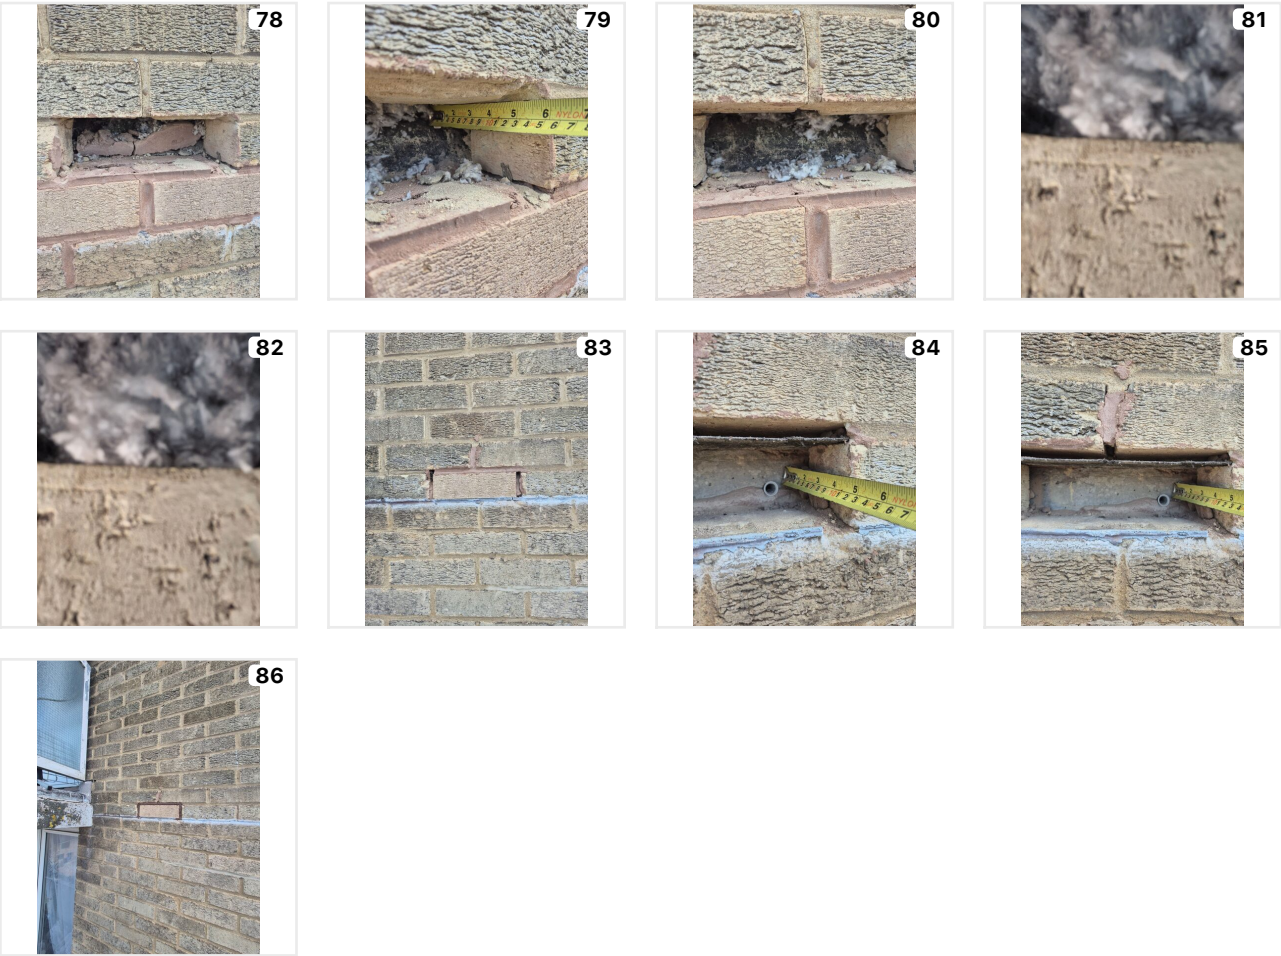
Location  
Compartment Floor and Wall Junction Interface

| 4 Elements | Thickness/Depth | Material | Photo Ref. | Rating (BS EN13501) |
|---|---|---|---|---|
| loose retrofitted blown mineral fibre found in the cavity | | | | |

Backing Wall Sits On The Floor Slab
