**FIRNTEC**  
BUILDING COMPLIANCE

# EXTERNAL WALL SURVEY

## ASTBURY COURT

Kingsway  
Brandhall  
B68 0QG

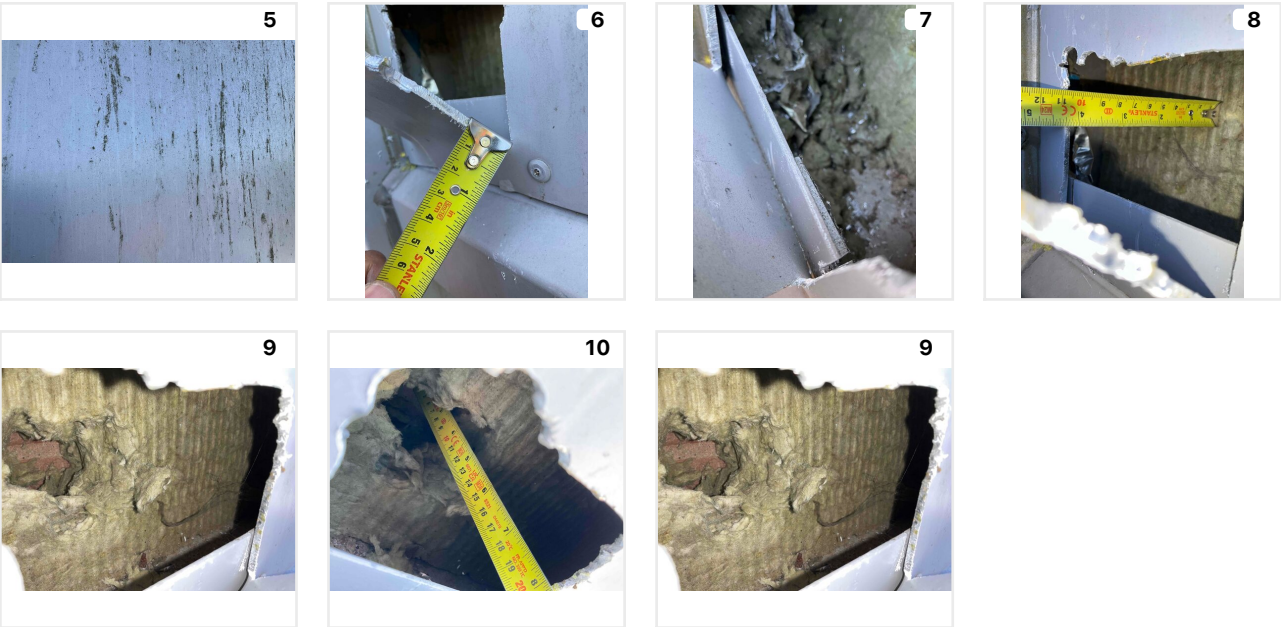
# Inspection: NSWVUT

Infill panel

Cavity closed at compartmentation wall

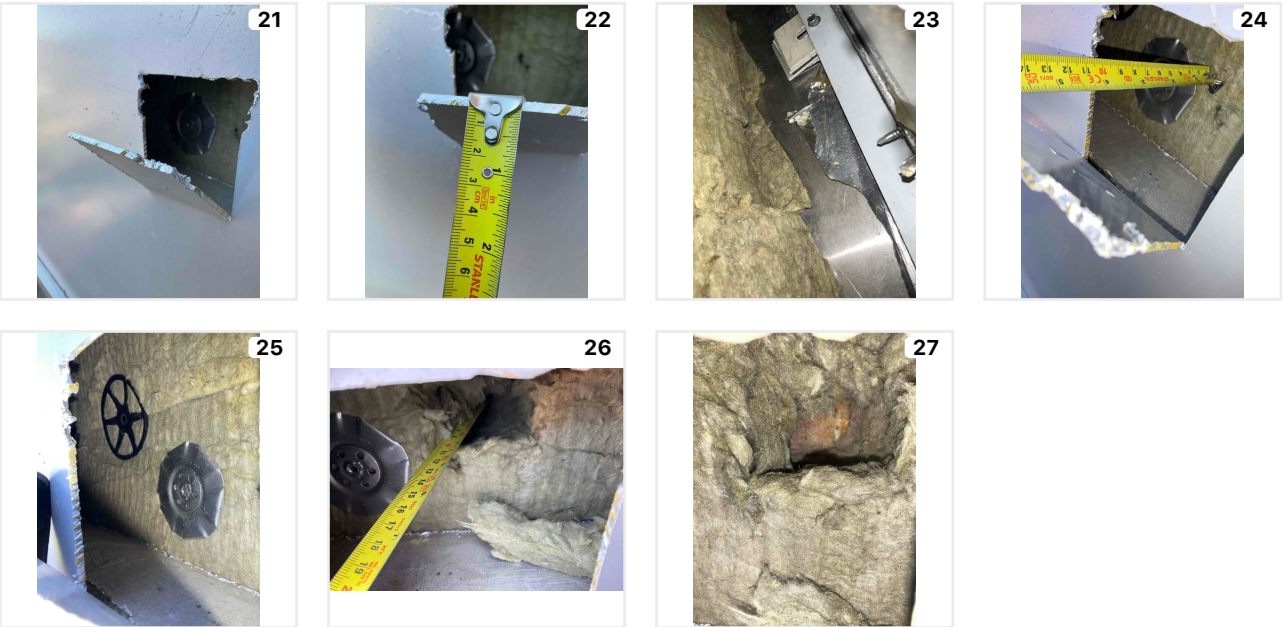
# Inspection: YR28CF

Infill panel

Cavity closed at compartmentation wall

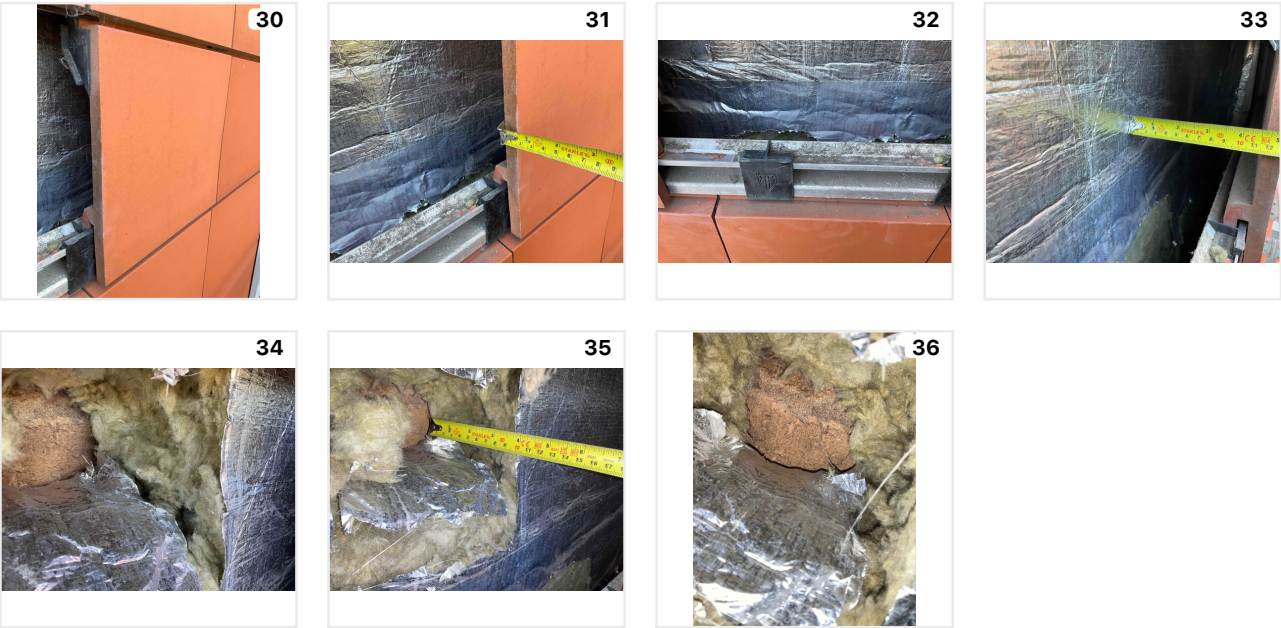
# Inspection: A7TMAS

Rainscreen

Cavity closed at compartmentation wall
