Survey Date 28/08/2025

# FIRE RISK APPRAISAL EXTERNAL WALLS

## ASTBURY COURT

Kingsway  
Brandhall  
B68 0QG

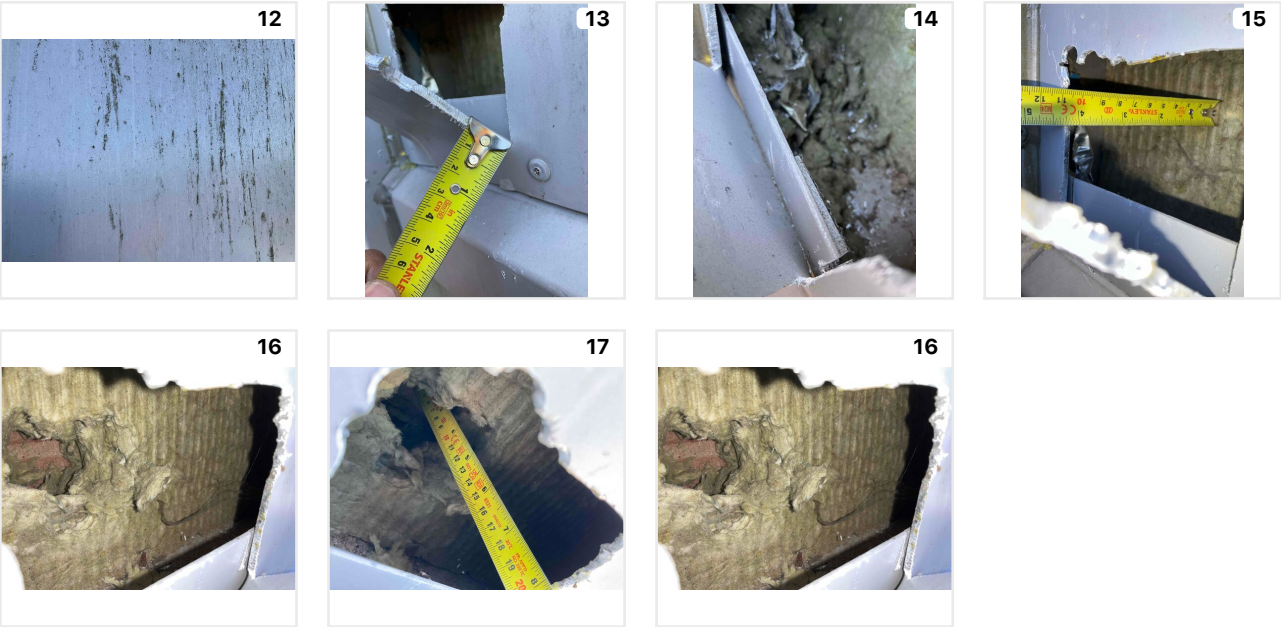
Backing Wall Sits On The Floor Slab

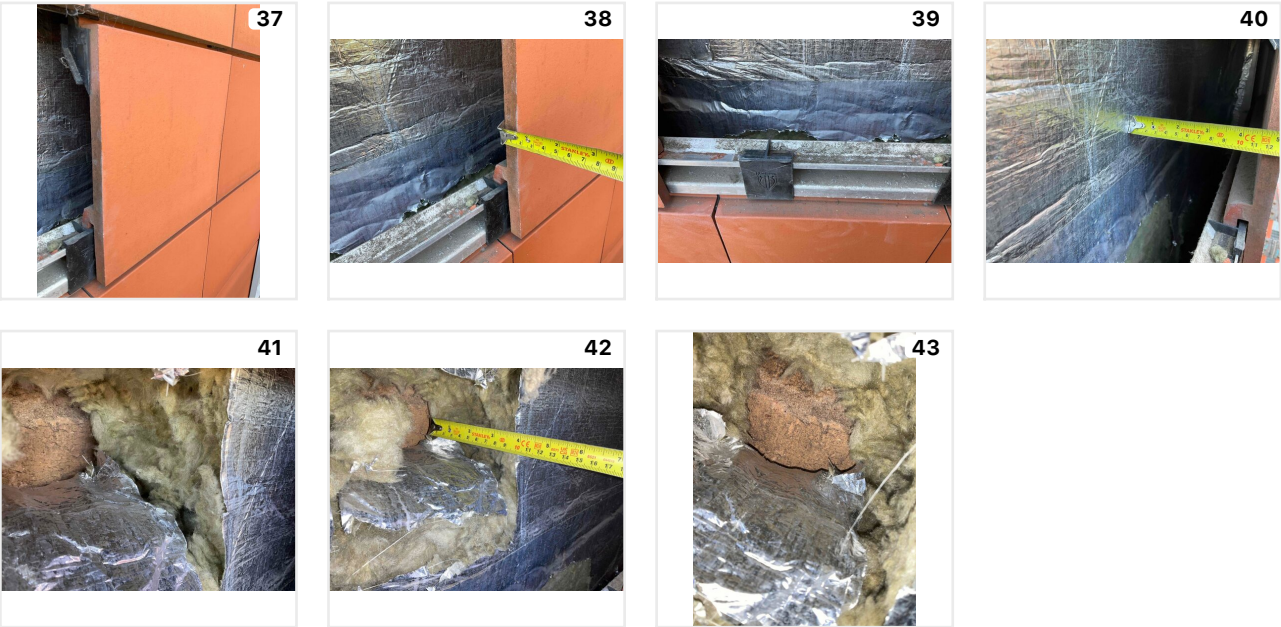
Backing Wall Sits On The Floor Slab

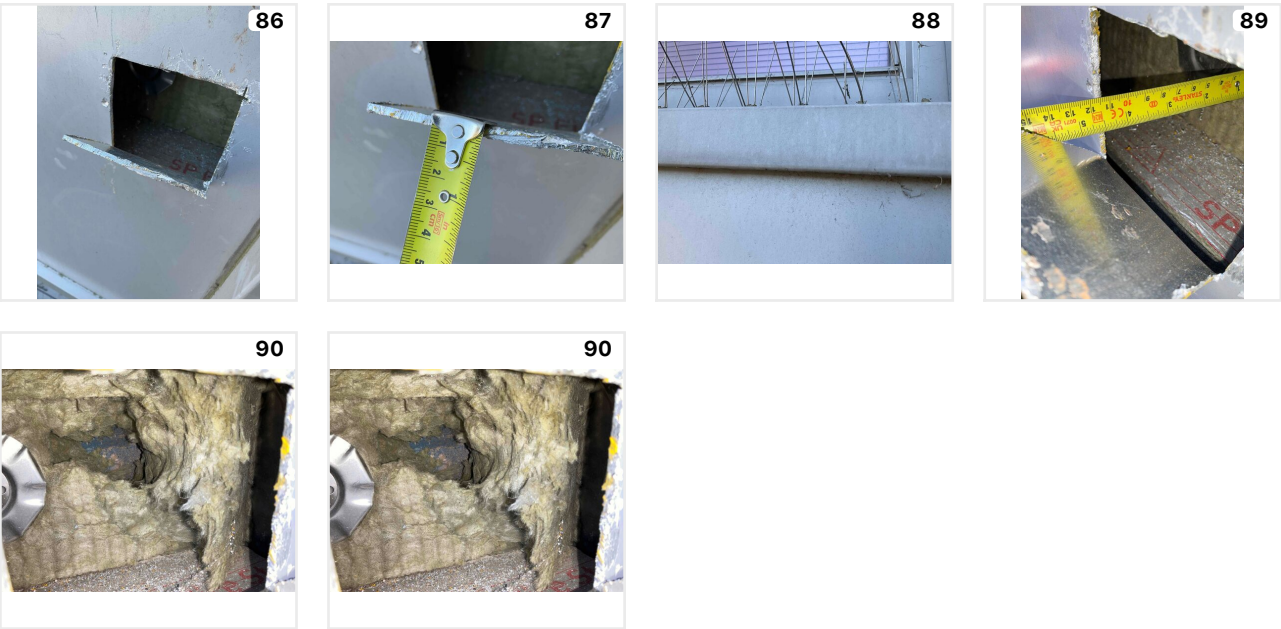
Backing Wall Sits On The Floor Slab
