Document Version 2  
Survey Date 30/05/2025  
Suggested Review Date 30/05/2030

# EXTERNAL WALL SURVEY

## 1-34 BEACONVIEW HOUSE

1 - 34 Beaconview Road  
West Brom  
B71 3PL

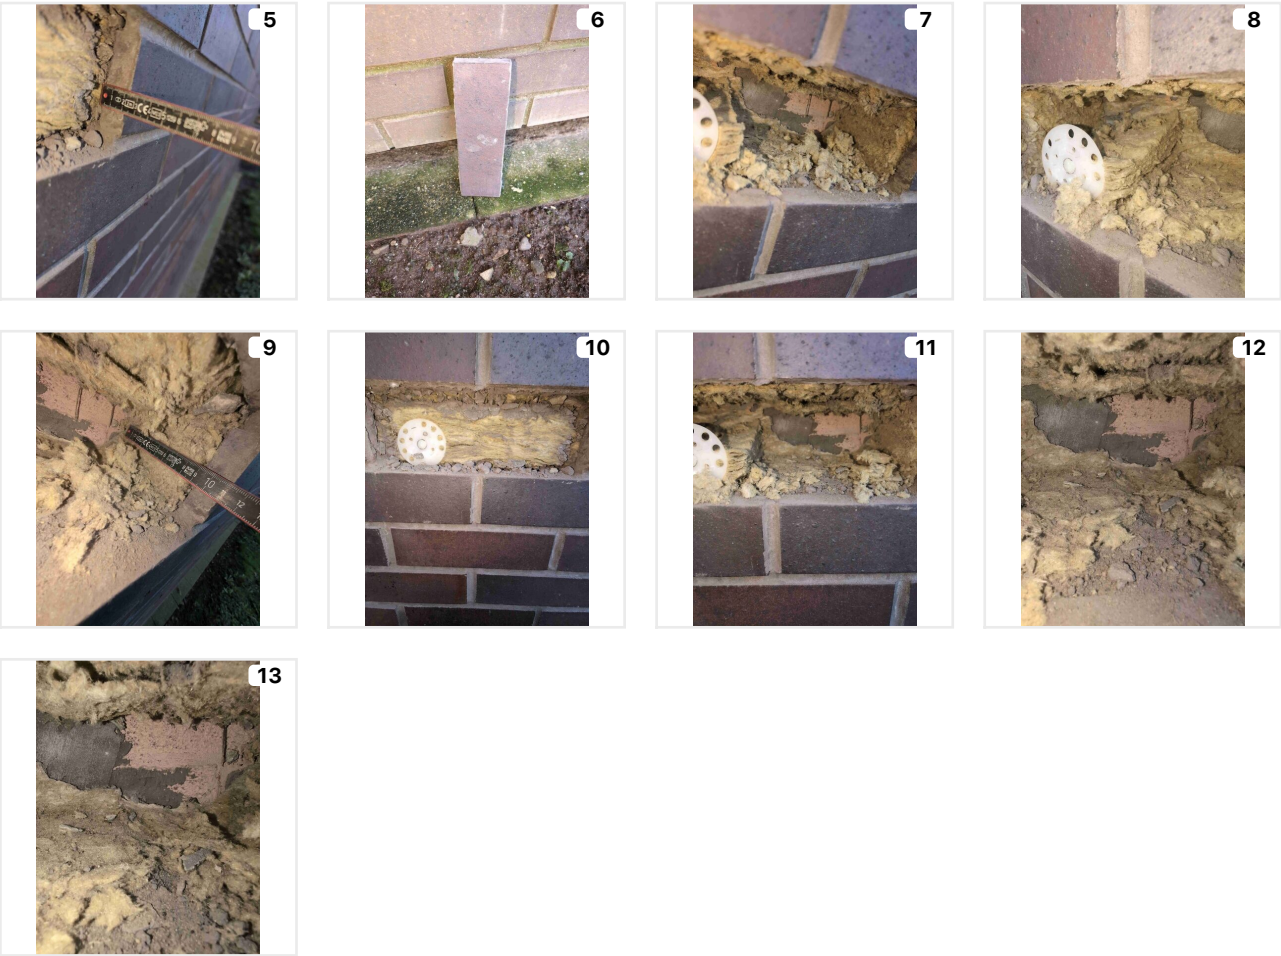
# Inspection: 7LQSLY

Elevation • Location  
North elevation • Window

| 3 Elements | Thickness/Depth | Material | Photo Ref. | Rating (BS EN13501) |
| External Surface Material | 20mm | Brick slip/Brick tile | 5, 6 | A1 - Non-Combustible |
| Insulation | 90mm | Mineral Wool Insulation | 7, 8, 9, 10 | A1 - Non-Combustible |
| Inner Leaf | | Brickwork<br>Material Brand:<br>Concentrate wall | 11, 12, 13 | A1 - Non-Combustible |

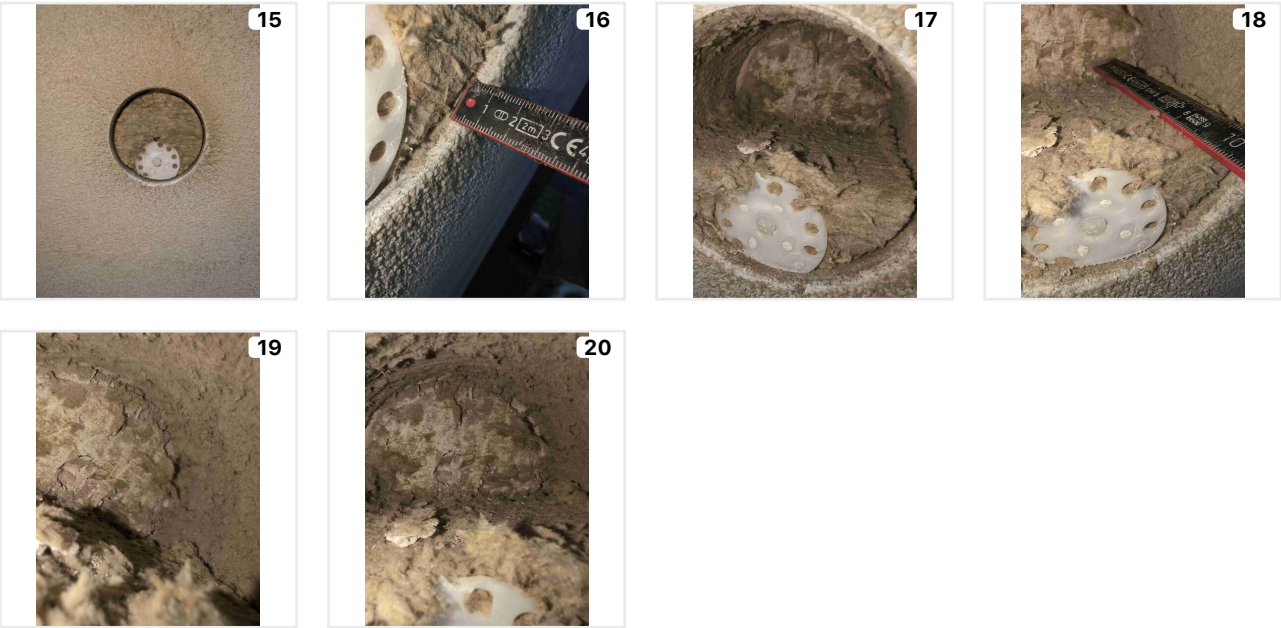
# Inspection: ZWWBLY

Elevation • Location  
North elevation • Compartment Floor Junction

| 3 Elements | Thickness/Depth | Material | Photo Ref. | Rating (BS EN13501) |
| External Surface Material | 4mm | Sto render | 15, 16 | A1 - Non-Combustible |
| Sto render backed up to rockwool slab | | | | |
| Insulation | 90mm | Mineral Wool Insulation | 17, 18 | A1 - Non-Combustible |
| Inner Leaf | | Brickwork | 19, 20 | A1 - Non-Combustible |

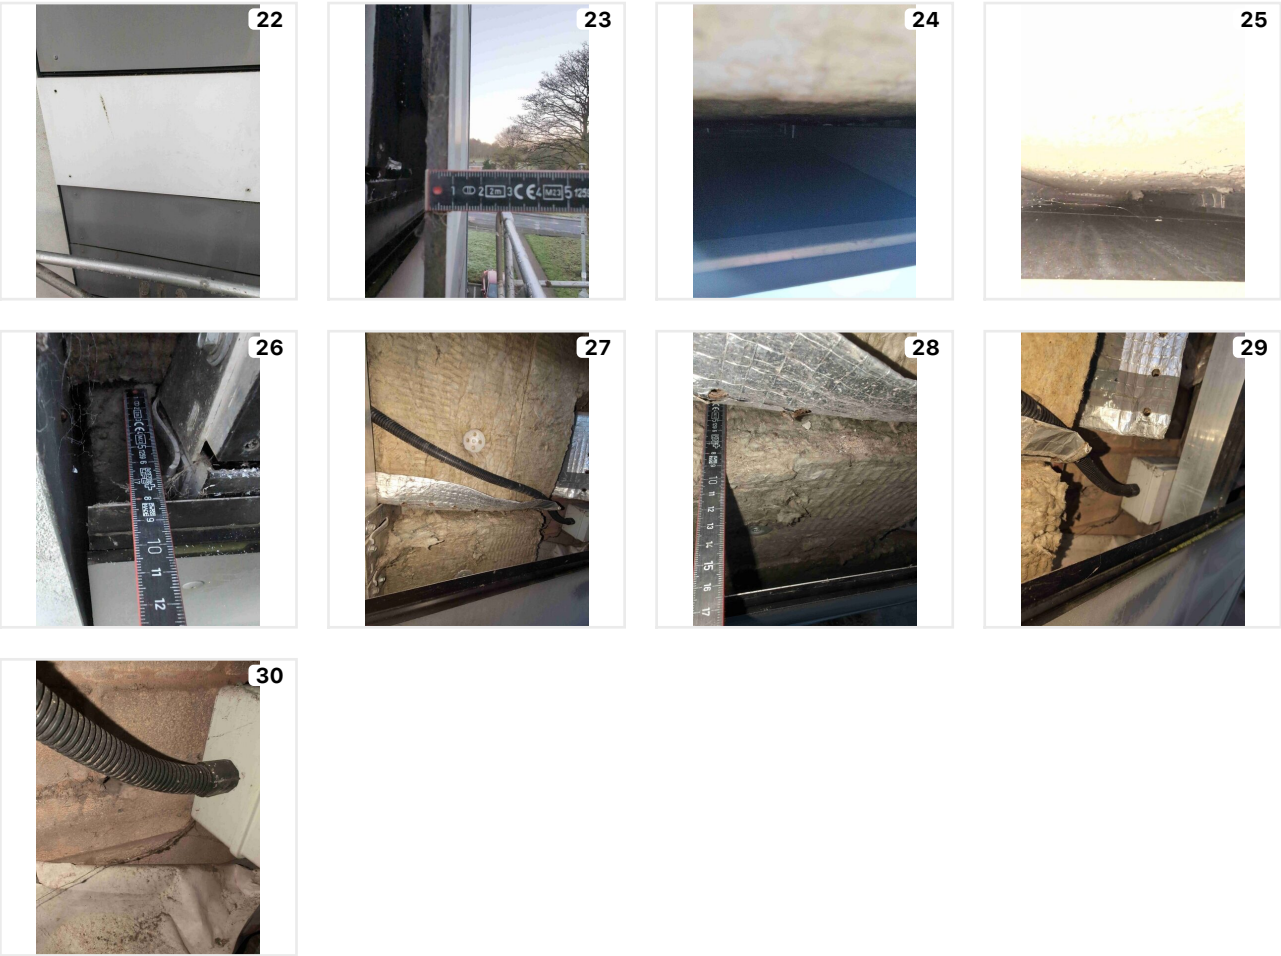
# Inspection: FBS31J

Elevation • Location  
North elevation • Compartment Floor Junction

| 4 Elements | Thickness/Depth | Material | Photo Ref. | Rating (BS EN13501) |
| External Surface Material | 8mm | Suspected High Pressure Laminate (HPL) Panel | 22, 23 | C - Combustible |
| Cavity | 80mm | | 24, 25, 26 | |
| Insulation | 90mm | Mineral Wool Insulation | 27, 28 | A1 - Non-Combustible |
| Inner Leaf | | Brickwork | 29, 30 | |

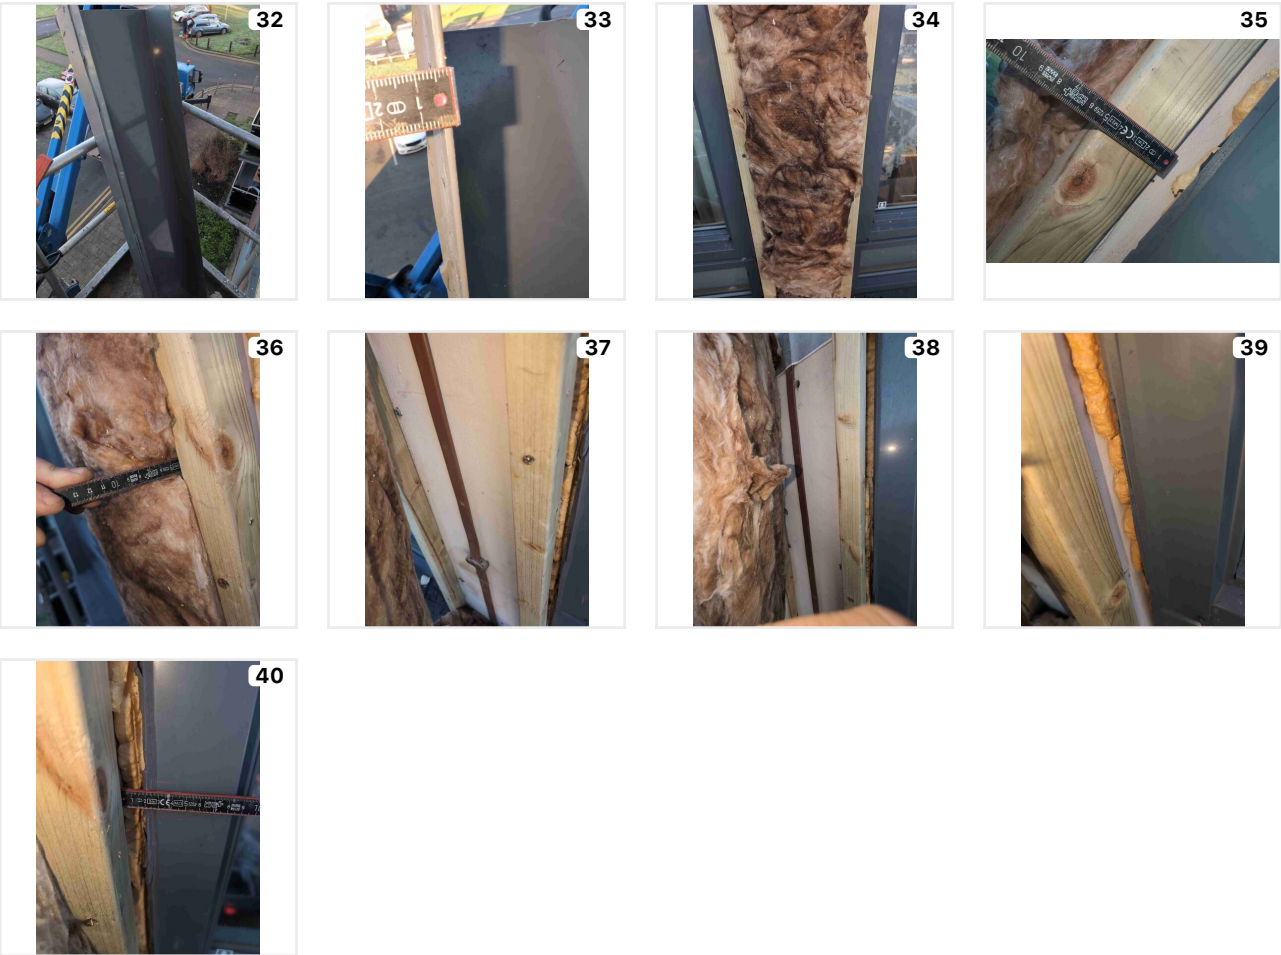
# Inspection: GNG7LT

Elevation • Location  
West elevation • Vertical Junction

| 5 Elements | Thickness/Depth | Material | Photo Ref. | Rating (BS EN13501) |
| External Surface Material | 3mm | Aluminium Panel | 32, 33 | A1 - Non-Combustible |
| Insulation | 50mm | Mineral Wool Insulation | 34, 35, 36 | A1 - Non-Combustible |
| 50mm timber beams around rockwool | | | | |
| Inner Leaf | | Reinforced concrete | 37, 38 | A1 - Non-Combustible |
| Cavity | 20mm | Void: Expanding foam around window | 39, 40 | |
| Framework | | Timber Batten | | D - Highly Combustible |

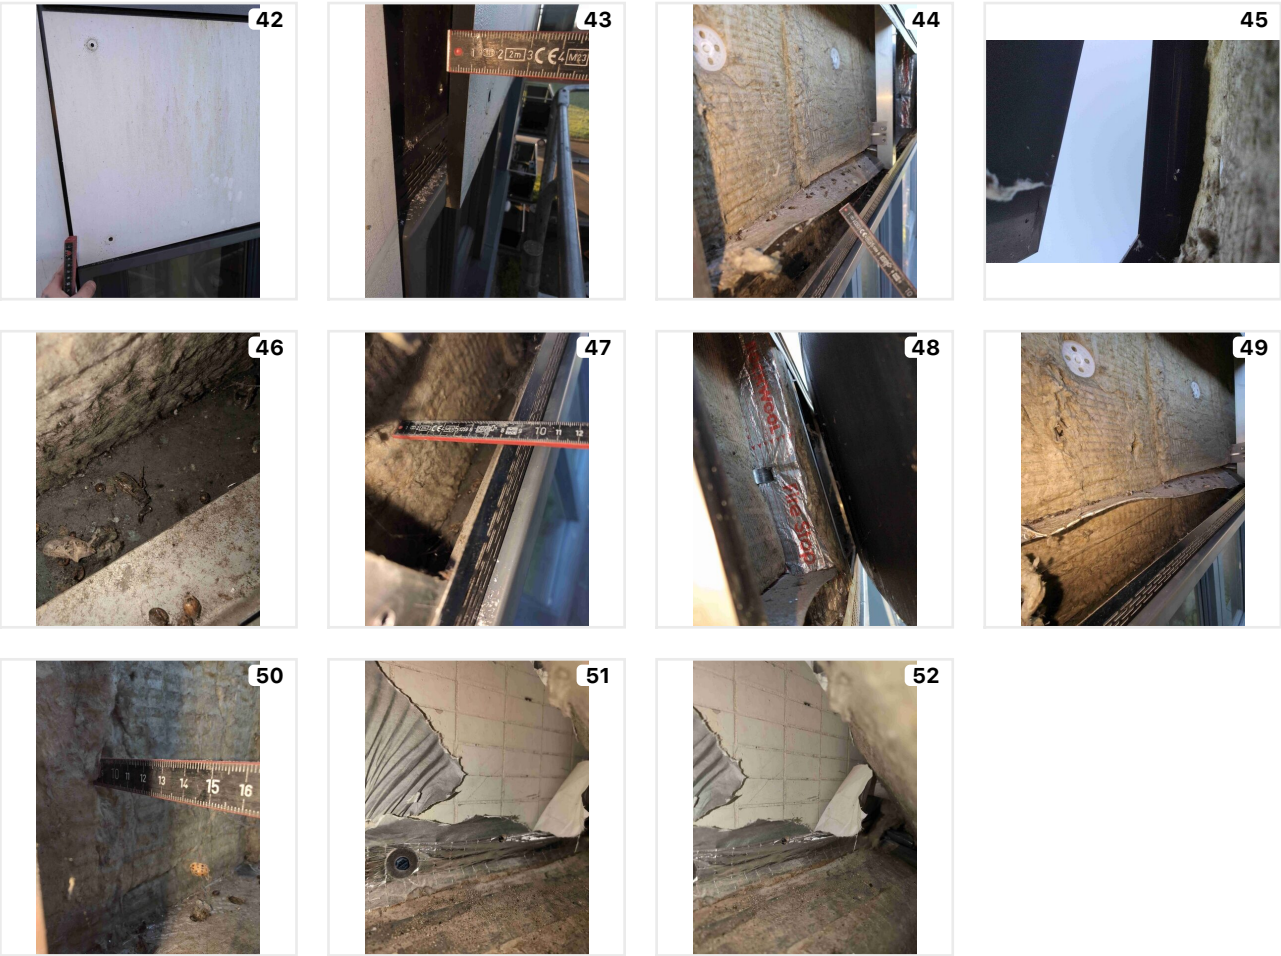
# Inspection: B6SCI1

Elevation • Location  
West elevation • Compartment Floor and Wall Junction Interface

| 4 Elements | Thickness/Depth | Material | Photo Ref. | Rating (BS EN13501) |
| External Surface Material | 8mm | Suspected High Pressure Laminate (HPL) Panel | 42, 43 | C - Combustible |
| Cavity | 8mm | | 44, 45, 46, 47 | |
| Insulation | 90mm | Mineral Wool Insulation<br>Material Brand: Rockwool slab with rockwool fire stop | 48, 49, 50 | A1 - Non-Combustible |
| Inner Leaf | | Reinforced concrete | 51, 52 | A1 - Non-Combustible |

| 1 Cavity Barrier | Material | Photo Ref. |
|---|---|---|
| Horizontal Cavity Barrier | Stonewool core, aluminium foil faces | |

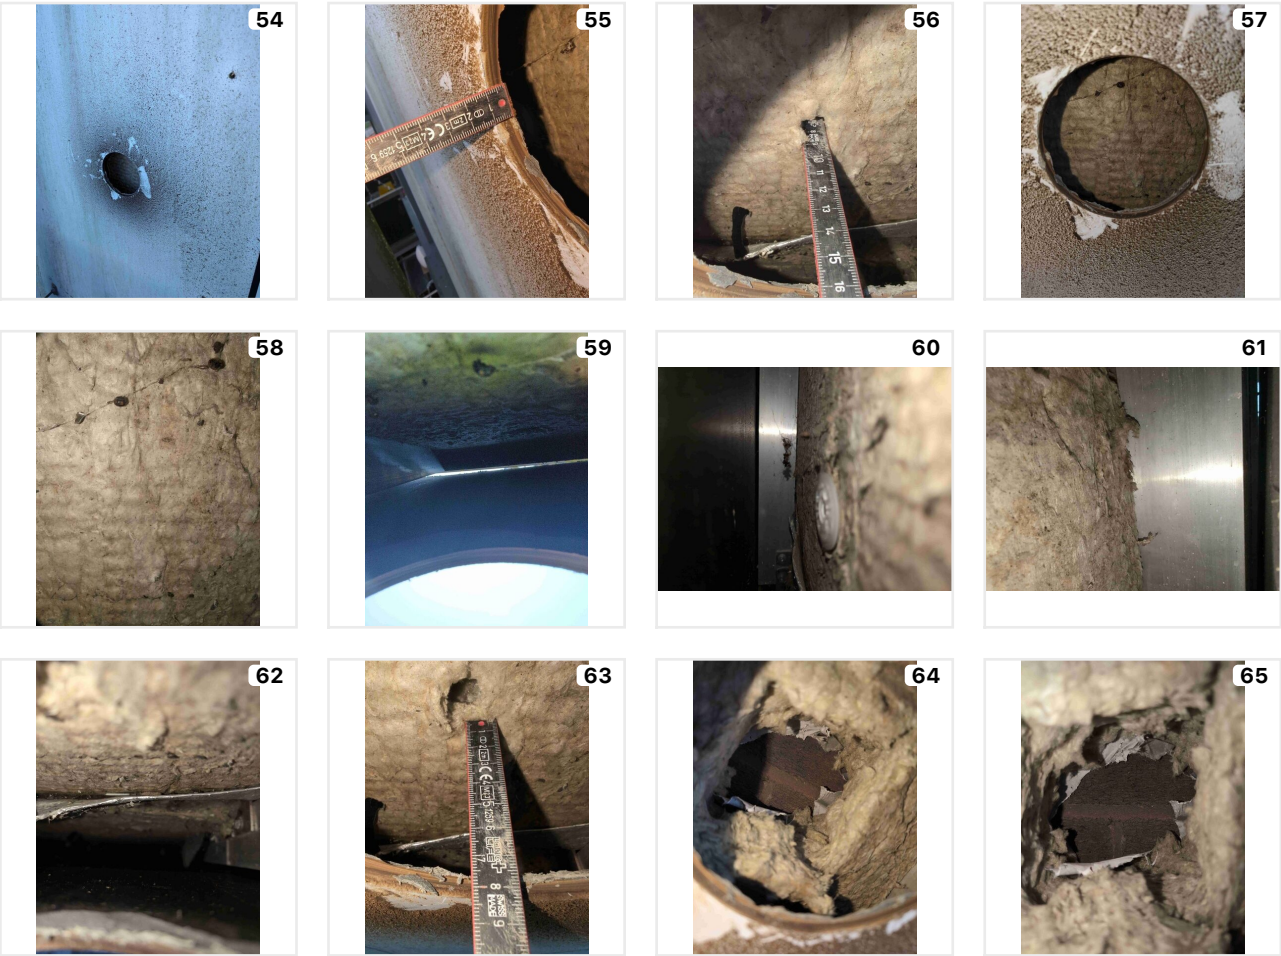
# Inspection: LJBXZS

Elevation • Location  
West elevation • Compartment Floor Junction

| 4 Elements | Thickness/Depth | Material | Photo Ref. | Rating (BS EN13501) |
| External Surface Material | 8mm | Suspected High Pressure Laminate (HPL) Panel | 54, 55 | C - Combustible |
| Insulation | 90mm | Mineral Wool Insulation | 56, 57, 58 | A1 - Non-Combustible |
| Cavity | 75mm | | 59, 60, 61, 62, 63 | |
| Inner Leaf | | Blockwork | 64, 65 | A1 - Non-Combustible |
