Document Version 1  
Survey Date 22/06/2025  
Suggested Review Date 22/06/2030

# EXTERNAL WALL SURVEY

## 380-450 BEACONVIEW ROAD

380 - 450 Beaconview Road  
Beaconview Road  
West Brom  
B71 3PH

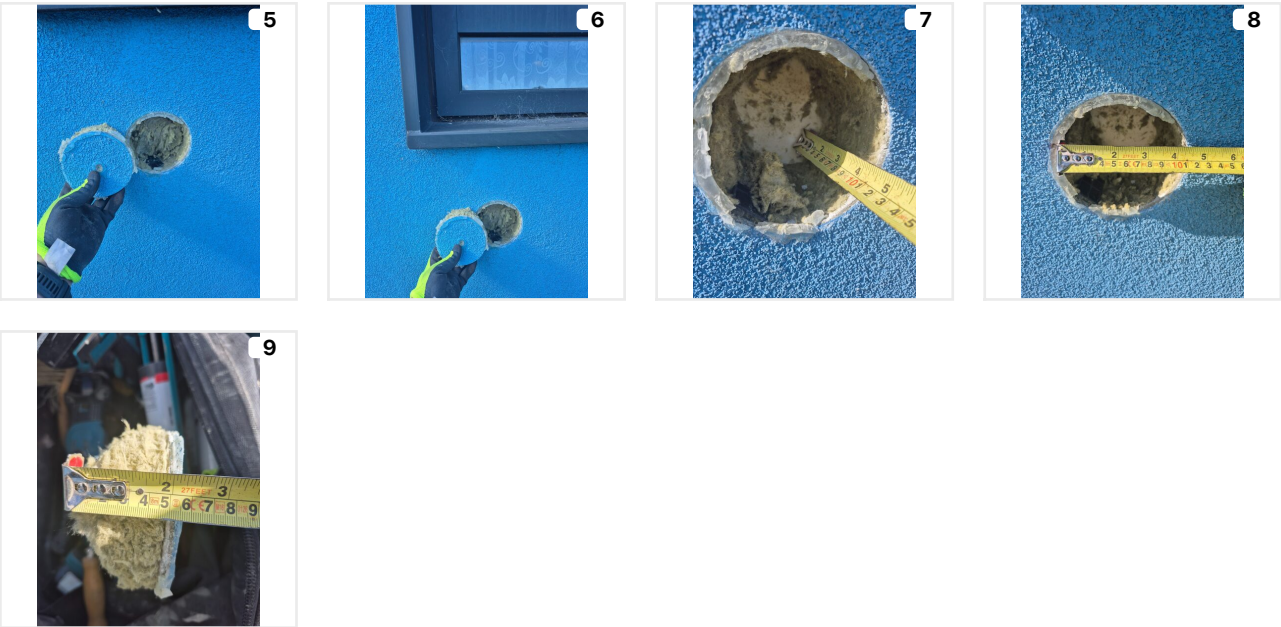
# Inspection: 6ZB317

Backing Wall Sits On The Floor Slab

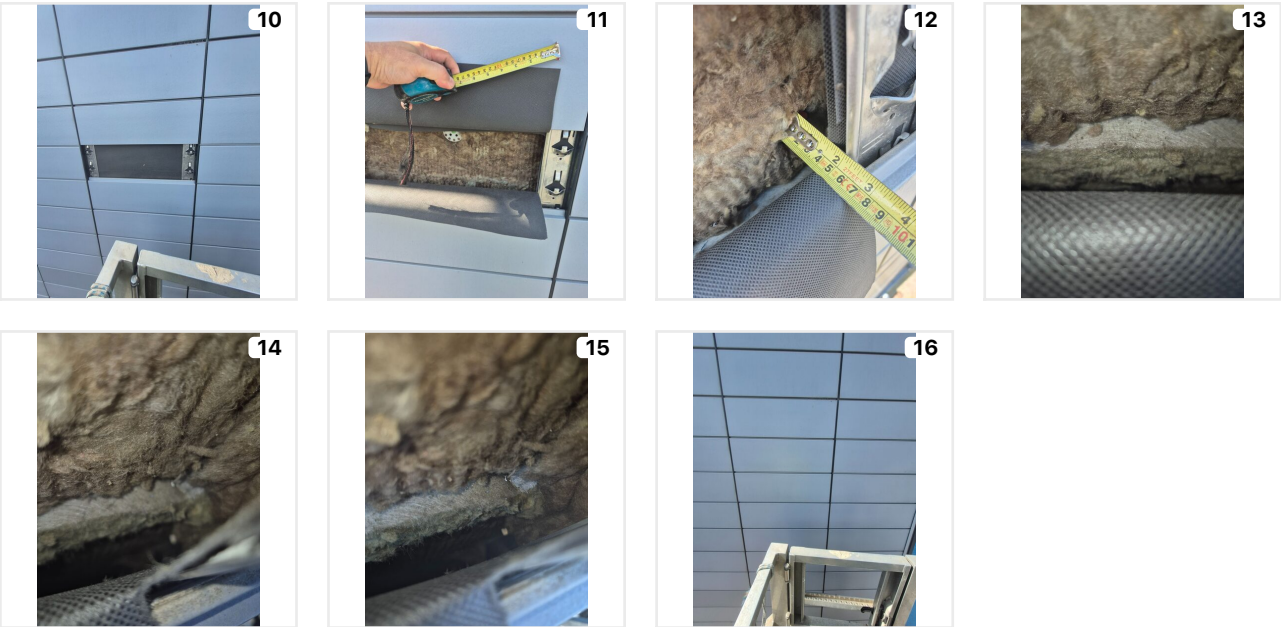
# Inspection: S8DXDB

Elevation • Location  
East elevation • Compartment Floor and Wall Junction Interface

Backing Wall Sits On The Floor Slab

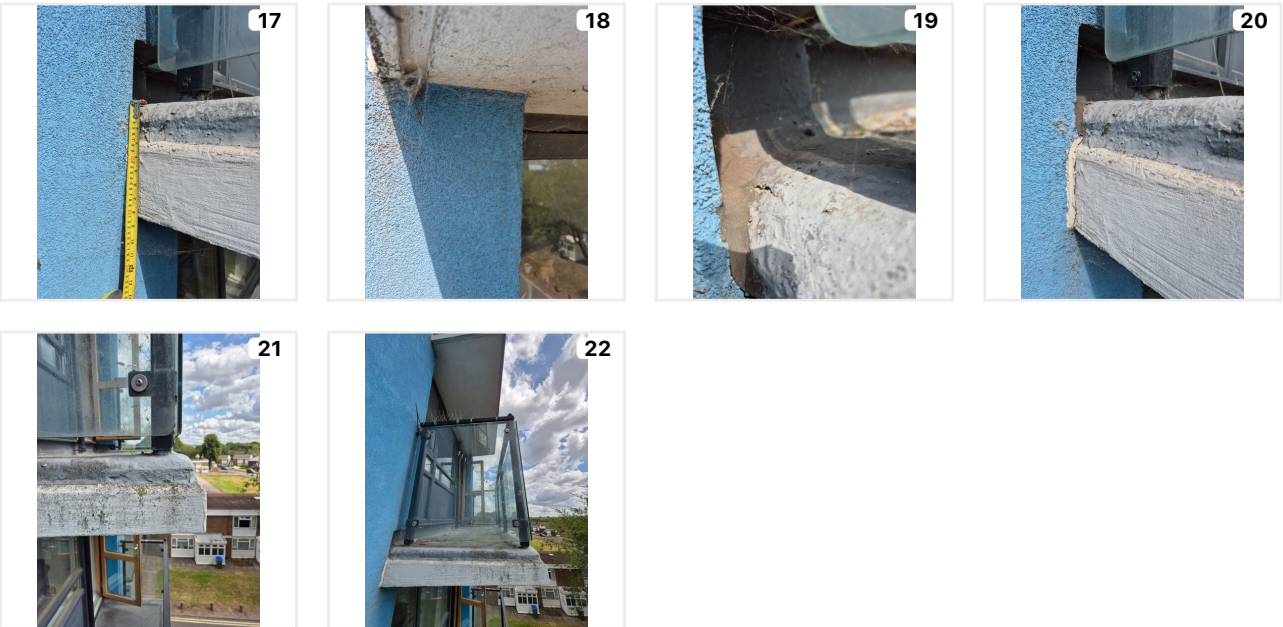
# Inspection: 26DGY2

Elevation • Location  
East elevation • Balcony floor and soffit finishes and build-up

| 2 Elements | Thickness/Depth | Material | Photo Ref. | Rating (BS EN13501) |
|---|---|---|---|---|
| Waterproof Membrane | | | | B - Combustible |

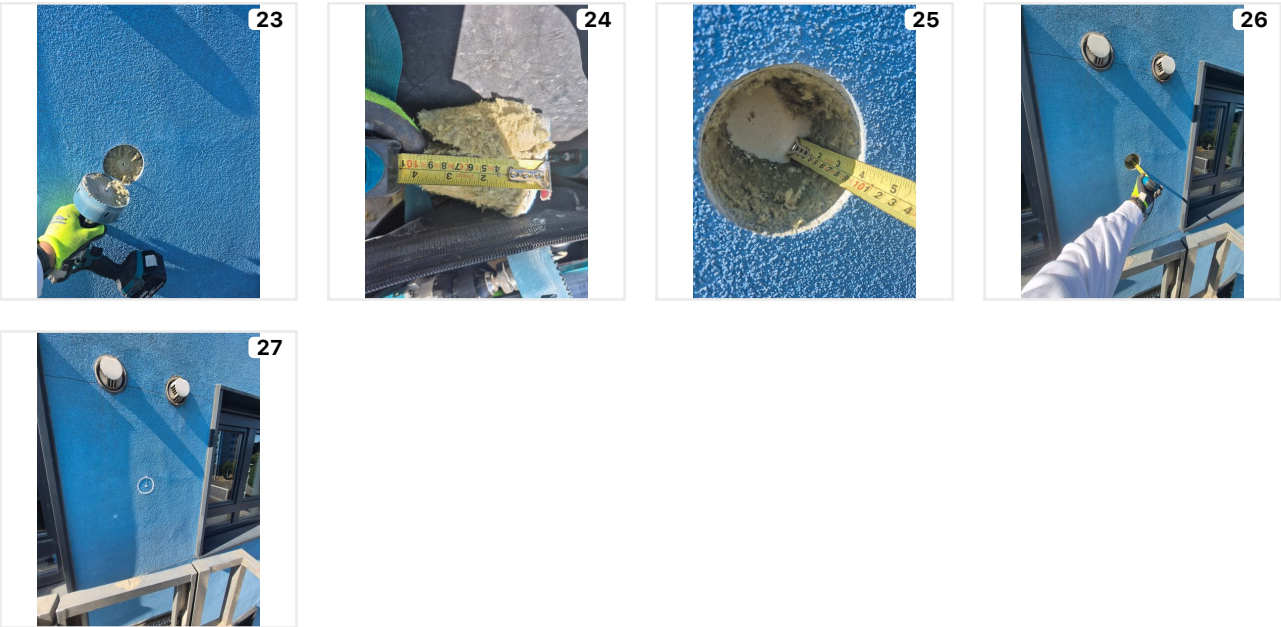
# Inspection: TWAGE4

Backing Wall Sits On The Floor Slab

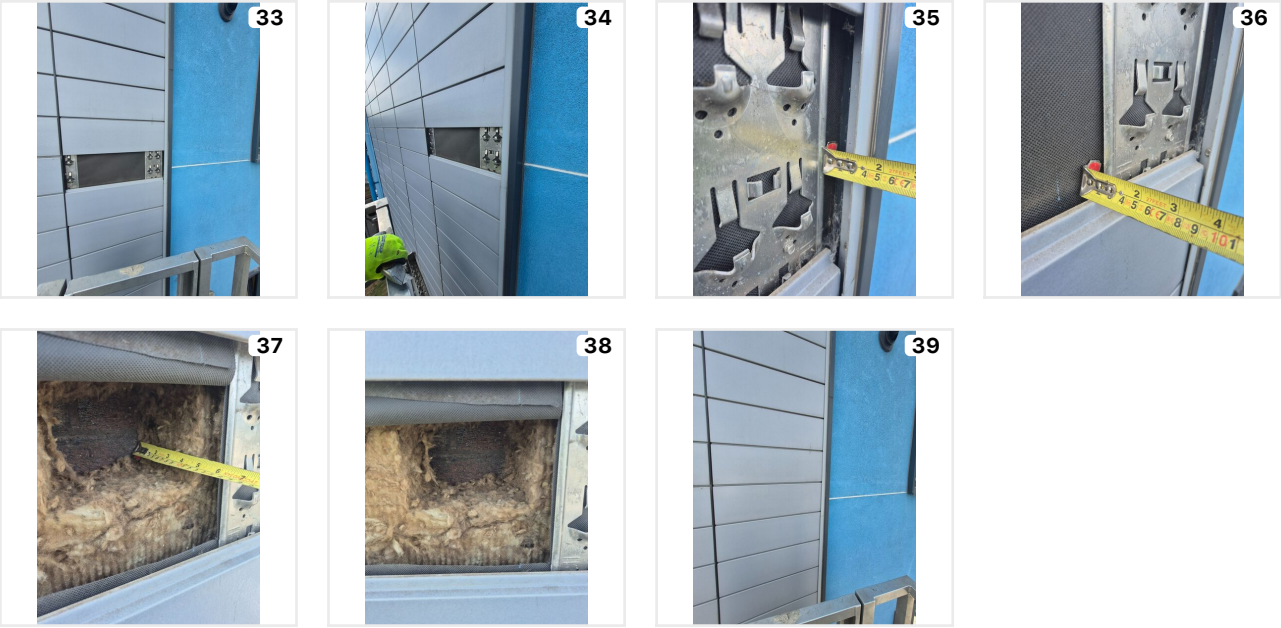
Backing Wall Sits On The Floor Slab

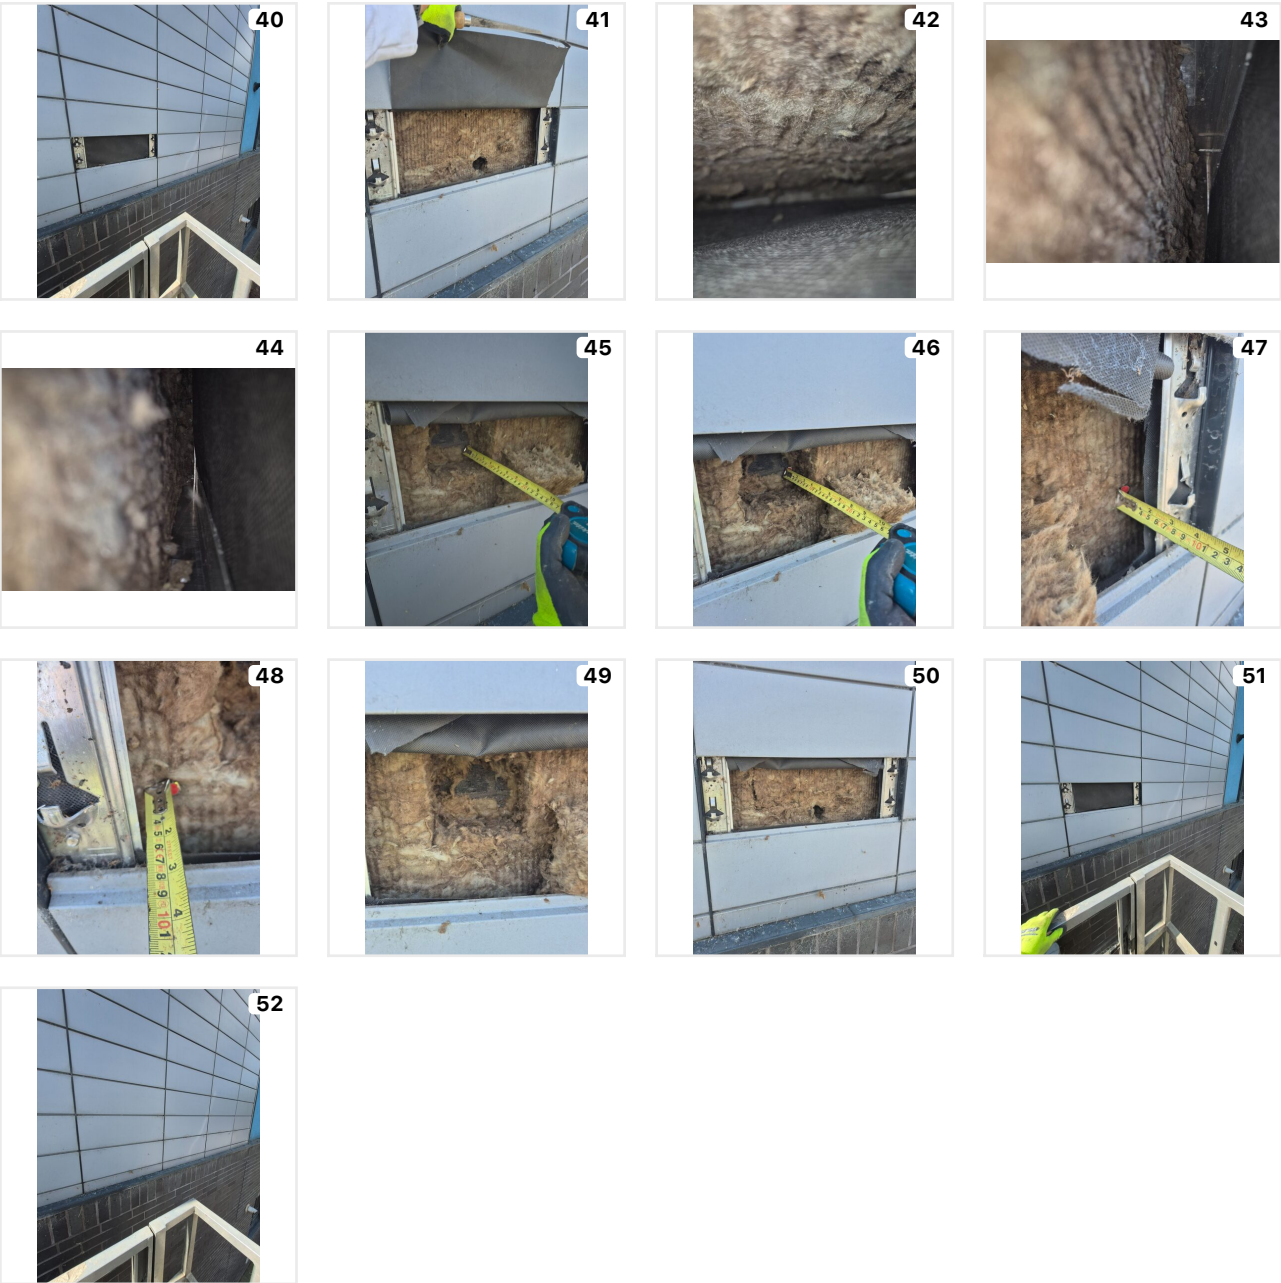
# Inspection: L85SVQ

Location  
Compartment Floor and Wall Junction Interface

Backing Wall Sits On The Floor Slab

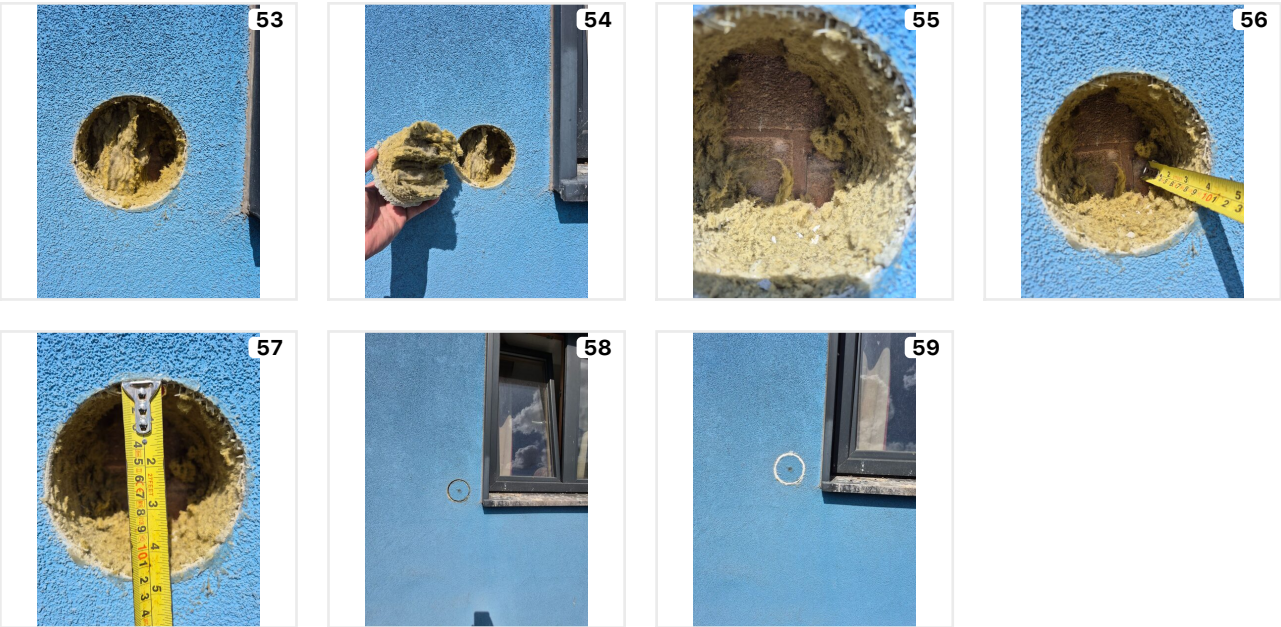
# Inspection: WRRJ6H

Location  
Compartment Floor and Wall Junction Interface

Backing Wall Sits On The Floor Slab

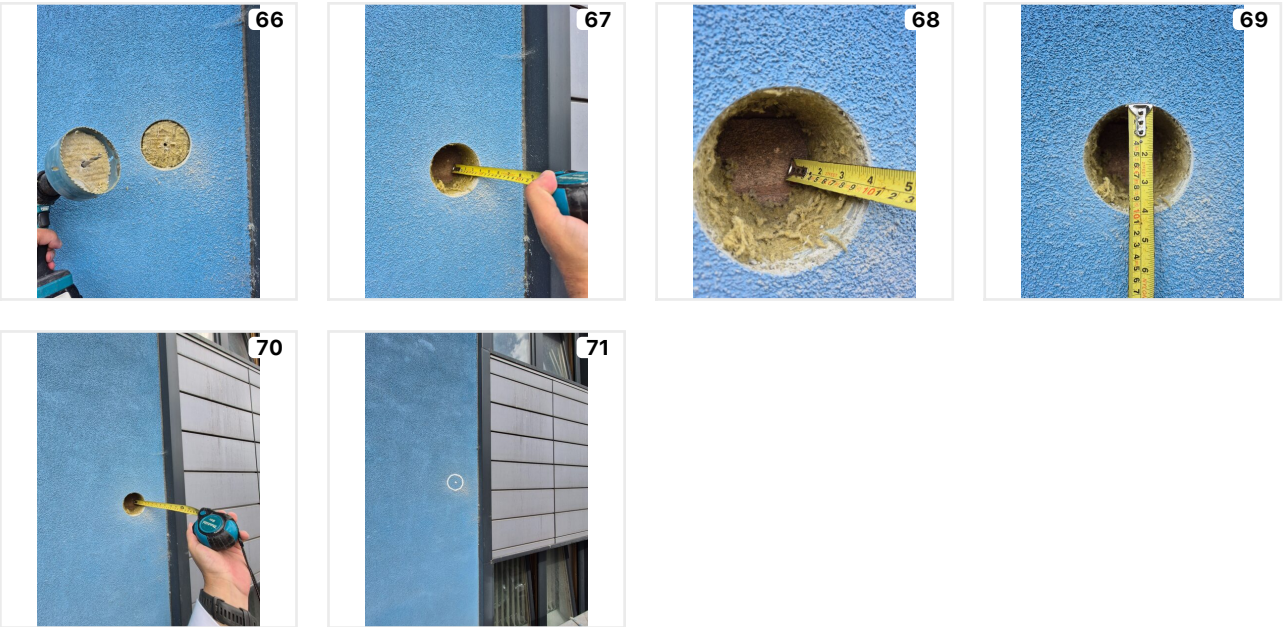
Backing Wall Sits On The Floor Slab

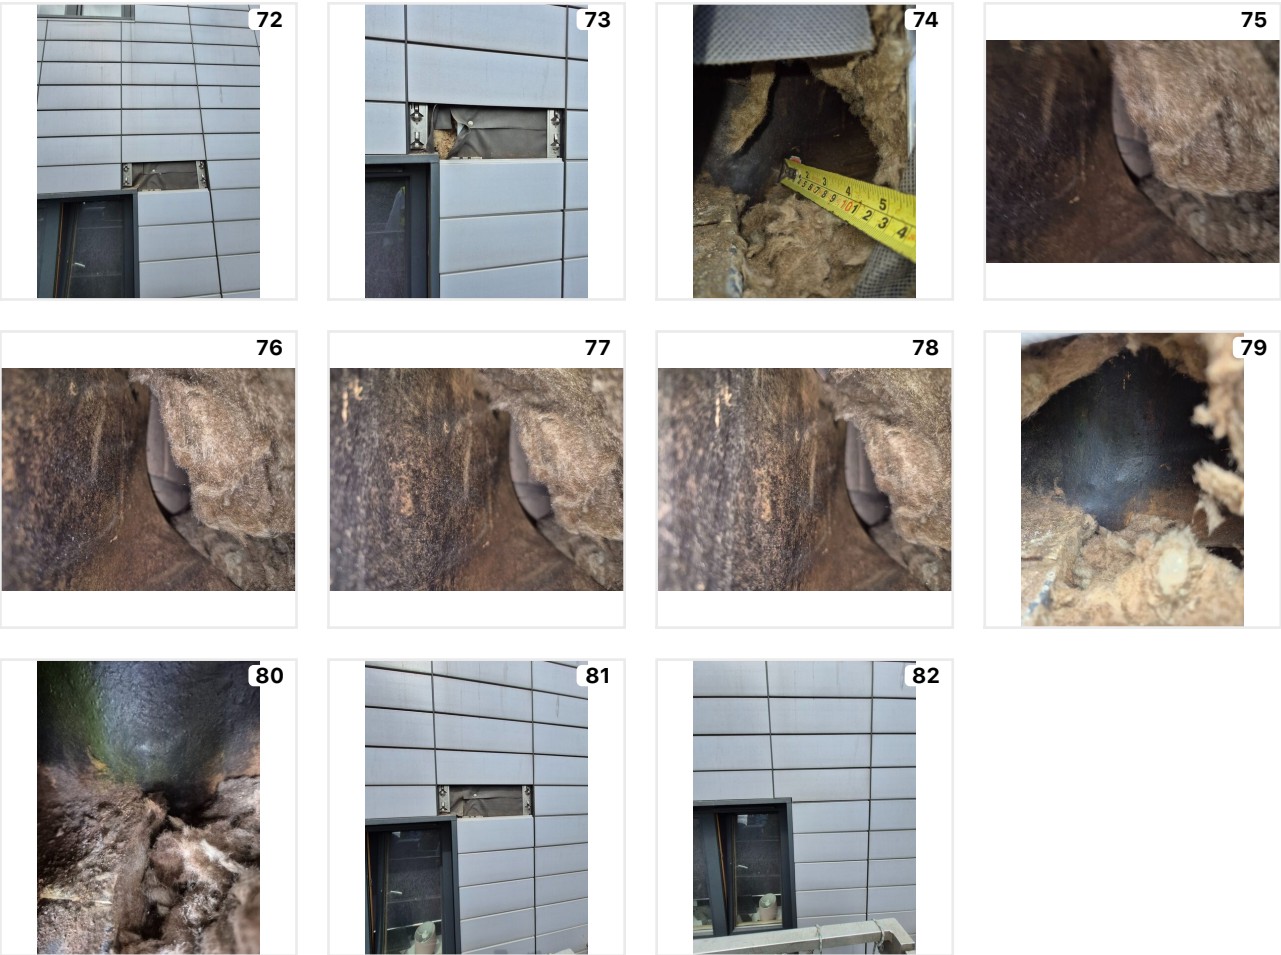
# Inspection: GD4WKV

Location  
Compartment Floor and Wall Junction Interface

Backing Wall Sits On The Floor Slab

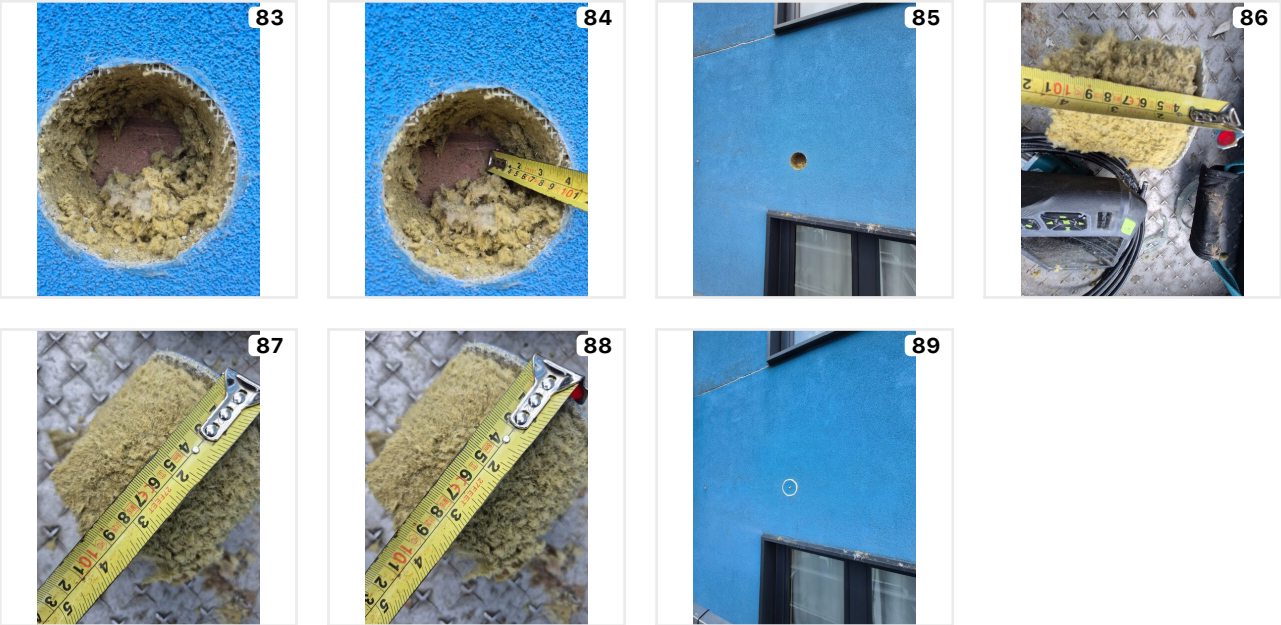
# Inspection: 28CUQG

Location  
Aperture Opening

Backing Wall Sits On The Floor Slab

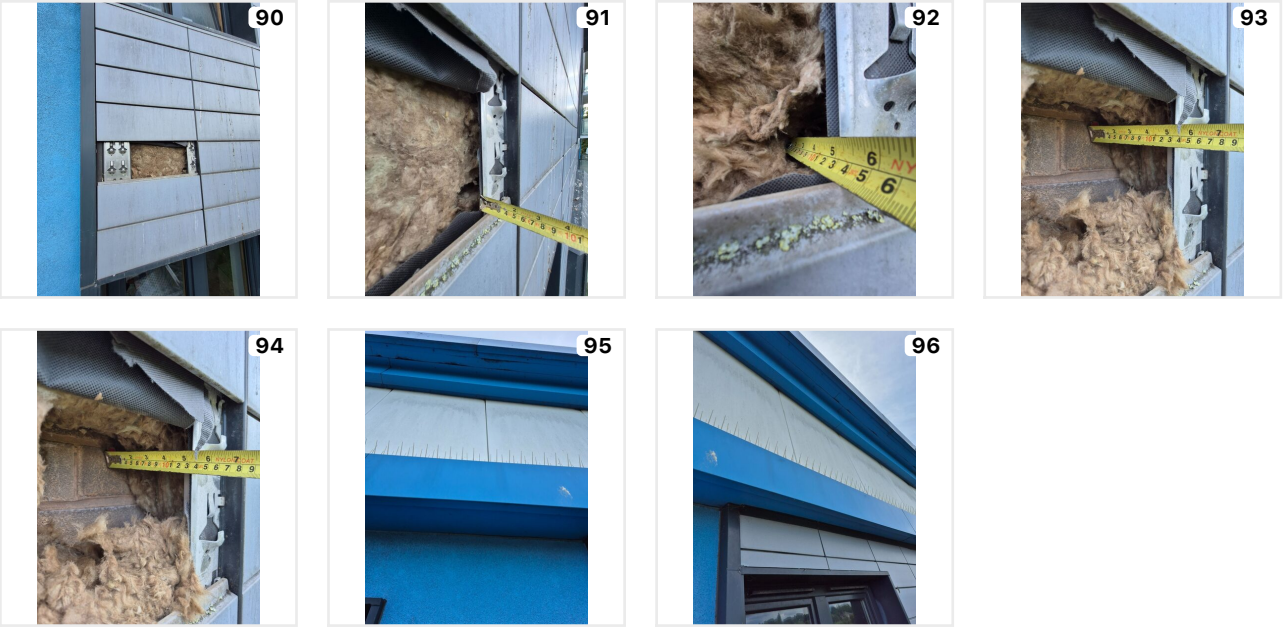
# Inspection: 7YR2QY

Location  
Compartment Floor and Wall Junction Interface

Backing Wall Sits On The Floor Slab

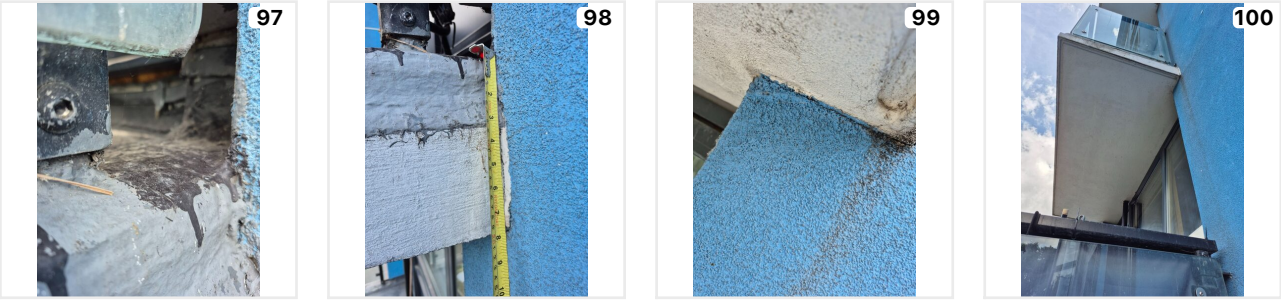
# Inspection: UVIUKI

Location  
Balcony floor and soffit finishes and build-up

| 2 Elements | Thickness/Depth | Material | Photo Ref. | Rating (BS EN13501) |
|---|---|---|---|---|
| Waterproof Membrane | | | | B - Combustible |
