# FIRE RISK APPRAISAL EXTERNAL WALLS

## 380-450 BEACONVIEW ROAD

380 - 450 Beaconview Road  
Beaconview Road  
West Brom  
B71 3PH

30/01/2025, James Major (Facade Manager)

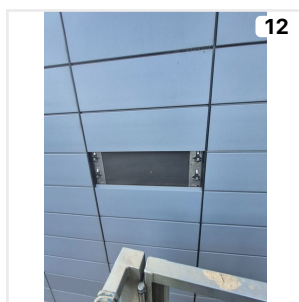
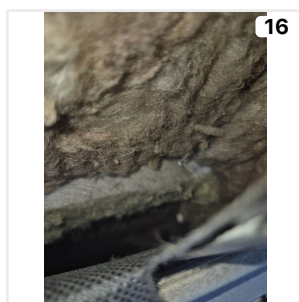
Backing Wall Sits On The Floor Slab

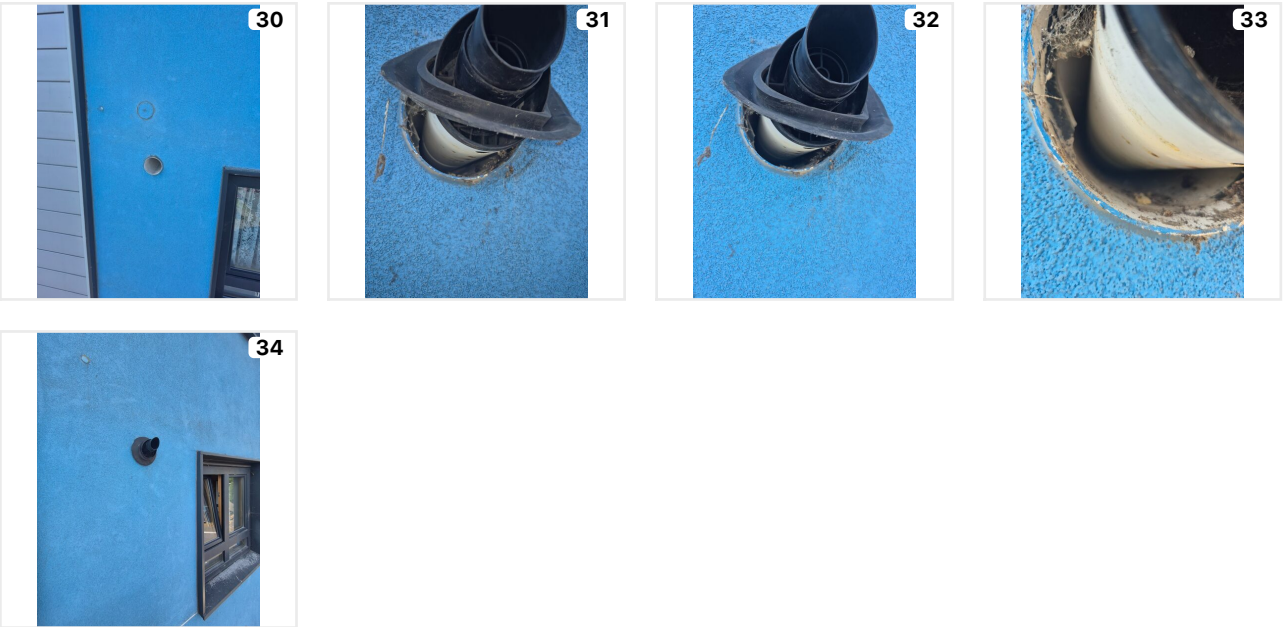
Location  
Aperture Opening

Backing Wall Sits On The Floor Slab

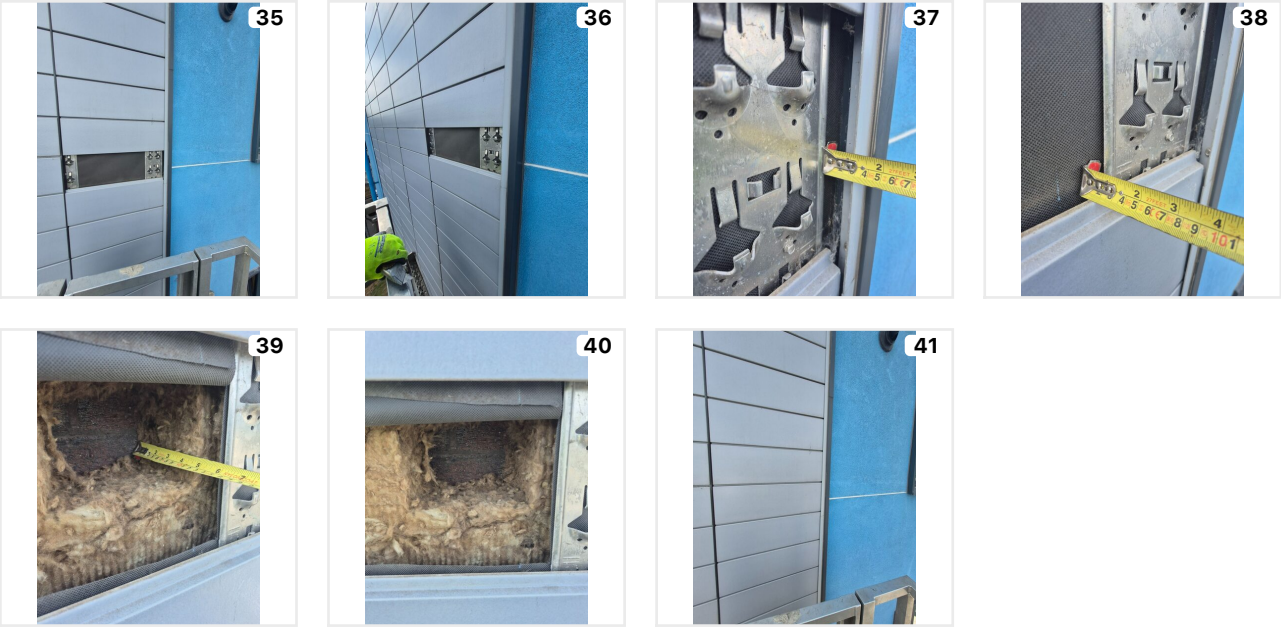
Location  
Compartment Floor and Wall Junction Interface

Backing Wall Sits On The Floor Slab

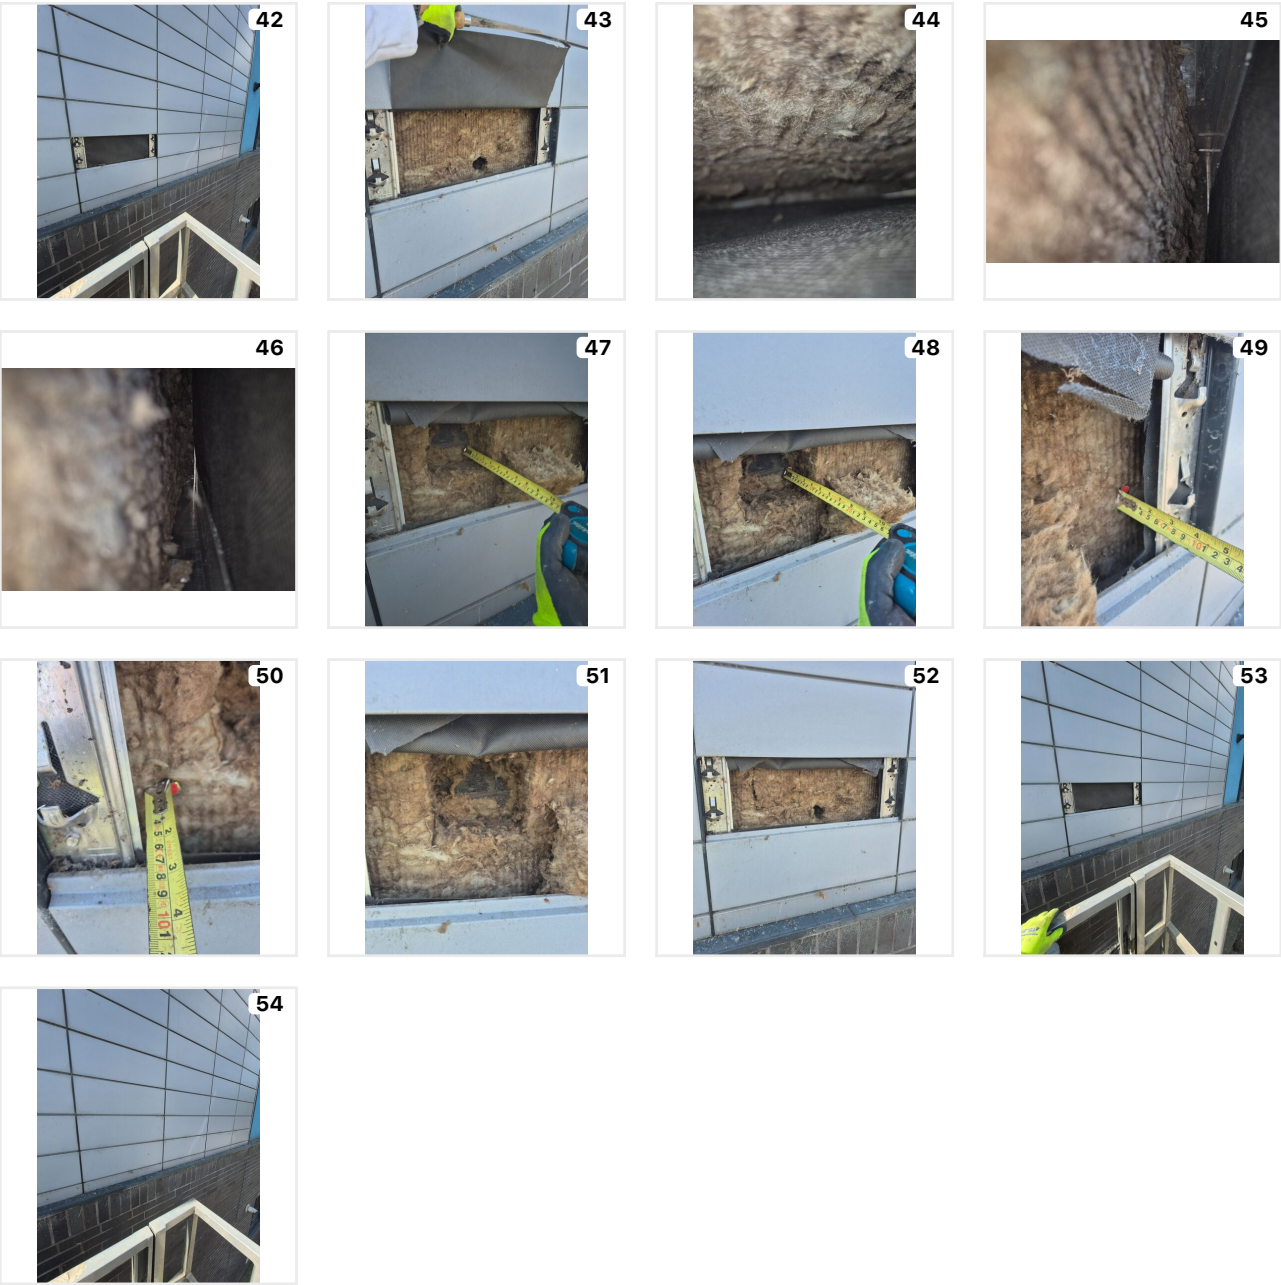
Location  
Compartment Floor and Wall Junction Interface

Backing Wall Sits On The Floor Slab

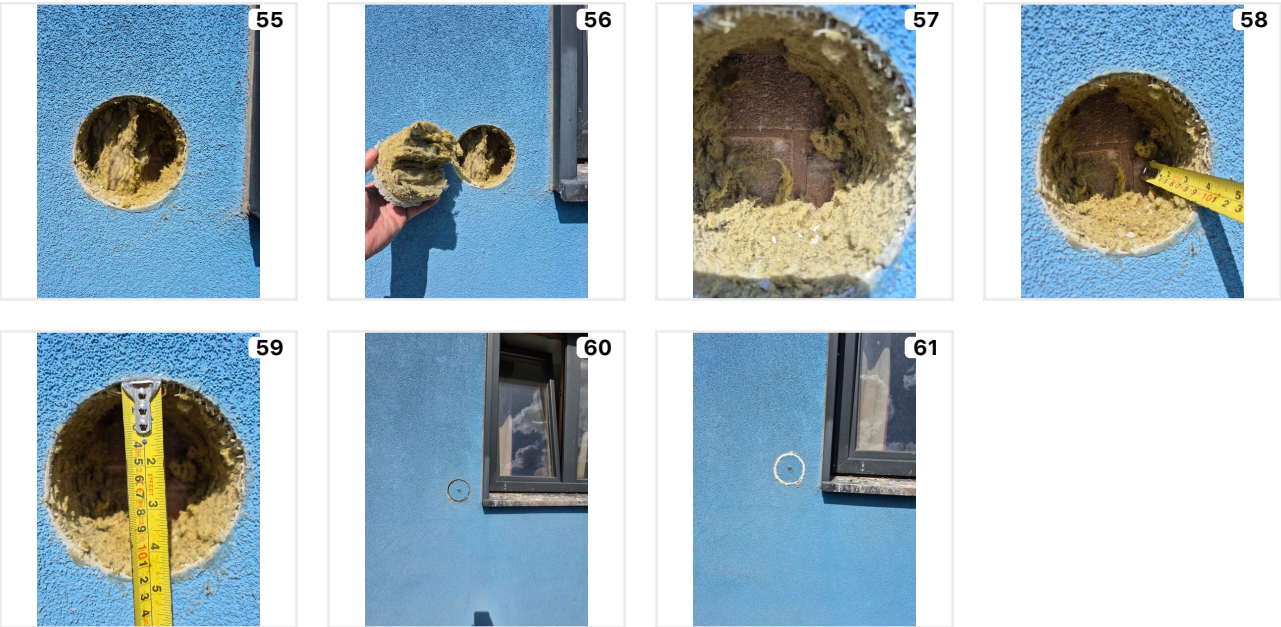
Location  
Compartment Floor and Wall Junction Interface

Backing Wall Sits On The Floor Slab

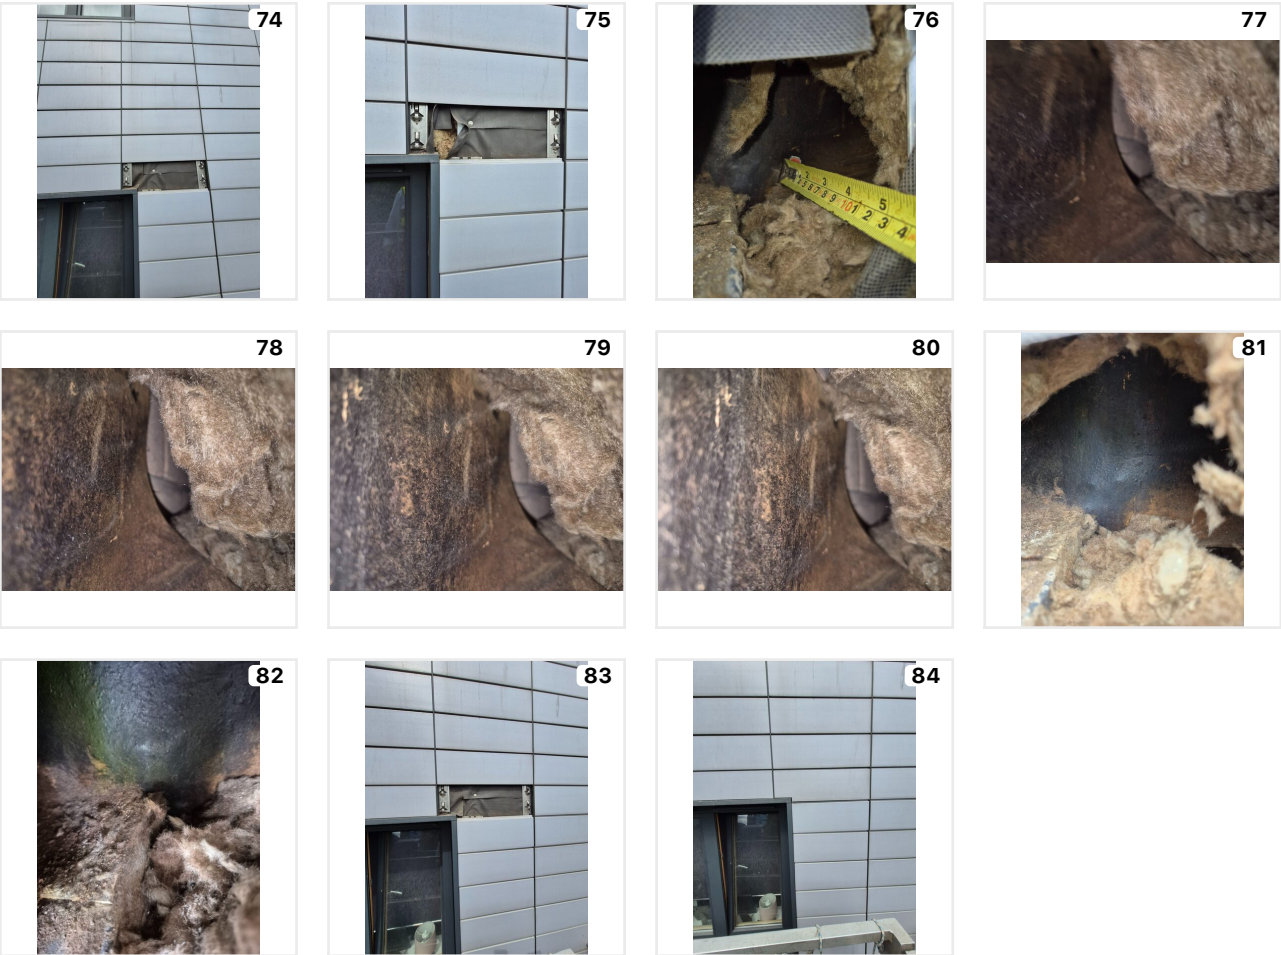
Location  
Compartment Floor and Wall Junction Interface

Backing Wall Sits On The Floor Slab

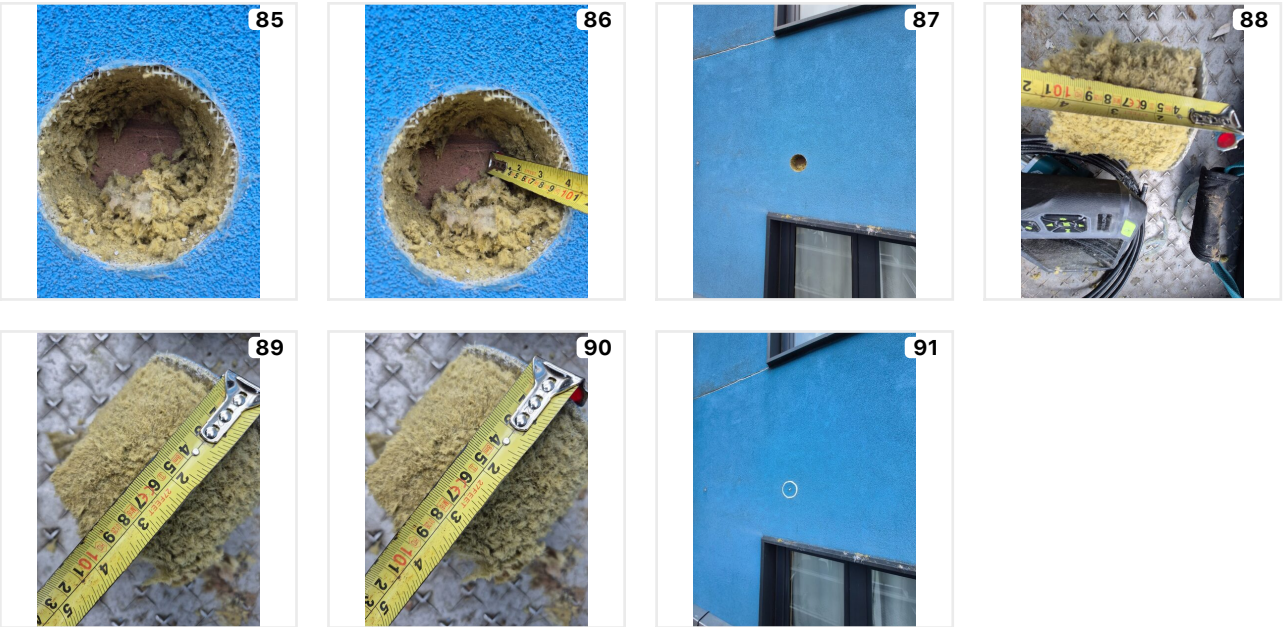
Location  
Aperture Opening

Backing Wall Sits On The Floor Slab

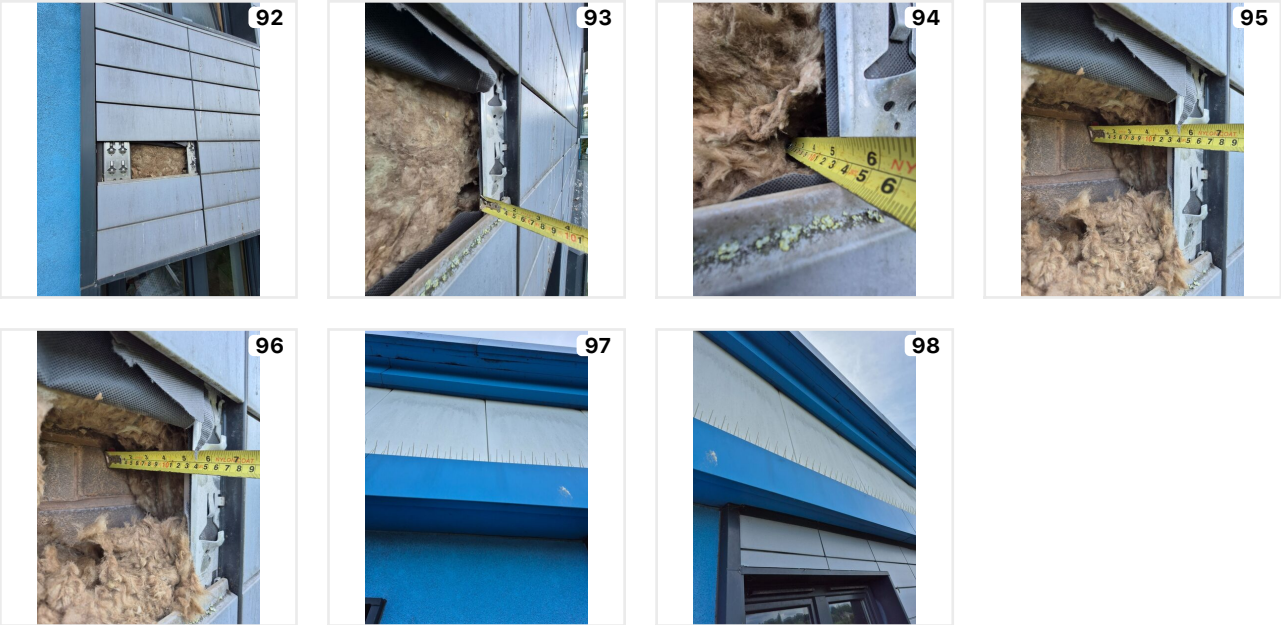
Location  
Compartment Floor and Wall Junction Interface

Backing Wall Sits On The Floor Slab

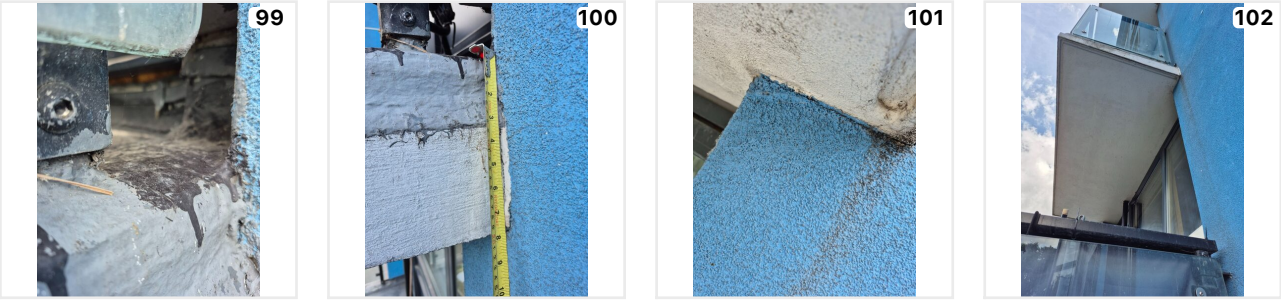
Location  
Balcony floor and soffit finishes and build-up

| 2 Elements | Thickness/Depth | Material | Photo Ref. | Rating (BS EN13501) |
|---|---|---|---|---|
| Waterproof Membrane | | | | B - Combustible |

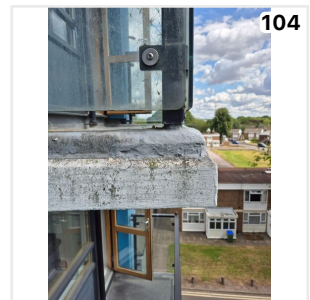
They are primarily formed of non-combustible materials, the steel frame and balustrade, and concrete soffit will not support, sustain, or contribute to the spread of fire across the external surface of the building. The soffit will also act to disrupt the mechanism for vertical fire spread between the balconies. The adjacent wall systems are non-combustible and, as such, will not be negatively impacted by a fire occurring on a balcony.
