**FIRNTEC**  
BUILDING COMPLIANCE

# EXTERNAL WALL SURVEY

## BOULTON HOUSE

Spon Lane  
Tipton  
B70 6BJ

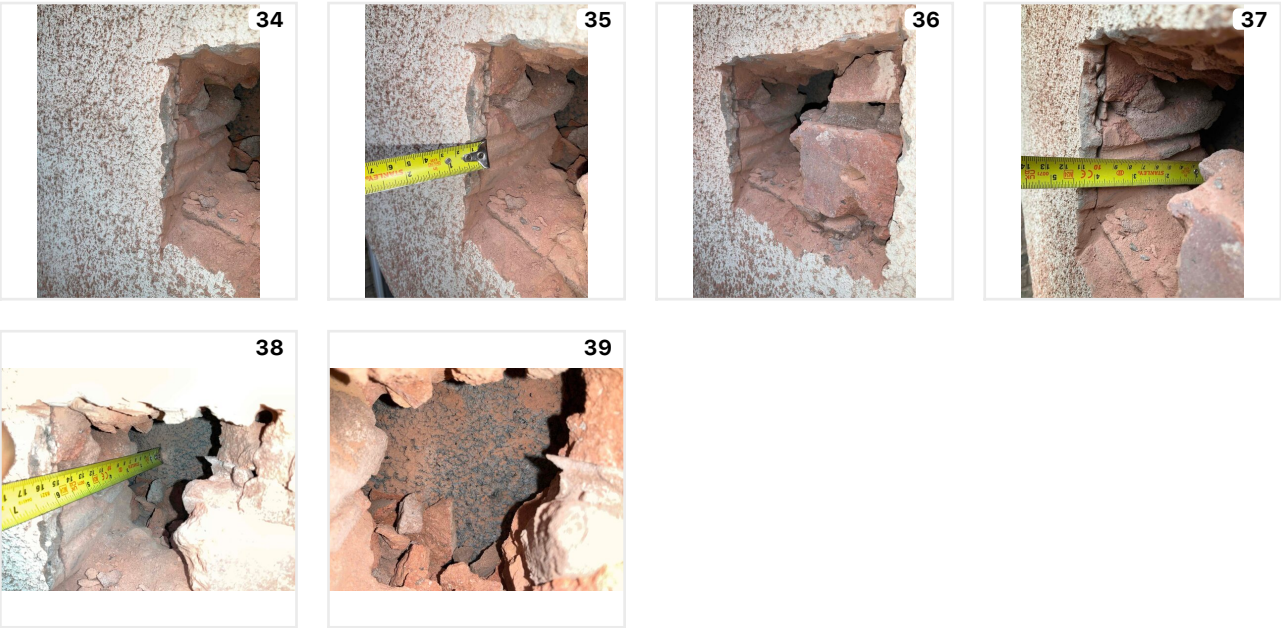
| 5 Elements | Thickness/Depth | Material | Photo Ref. | Rating (BS EN13501) |
| External Surface Material | 2mm | Render | 34 | A1 - Non-Combustible |
| Outer leaf | 10mm | | 35 | A1 - Non-Combustible |
| Outer leaf | 102mm | | 36, 37 | A1 - Non-Combustible |
| Cavity | 50mm | | 38 | |
| Substrate | | Original blockwork | 39 | A1 - Non-Combustible |

No cavity barrier identified at this inspection location

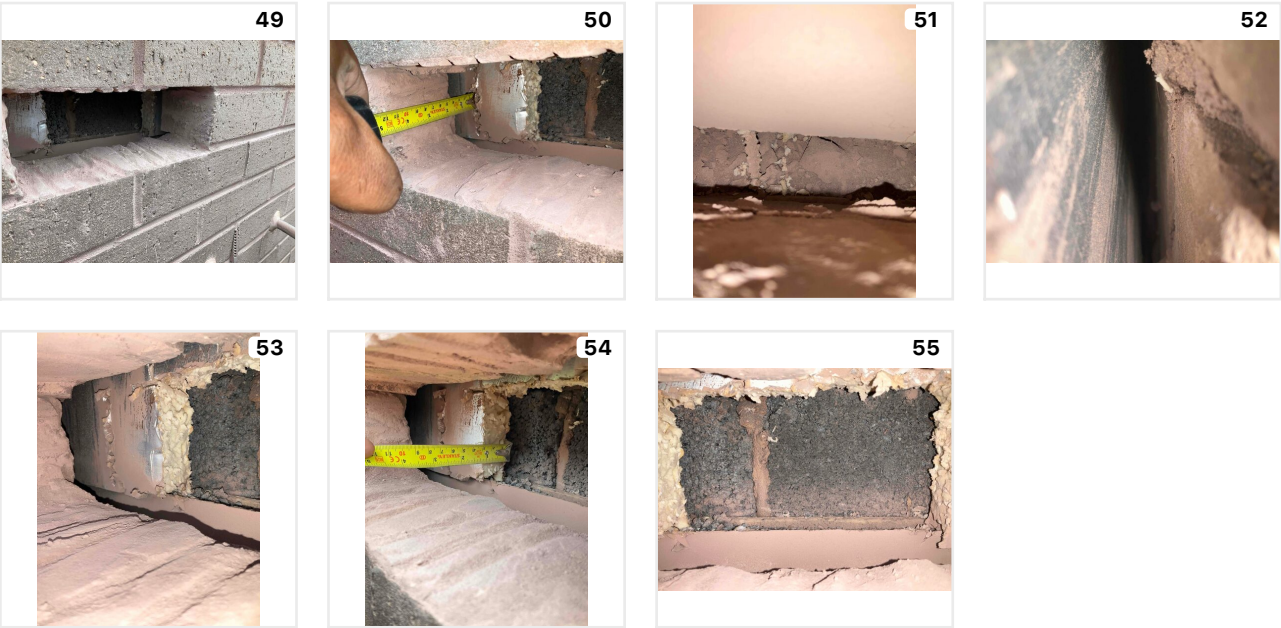
| 4 Elements | Thickness/Depth | Material | Photo Ref. | Rating (BS EN13501) |
| External Surface Material | 102mm | Brickwork | 49 | A1 - Non-Combustible |
| Cavity | 30mm | | 50, 51, 52 | |
| Insulation | 30mm | PIR Insulation | 53, 54 | F - Highly Combustible |
| Substrate | 100mm | Original blockwork | 55 | A1 - Non-Combustible |

No cavity barrier identified at this inspection location
