Document Version 1  
Survey Date 04/11/2024  
Suggested Review Date 04/11/2029

# EXTERNAL WALL SURVEY

## BOWATER HOUSE

Bowater House

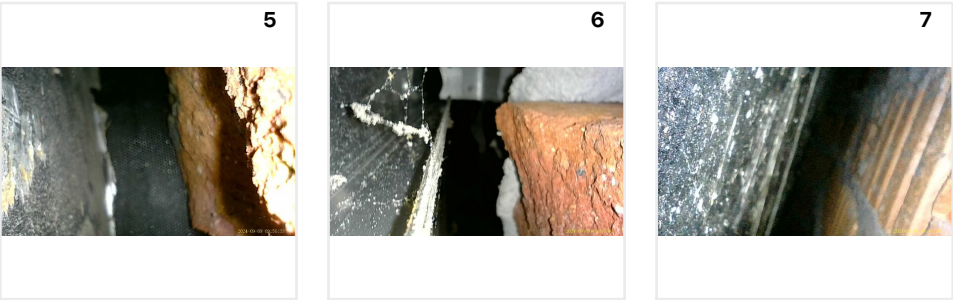
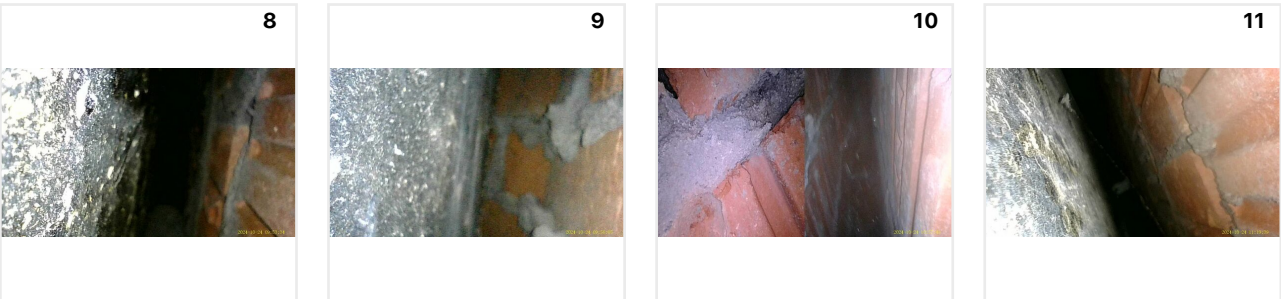
# Inspection: 9KE1FV

Wall Type 1 - Cavity Brickwork

The brickwork cavity is an open void between floor slabs

None

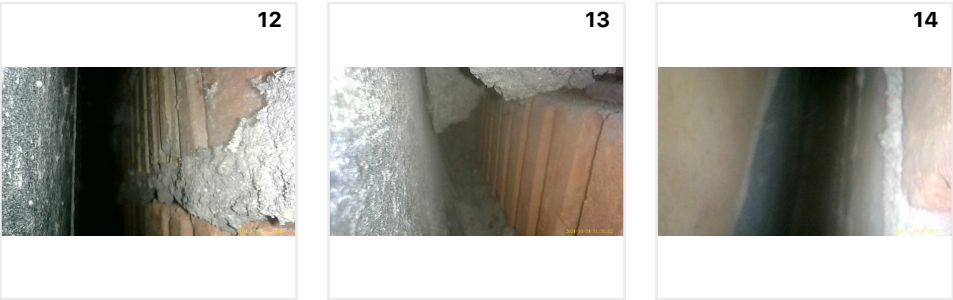
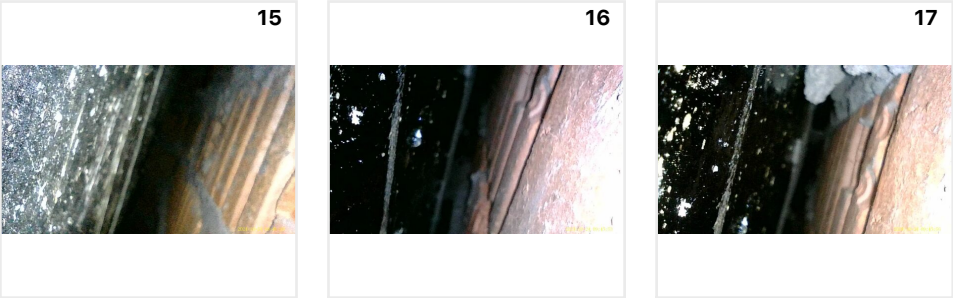
# Inspection: Q45DMQ

Wall Type 1 - Cavity Brickwork

The brickwork cavity is an open void between floor slabs

None

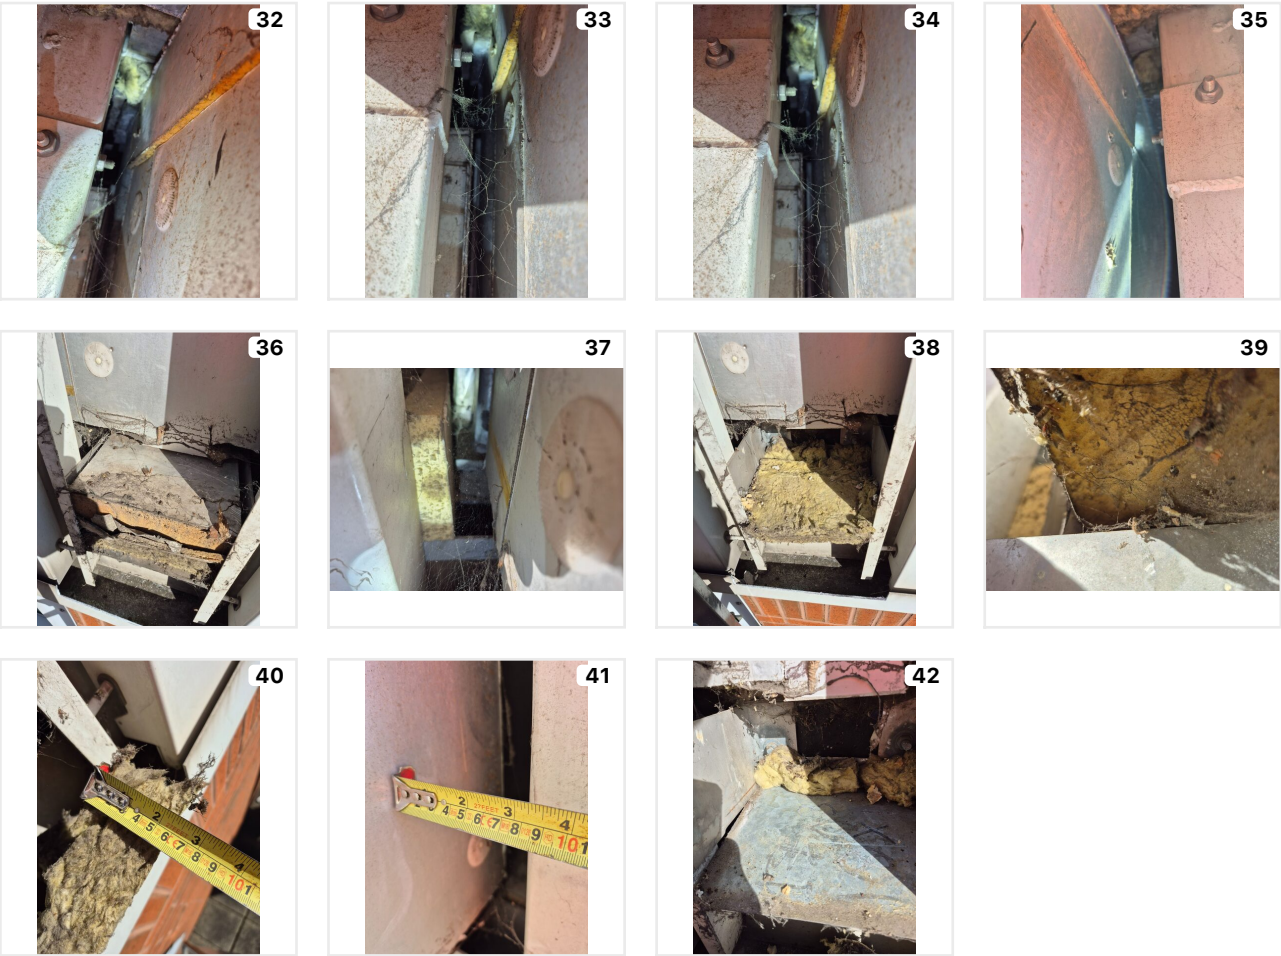
Backing Wall Sits On The Floor Slab
