# FIRE RISK APPRAISAL EXTERNAL WALLS

## BOWATER HOUSE

Moor Lane  
West Brom  
B70 7AW

03/03/2026, James Major (Facade Manager)

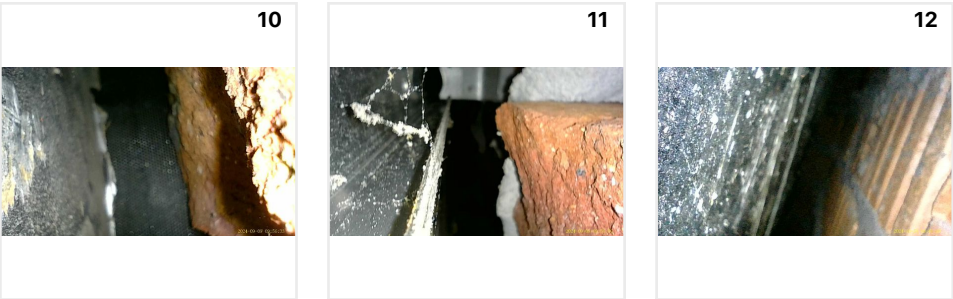
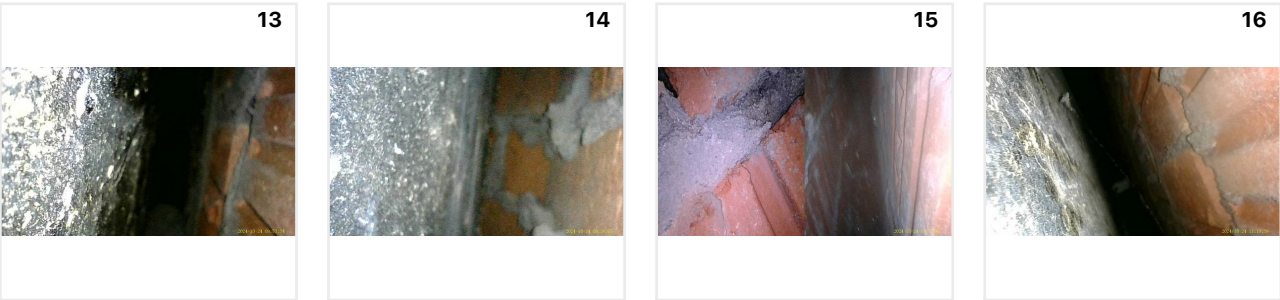
Backing Wall Sits On The Floor Slab

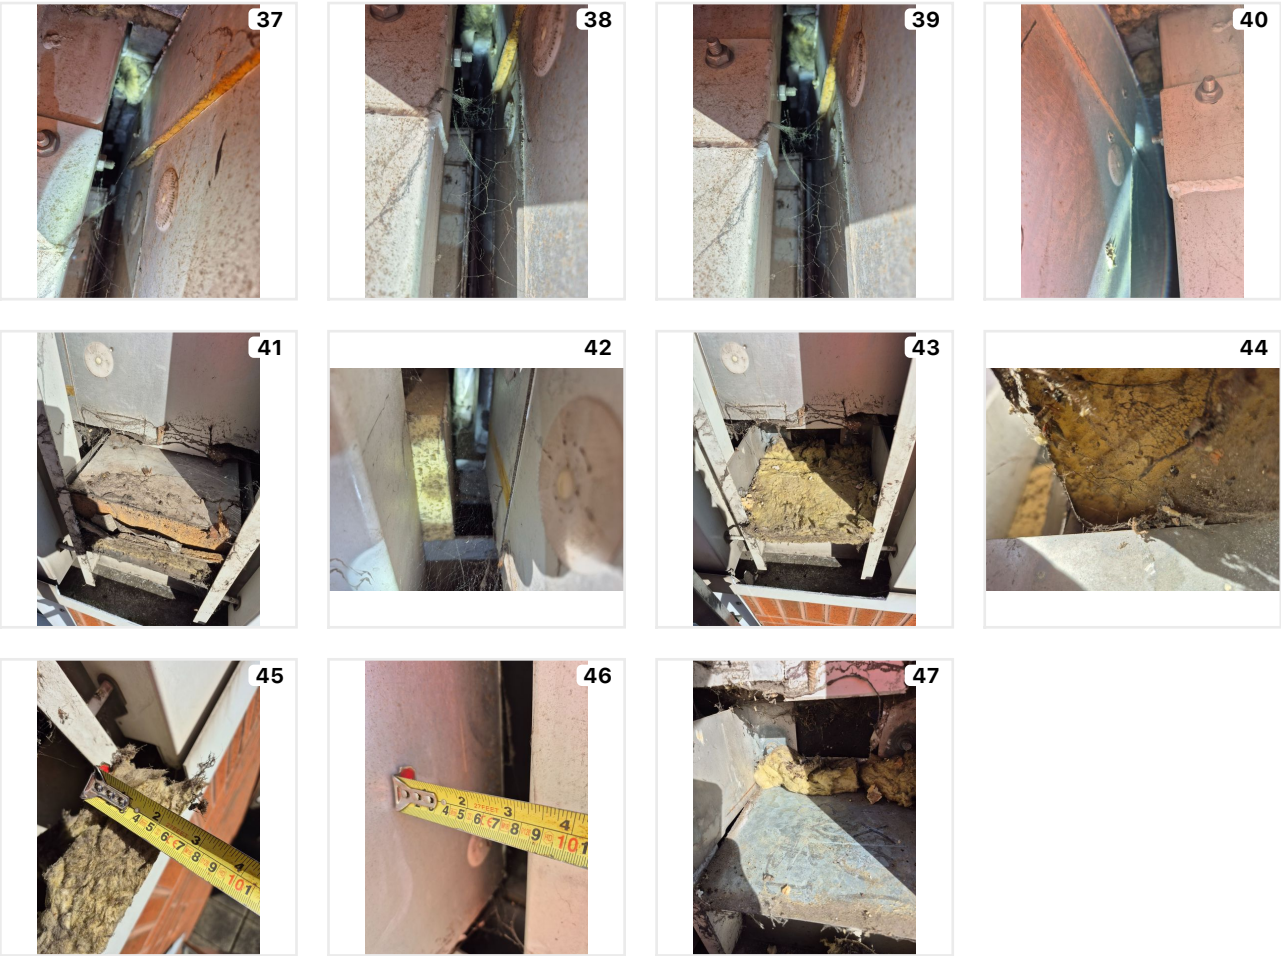
Backing Wall Sits On The Floor Slab

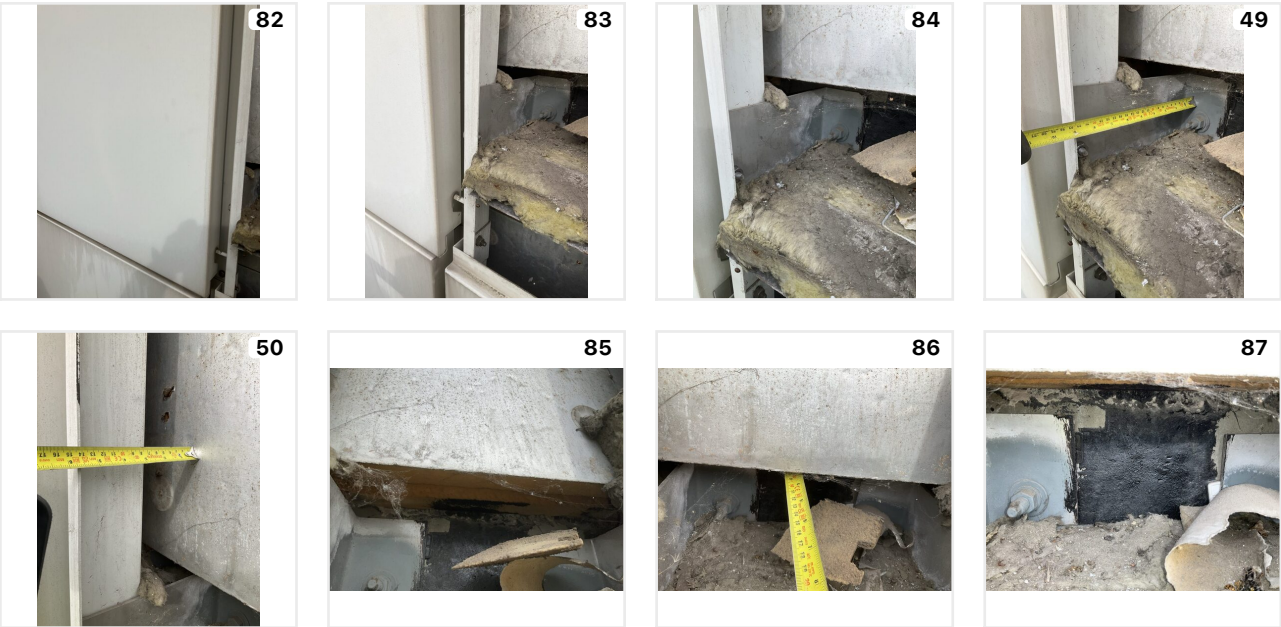
# Inspection: LTPZQB

Elevation • Location  
South Elevation • Cladding/PV Panel Interface

Loose fit in the cavity
