Document Version 3  
Survey Date 12/11/2024  
Suggested Review Date 12/11/2029

# EXTERNAL WALL SURVEY

## BRAYBROOK HOUSE

Braybrook House  
Moor Lane  
West Brom  
B70 7AU

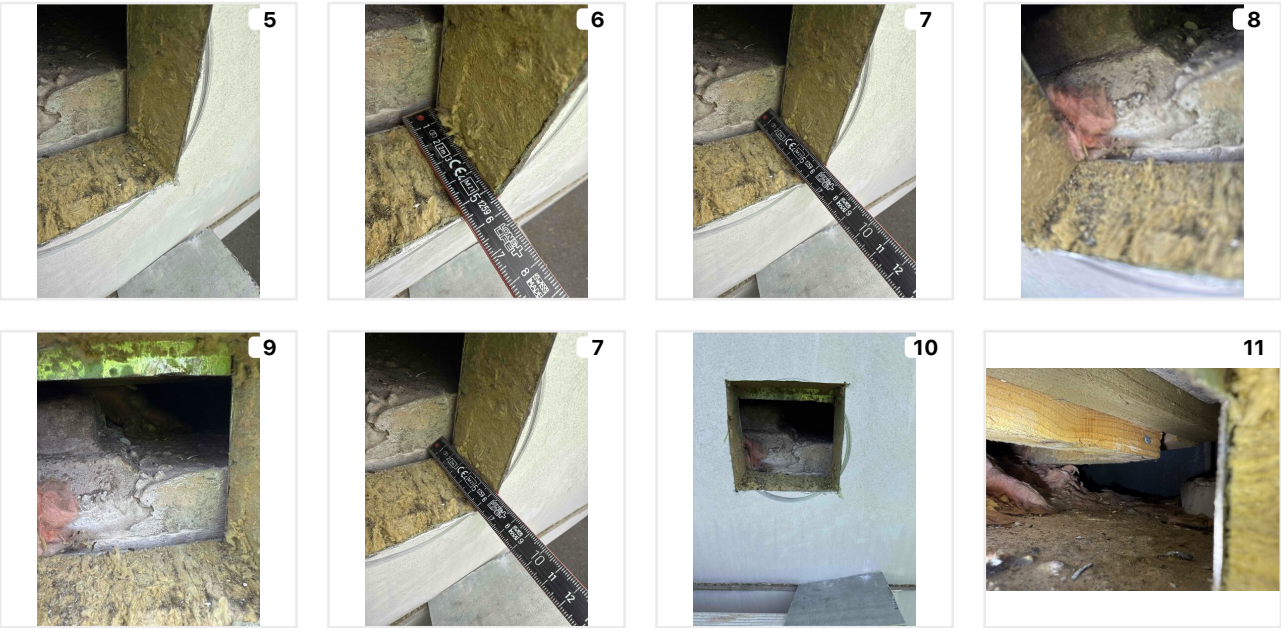
| 4 Elements | Thickness/Depth | Material | Photo Ref. | Rating (BS EN13501) |
|---|---|---|---|---|
| Surface Finish | 55mm | Aluminium panel with rockwool then a steel panel on the back | 5, 6, 7, 8, 9 | A1 - Non-Combustible |
| Aluminium panel<br>Rockwool<br>Steel panel<br><br>Slab timber frame makeup to bottom of window cill<br><br>There is an 8 mm gap behind the cladding panel to slab edge | | | | |
| Insulation | 50mm | Mineral Wool Insulation | 7 | A1 - Non-Combustible |
| Surface Finish | | Sheet Metal | 10 | A1 - Non-Combustible |
| Cavity Support Frame | | Timber Batten | 11 | D - Highly Combustible |

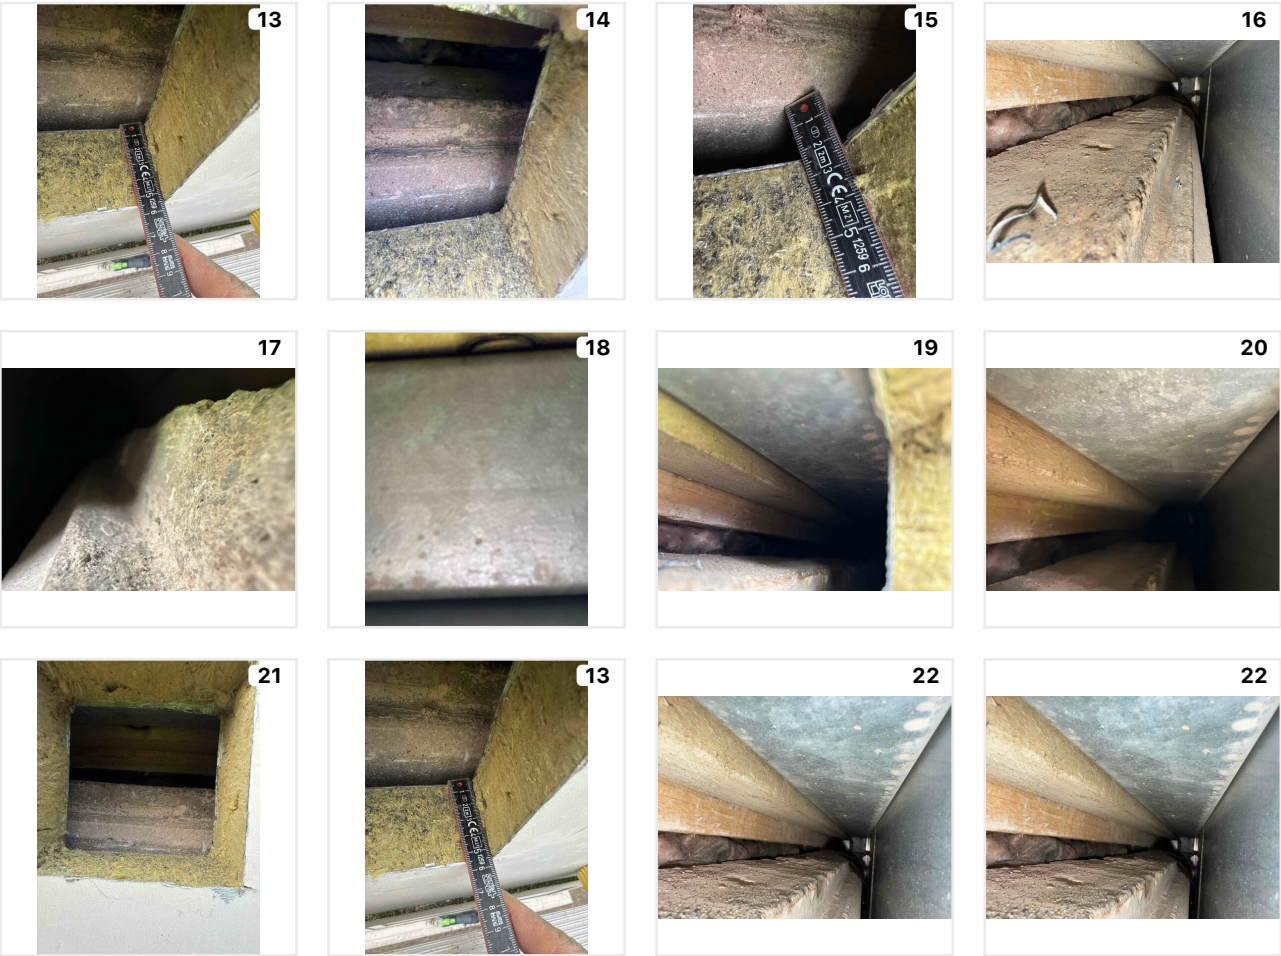
| 4 Elements | Thickness/Depth | Material | Photo Ref. | Rating (BS EN13501) |
|---|---|---|---|---|
| Surface Finish | 2mm | Aluminium panel<br>rockwool steel panel | 13, 14, 15, 16,<br>17, 18, 19, 20,<br>21 | A1 - Non-Combustible |
| Aluminium panel bonded to rockwool then a steel panel | | | | |
| Slab to panel 23mm gap | | | | |
| A steel beam above slab 80mm from timber to back of panel | | | | |
| Insulation | 50mm | Mineral Wool Insulation | 13 | A1 - Non-Combustible |
| Surface Finish | 2mm | Sheet Metal | 22 | A1 - Non-Combustible |
| Cavity Support<br>Frame | | Timber Batten | 22 | D - Highly Combustible |

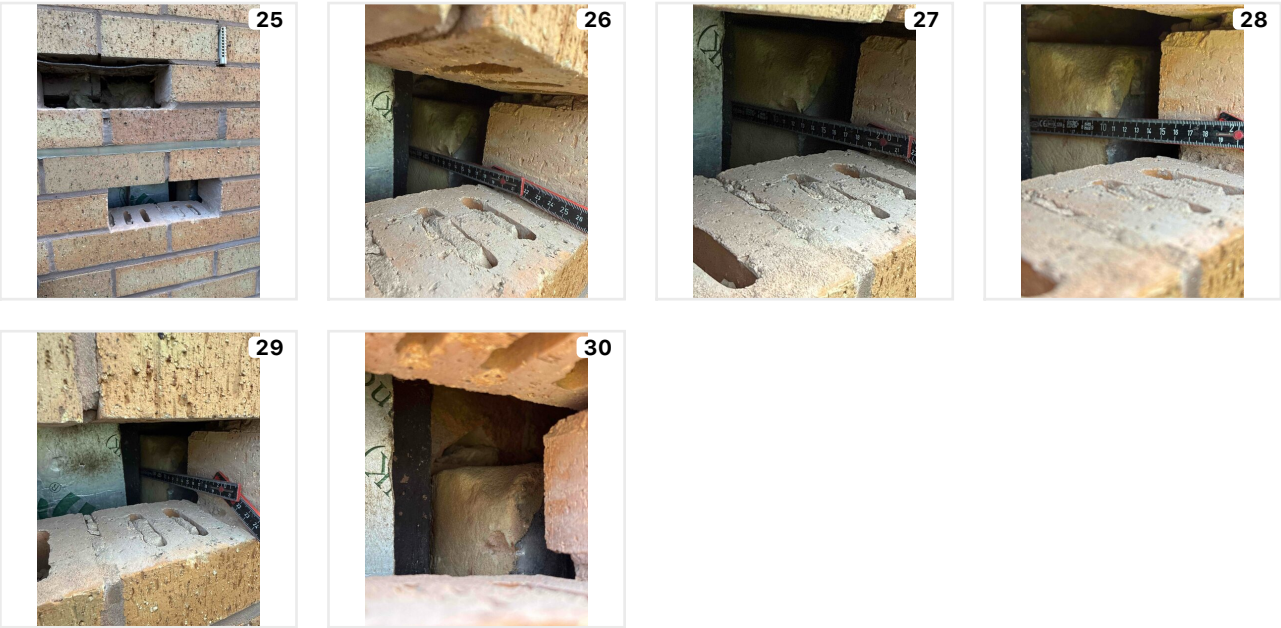
| 4 Elements | Thickness/Depth | Material | Photo Ref. | Rating (BS EN13501) |
|---|---|---|---|---|
| Surface Finish | 100mm | Brickwork | 25 | A1 - Non-Combustible |
| Cavity | 170mm | | 26, 27 | |
| Insulation | 100mm | PIR Insulation<br>Material Brand:<br>Kingspan | 28, 29 | C - Combustible |
| Inner Leaf | 100mm | Blockwork | 30 | A1 - Non-Combustible |

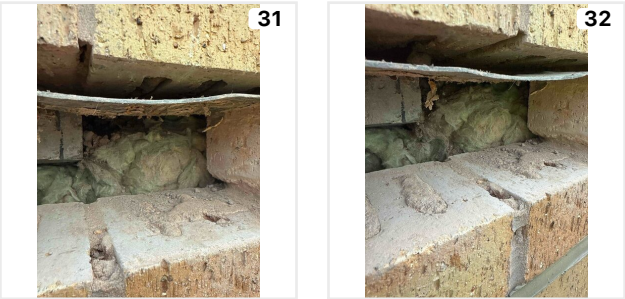
| 1 Cavity Barrier | Material | Photo Ref. |
|---|---|---|
| Horizontal Cavity Barrier | Loose fill mineral wool at slab | 31, 32 |

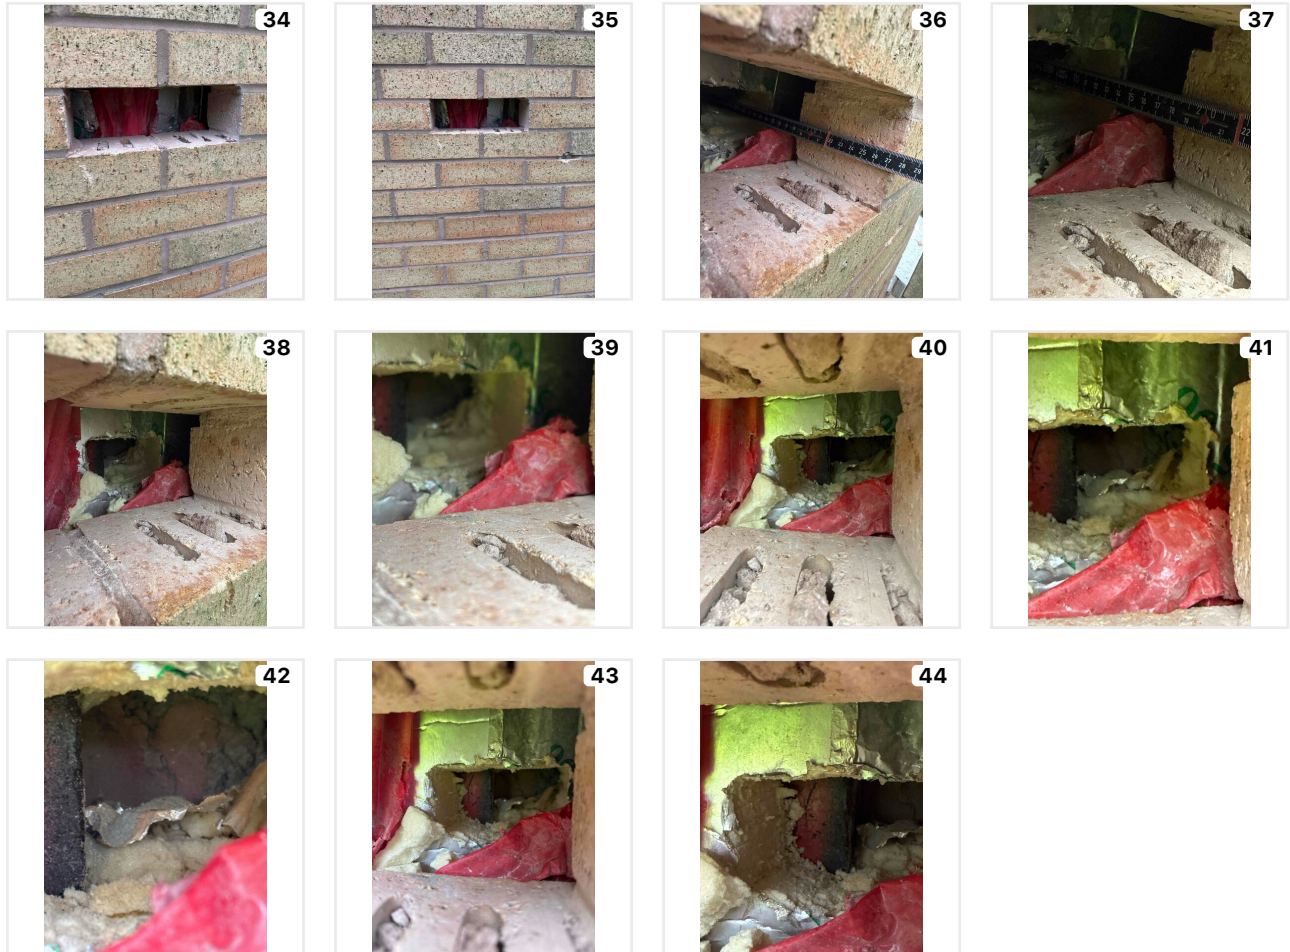
| Outer leaf | 100mm | | 34, 35 | A1 - Non-Combustible |

Brick

| Cavity | 180mm | | 36, 37 | |

| Insulation | 100mm | PIR Insulation<br>Material Brand:<br>Kingspan | 38, 39, 40 | C - Combustible |

| Inner Leaf | 100mm | Blockwork | 41, 42 | A1 - Non-Combustible |

| Other | | | 43, 44 | A1 - Non-Combustible |

Steel column in cavity with pir covering the steel

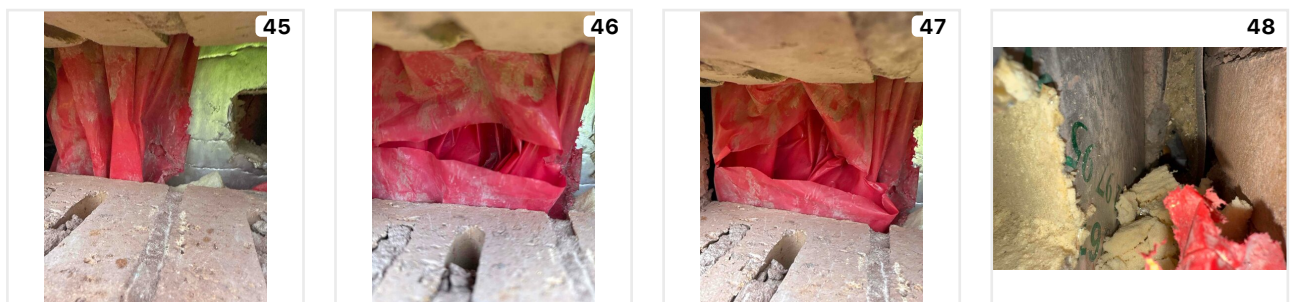
| Vertical Cavity Barrier | Cavity Sock | 45, 46, 47, 48,<br>49, 50, 51 |

Cavity sock is on top of PIR and to back of brickwork but there is no mineral wool inside this section of vertical barrier also window jam see pic
