Document Version 5  
Survey Date 19/02/2025  
Suggested Review Date 19/02/2030

# FIRE RISK APPRAISAL EXTERNAL WALLS

## BRAYBROOK HOUSE

Braybrook House  
Moor Lane  
West Brom  
B70 7AU

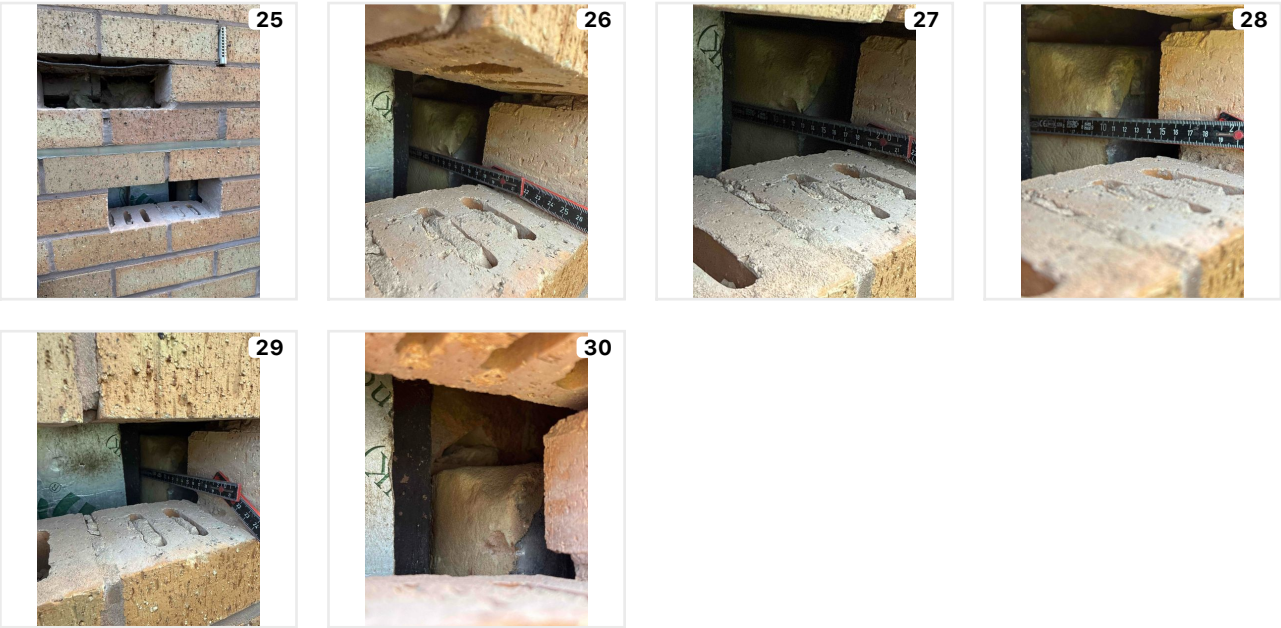
Backing Wall Sits On The Floor Slab

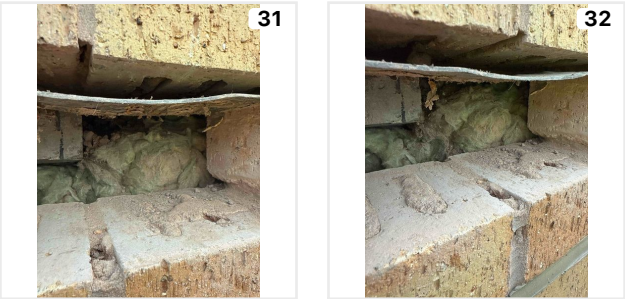
| 1 Cavity Barrier | Material | Photo Ref. |
|---|---|---|
| Horizontal Cavity Barrier | Loose fill mineral wool at slab | 31, 32 |
