**FIRNTEC**  
BUILDING COMPLIANCE

# EXTERNAL WALL SURVEY

## BROADMEDE HOUSE

Broadmede House  
Pavilion Avenue  
Smethwick  
West Midlands  
B67 6LB

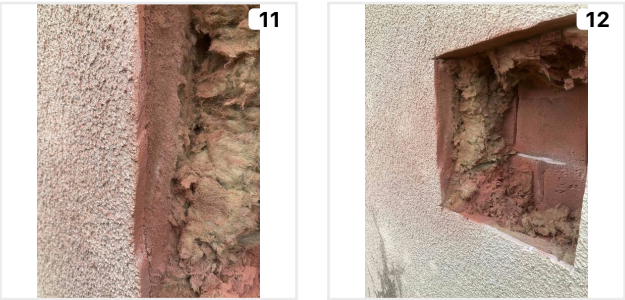
| 4 Elements | Thickness/Depth | Material | Photo Ref. | Rating (BS EN13501) |
| External Surface Material | 1mm | Render | | A1 - Non-Combustible |
| Outer leaf | 3mm | | 11 | |
| Insulation | 100mm | Mineral Wool Insulation | 12 | A1 - Non-Combustible |
| Substrate | 102mm | Original brickwork | | A1 - Non-Combustible |

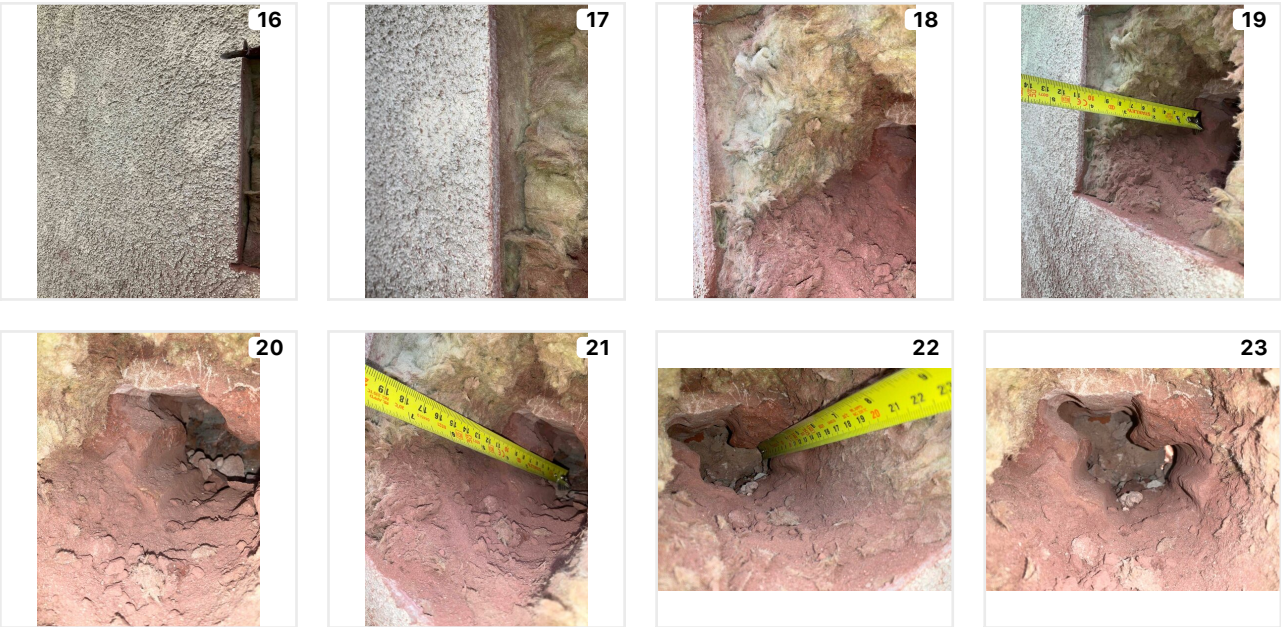
| 6 Elements | Thickness/Depth | Material | Photo Ref. | Rating (BS EN13501) |
| External Surface Material | 2mm | Render | 16 | A1 - Non-Combustible |
| Outer leaf | 3mm | | 17 | A1 - Non-Combustible |
| Insulation | 100mm | Mineral Wool Insulation | 18, 19 | A1 - Non-Combustible |
| Substrate | 102mm | Original brickwork | 20, 21 | A1 - Non-Combustible |
| Cavity | 60mm | | 22 | |
| Inner Leaf | | Blockwork | 23 | A1 - Non-Combustible |

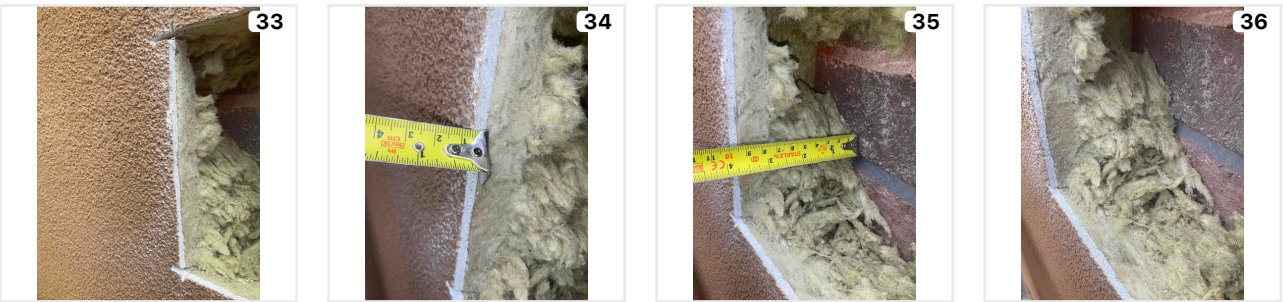
| 4 Elements | Thickness/Depth | Material | Photo Ref. | Rating (BS EN13501) |
| External Surface Material | 1mm | Render | 33 | A1 - Non-Combustible |
| Outer leaf | 3mm | | 34 | A1 - Non-Combustible |
| Insulation | 95mm | Mineral Wool Insulation | 35, 36 | A1 - Non-Combustible |
| Attached via mechanical fixers | | | | |
| Substrate | 102mm | Original brickwork | 37 | A1 - Non-Combustible |
