# FIRE RISK APPRAISAL EXTERNAL WALLS

## BROADMEDE HOUSE

Broadmede House  
Pavilion Avenue  
Smethwick  
West Midlands  
B67 6LB

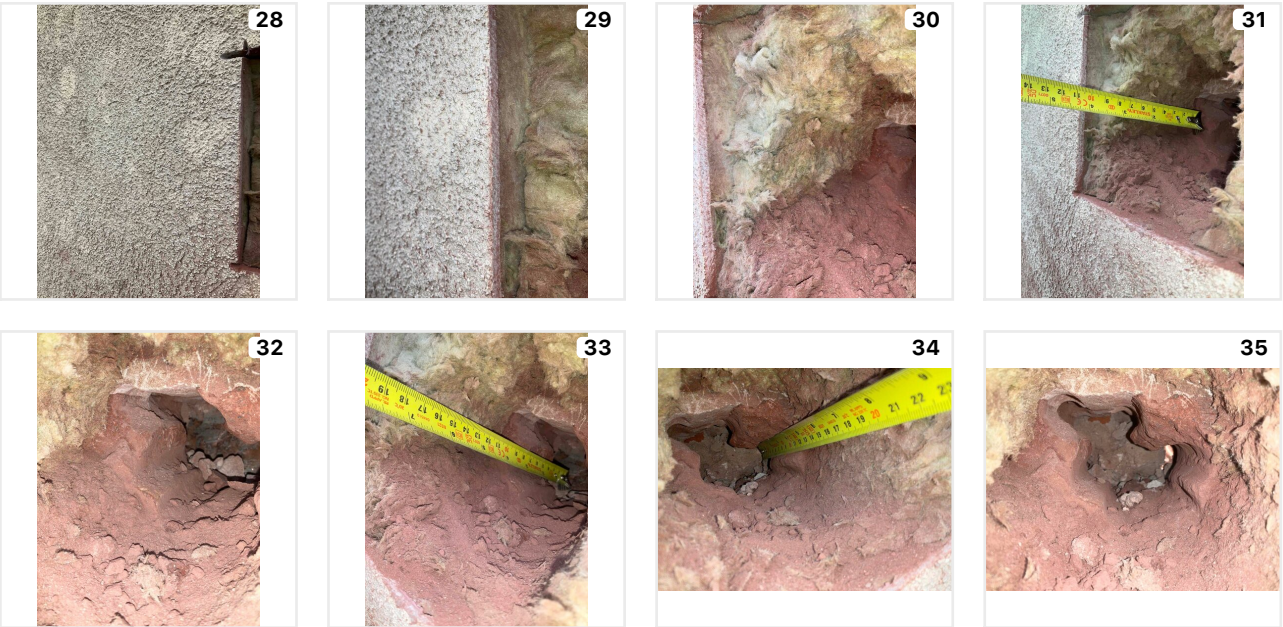
## Build-up Photos

Backing Wall Sits On The Floor Slab
