Document Version 3  
Survey Date 04/11/2024  
Suggested Review Date 04/11/2029

# EXTERNAL WALL SURVEY

## BROOKVIEW

Brookview  
Stanhope Road  
Semethwick  
West Midlands  
B67 6HG

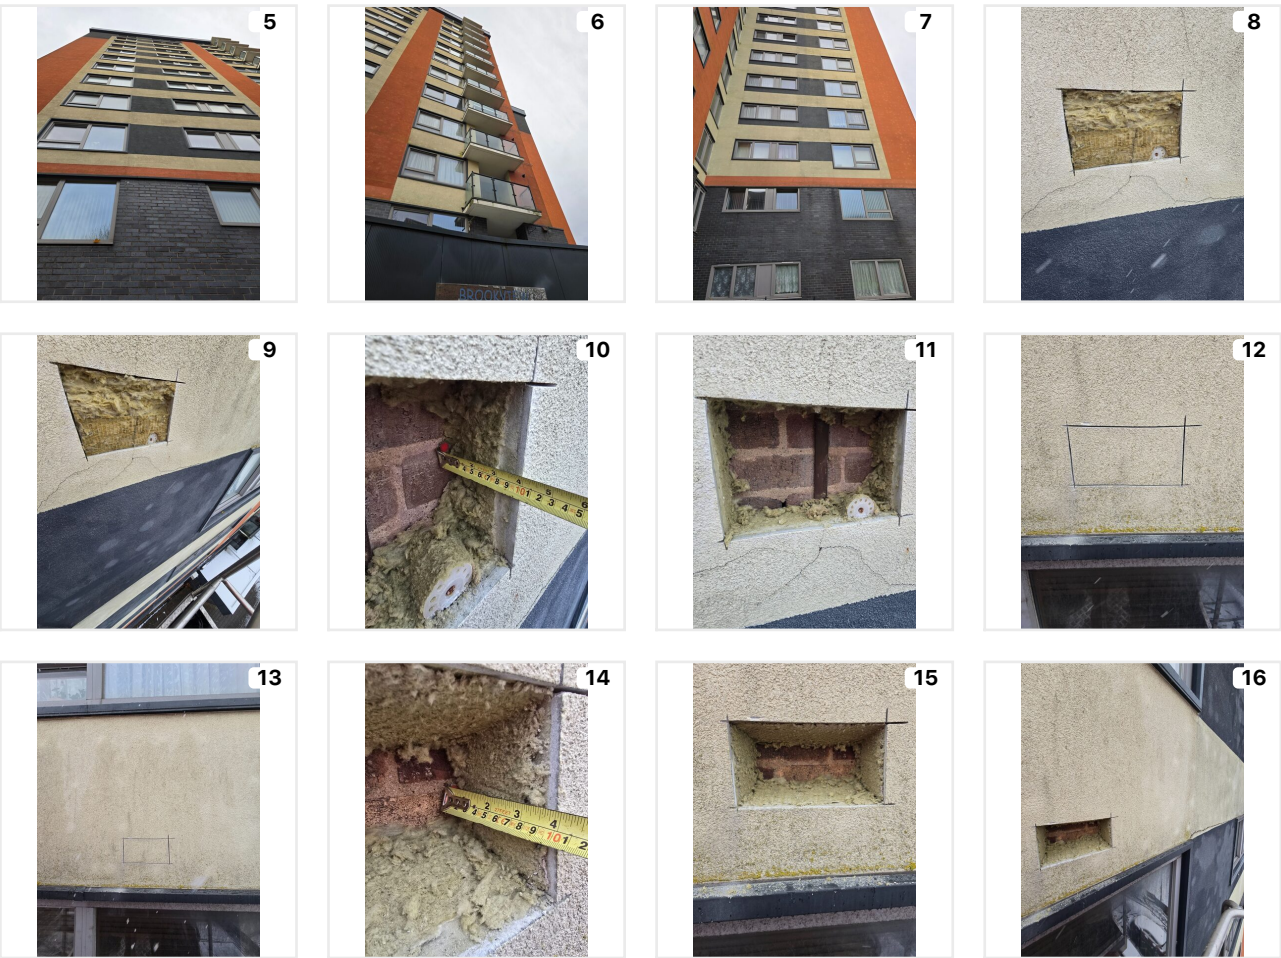
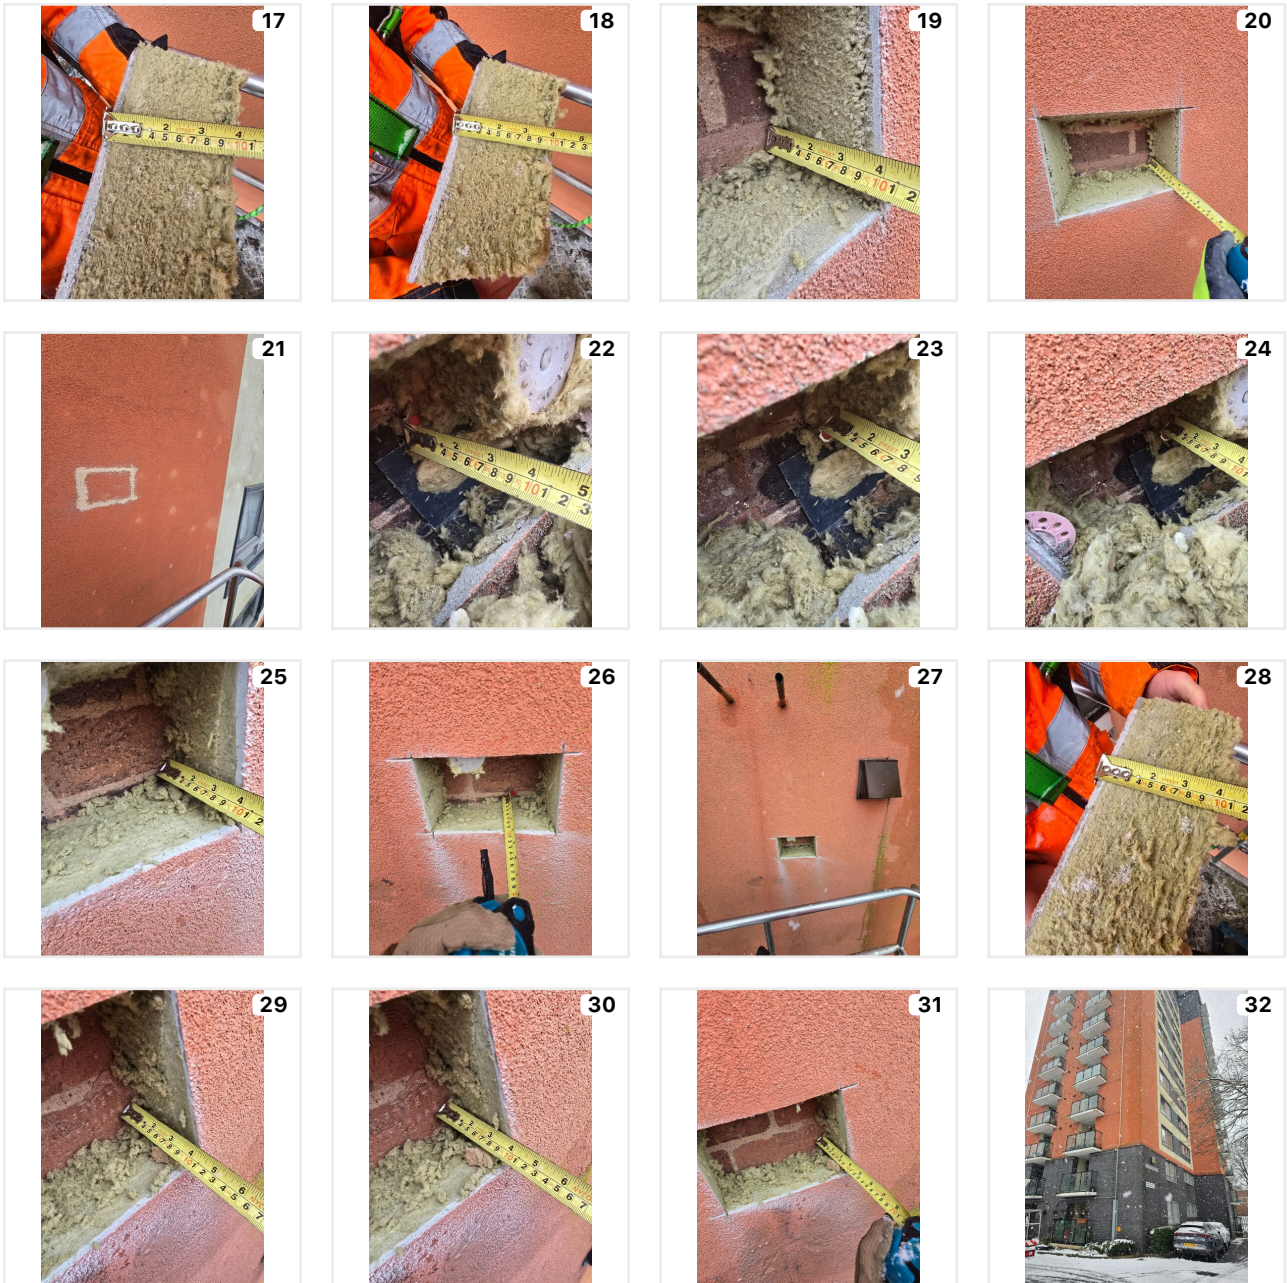
# Inspection: VDEYHC

Wall Type 1 - (EWI) render over mechanically fixed mineral wool attached to original brickwork

Insulation with a render finish has been added to the original construction

There is no external wall cavity

Backing Wall Sits On The Floor Slab

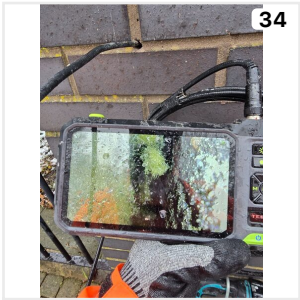
Backing Wall Sits On The Floor Slab
