Document Version 4

# EXTERNAL WALL SURVEY

## BROOME HOUSE

Beaconview House  
Beaconview Road  
West Brom  
B71 3PL

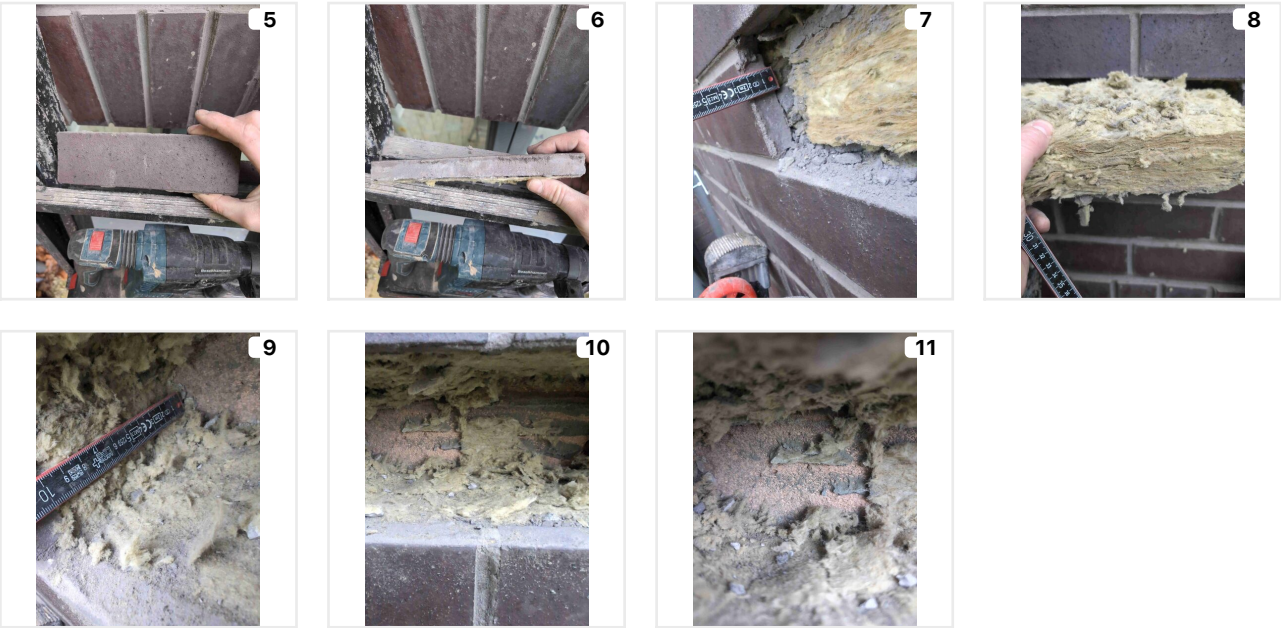
# Inspection: VMV16R

| 3 Elements | Thickness/Depth | Material | Photo Ref. | Rating (BS EN13501) |
|---|---|---|---|---|
| Surface Finish | 20mm | Brick Slip / Brick Tile | 5, 6, 7 | A1 - Non-Combustible |
| Insulation | 90mm | Mineral Wool Insulation | 8, 9 | A1 - Non-Combustible |
| Inner Leaf | | Reinforced concrete | 10, 11 | A1 - Non-Combustible |

| 1 Cavity Barrier | Material | Photo Ref. |
|---|---|---|
| Horizontal Cavity Barrier | Solid State Mineral Wool | |

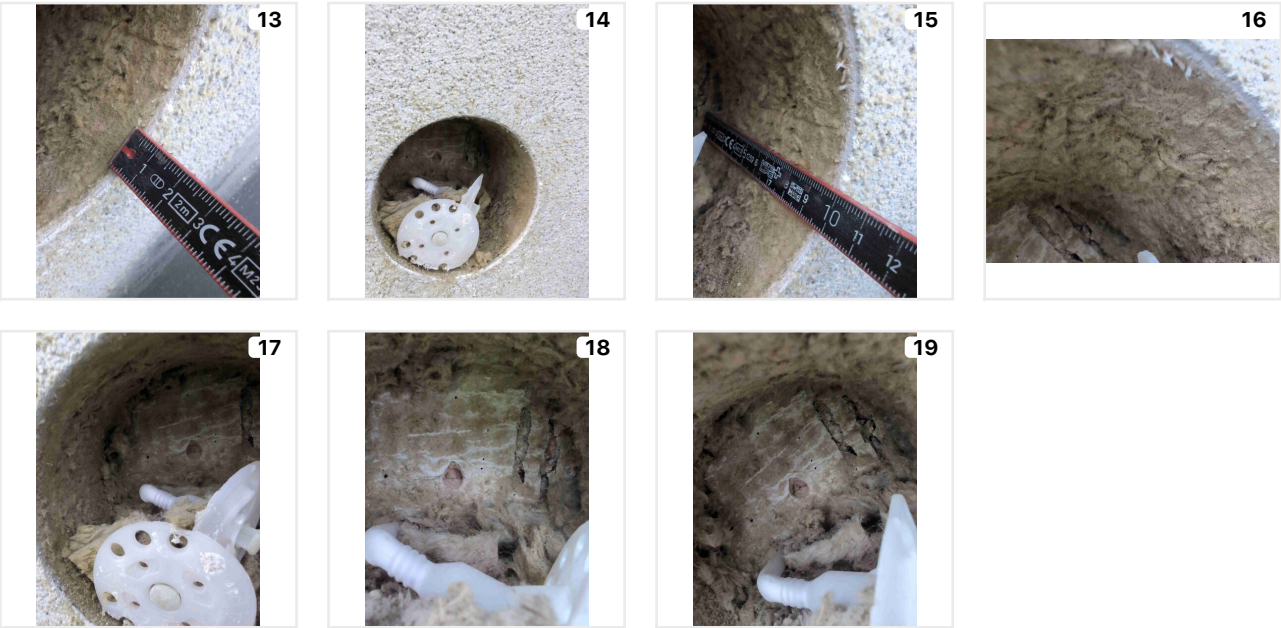
# Inspection: JZAARV

| 3 Elements | Thickness/Depth | Material | Photo Ref. | Rating (BS EN13501) |
|---|---|---|---|---|
| Surface Finish | 4mm | Sto render | 13, 14 | A1 - Non-Combustible |
| Insulation | 90mm | Mineral Wool Insulation | 15, 16, 17 | A1 - Non-Combustible |
| Inner Leaf | | Reinforced concrete | 18, 19 | A1 - Non-Combustible |

| 1 Cavity Barrier | Material | Photo Ref. |
|---|---|---|
| Horizontal Cavity Barrier | Solid State Mineral Wool | |

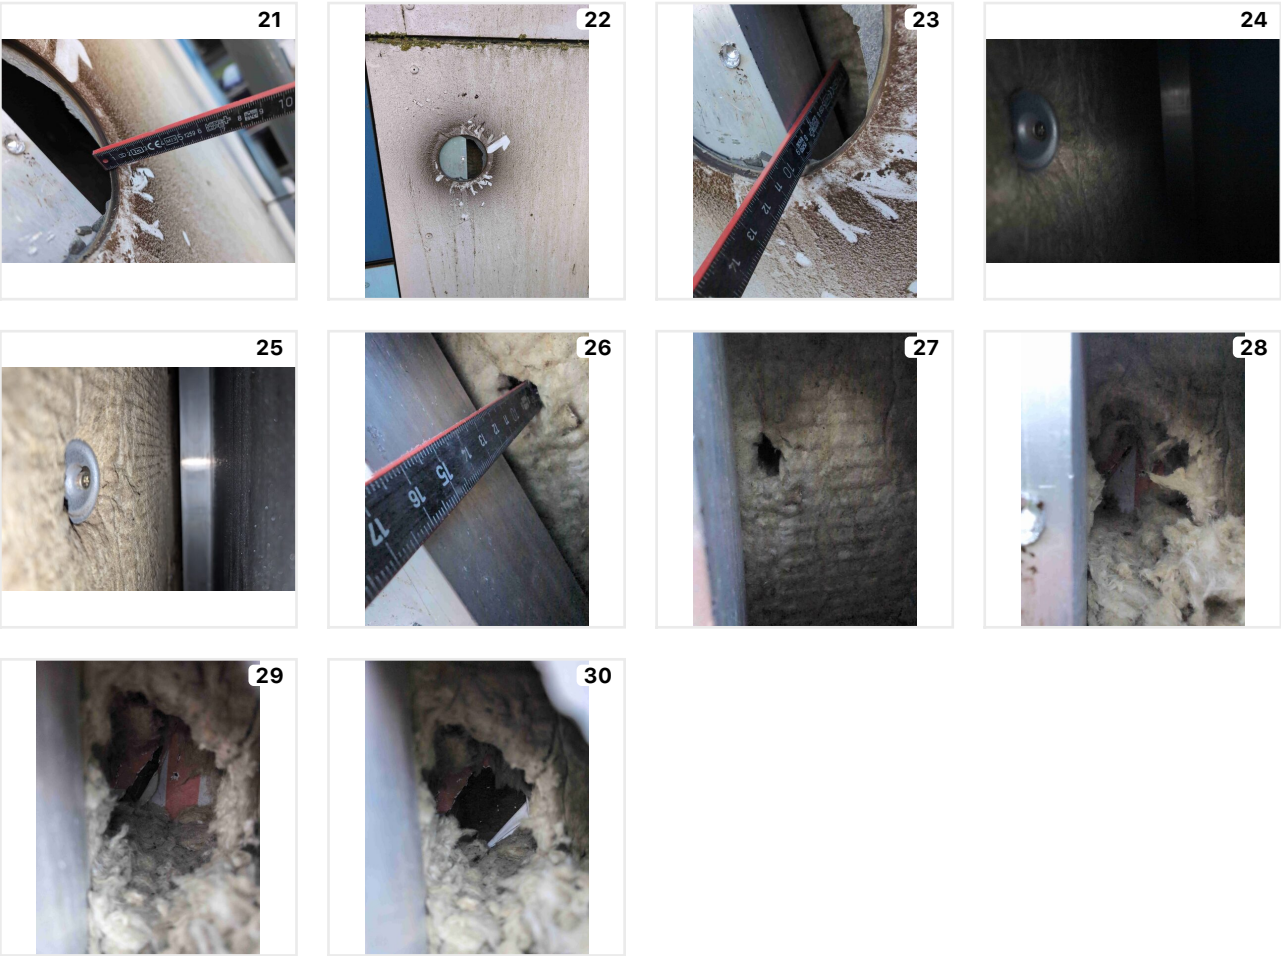
# Inspection: 9QJBQA

| 4 Elements | Thickness/Depth | Material | Photo Ref. | Rating (BS EN13501) |
|---|---|---|---|---|
| Surface Finish | 8mm | Suspected High Pressure Laminate (HPL) Panel<br>Material Brand: TRESPA METEON | 21, 22 | D - Highly Combustible |
| Cavity | 85mm | | 23, 24, 25 | |
| Insulation | 80mm | Mineral Wool Insulation | 26, 27 | A1 - Non-Combustible |
| Inner Leaf | | Blockwork | 28, 29, 30 | A1 - Non-Combustible |

Installed

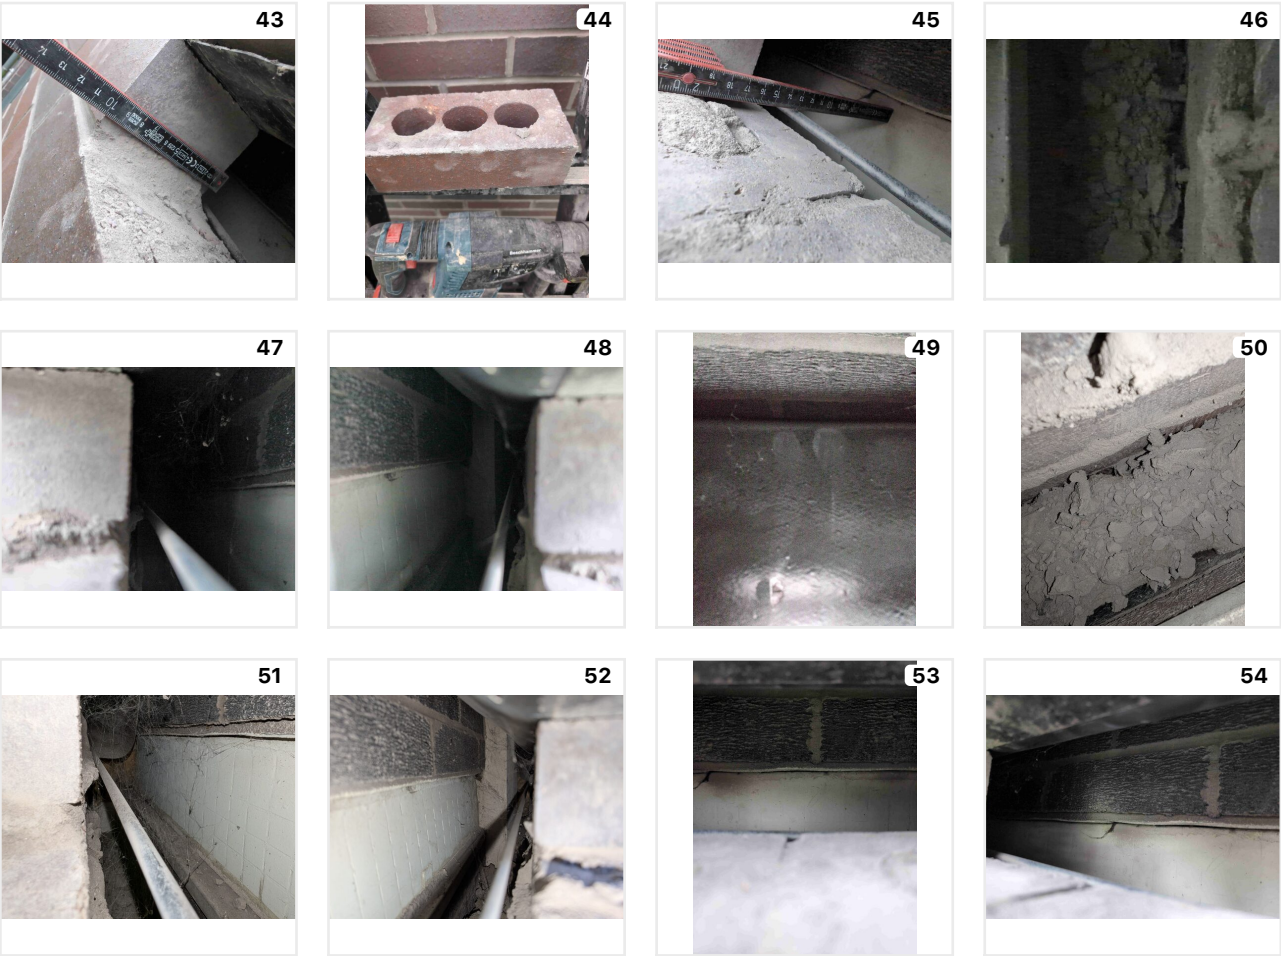
# Inspection: USP71K

| 3 Elements | Thickness/Depth | Material | Photo Ref. | Rating (BS EN13501) |
|---|---|---|---|---|
| Surface Finish | 100mm | Brickwork | 43, 44 | A1 - Non-Combustible |
| Cavity | 150mm | | 45, 46, 47, 48, 49, 50, 51, 52 | |
| Inner Leaf | | Blockwork | 53, 54 | A1 - Non-Combustible |

None
