Survey Date 02/05/2025

# EXTERNAL WALL SURVEY

## FARLEY STREET

West Brom  
DY4 7LA

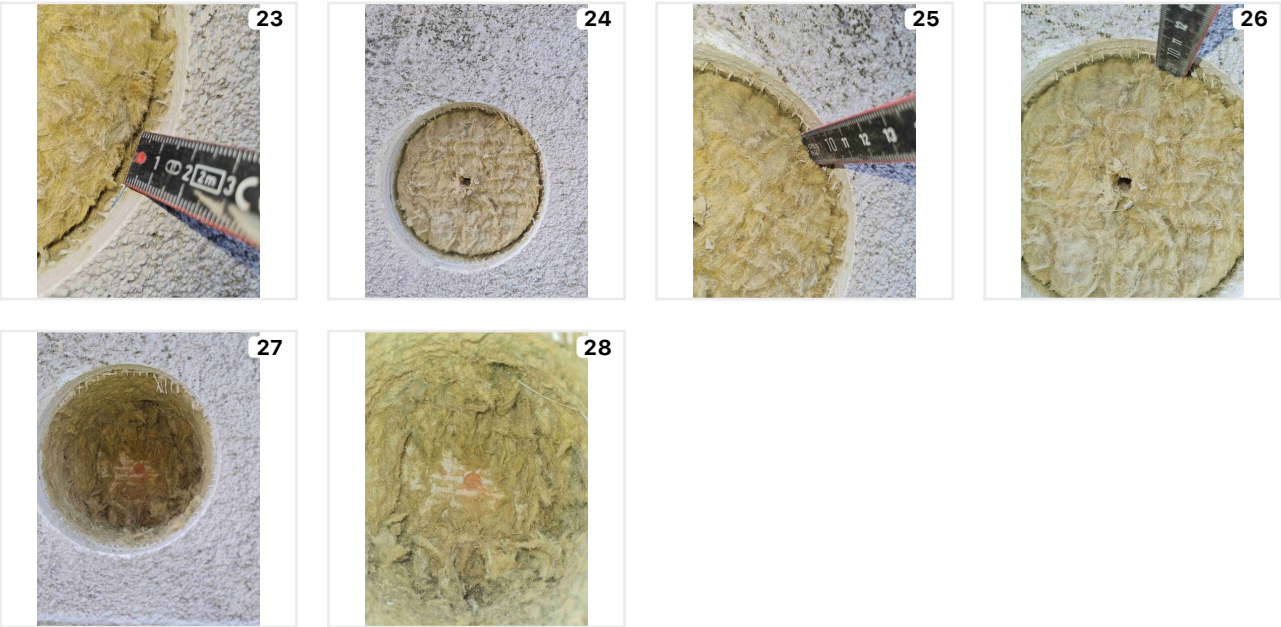
| 3 Elements | Thickness/Depth | Material | Photo Ref. |
|---|---|---|---|
| Surface Finish | 9mm | Sto render | 23, 24 |
| Insulation | 90mm | Mineral wool | 25, 26 |
| Inner Leaf | | Concrete wall | 27, 28 |

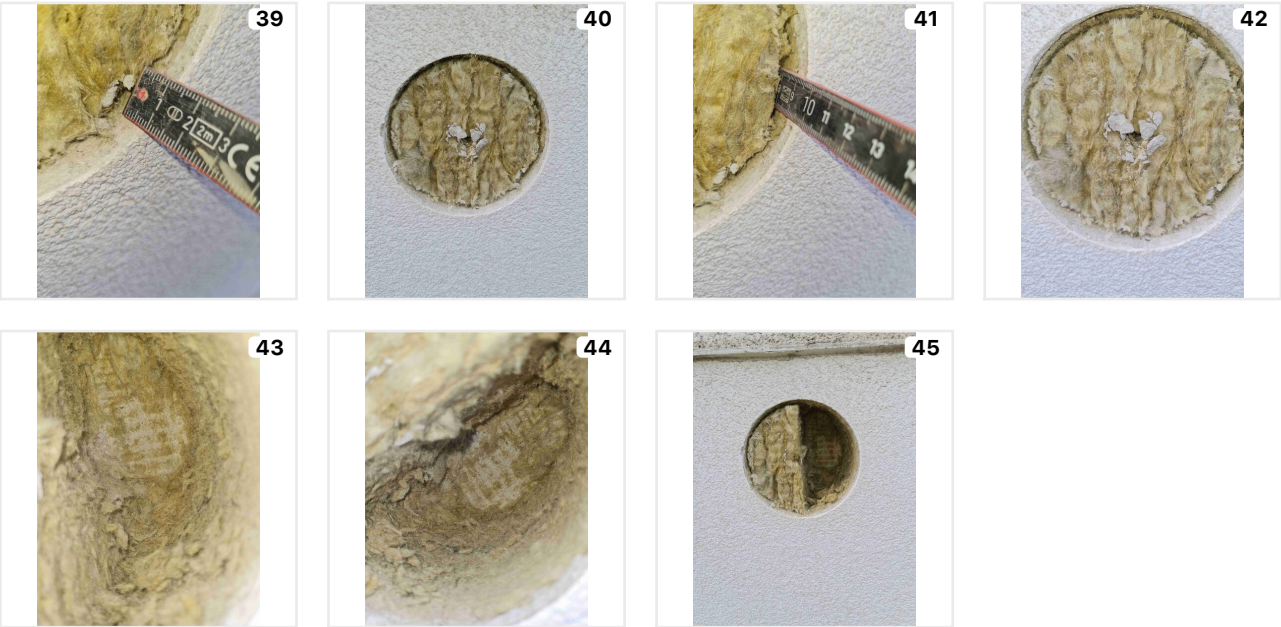
| 3 Elements | Thickness/Depth | Material | Photo Ref. |
|---|---|---|---|
| Surface Finish | 9mm | Sto render | 39, 40 |
| Insulation | 90mm | Mineral wool | 41, 42 |
| Inner Leaf | | Concrete wall | 43, 44, 45 |

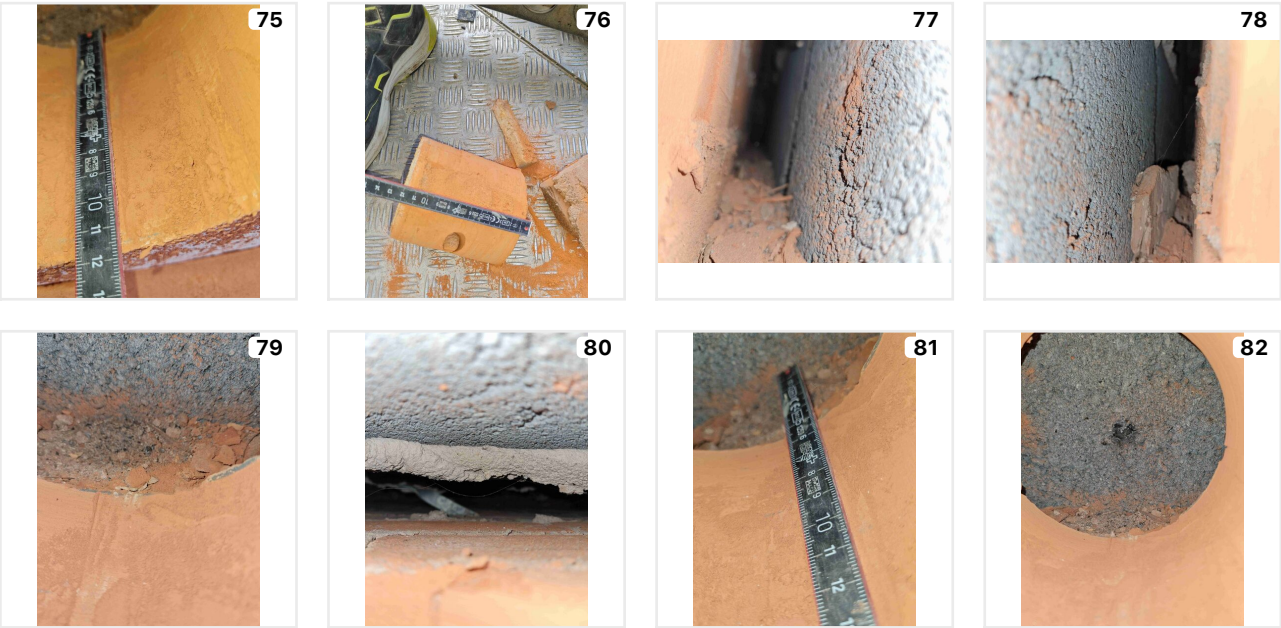
| 3 Elements | Thickness/Depth | Material | Photo Ref. |
|---|---|---|---|
| Surface Finish | 120mm | Block render | 75, 76 |
| Cavity | 55mm | | 77, 78, 79, 80, 81 |
| Inner Leaf | | Blockwork | 82, 83 |

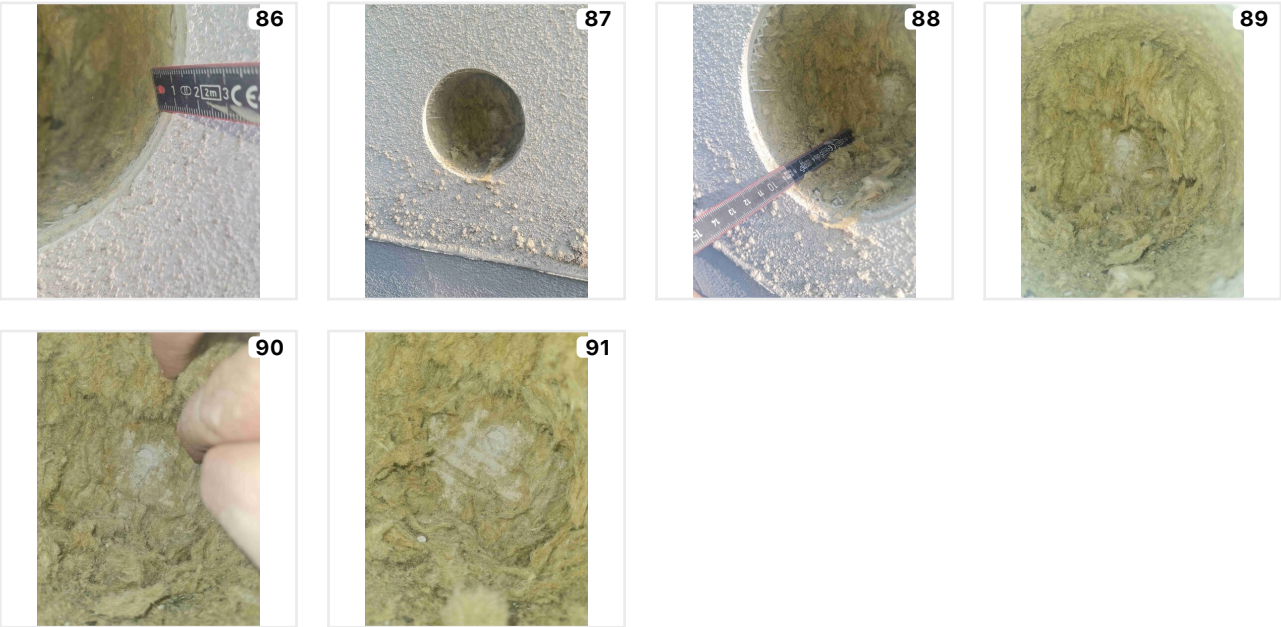
| 3 Elements | Thickness/Depth | Material | Photo Ref. |
|---|---|---|---|
| Surface Finish | 9mm | Sto render | 86, 87 |
| Insulation | 90mm | Mineral wool | 88, 89 |
| Inner Leaf | | Concrete wall | 90, 91 |
