Survey Date 24/08/2024

# PAS 9980 STEP 2-5 (FRAEW)

## GREENFORD HOUSE

Greenford House  
Maria Street  
West Brom  
B70 6DX

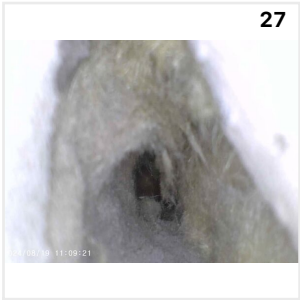
Backing Wall Sits On The Floor Slab
