Document Version 3  
Survey Date 05/11/2024  
Suggested Review Date 05/11/2029

# EXTERNAL WALL SURVEY

## HACKWOOD HOUSE

Hackwood House  
Hartlebury Road  
Oldbury  
West Midlands  
B69 1EG

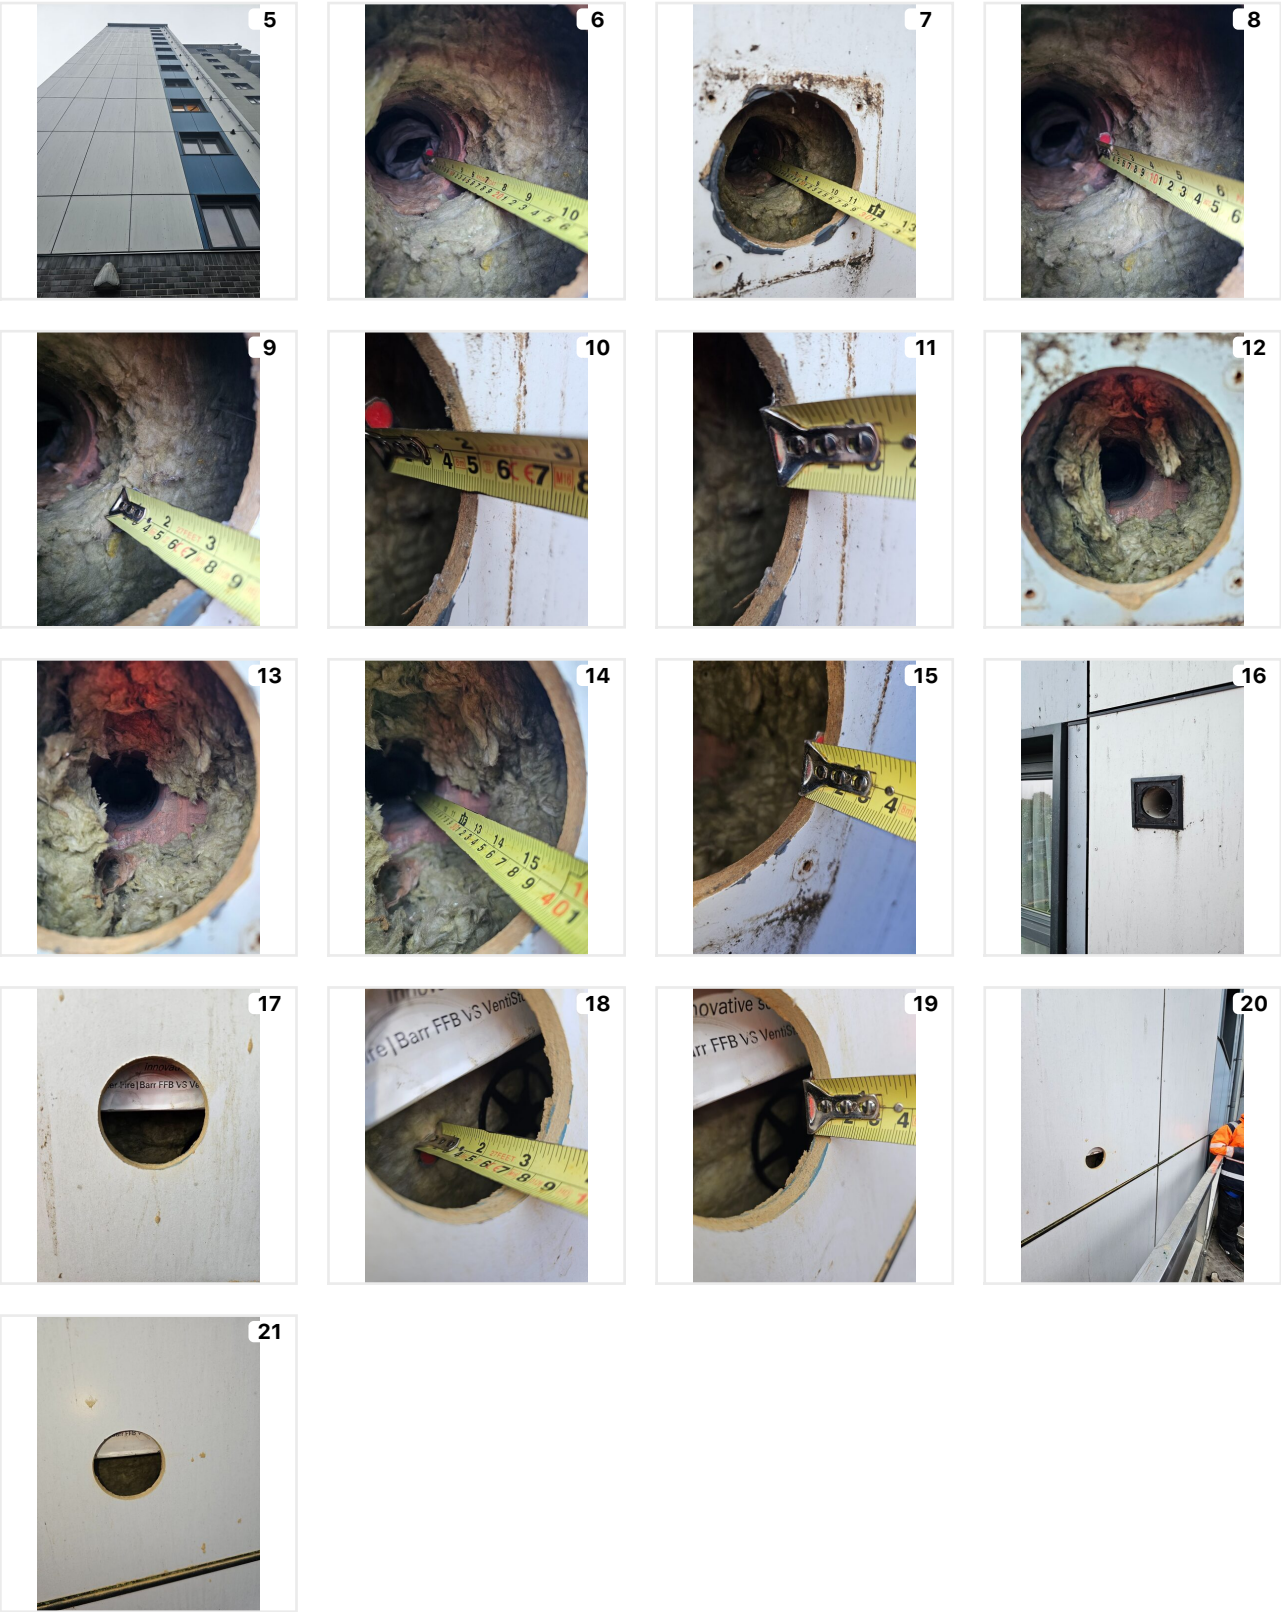
# Inspection: 1XUPXZ

Wall Type 1 - Rainscreen cladding

| 3 Elements | Thickness/Depth | Material | Photo Ref. | Rating (BS EN13501) |
|---|---|---|---|---|
| Surface Finish | 10mm | A1 rated rainscreen mineral based panel | | A1 - Non-Combustible |
| Insulation | 100mm | Mineral Wool Insulation | | A1 - Non-Combustible |

The insulation has the appearance of Rockwool Duo Slab

| 1 Cavity Barrier | Material | Photo Ref. |
|---|---|---|
| Horizontal Cavity Barrier | Open State Cavity Barrier | |

Floor Slab Abuts The Backing Wall

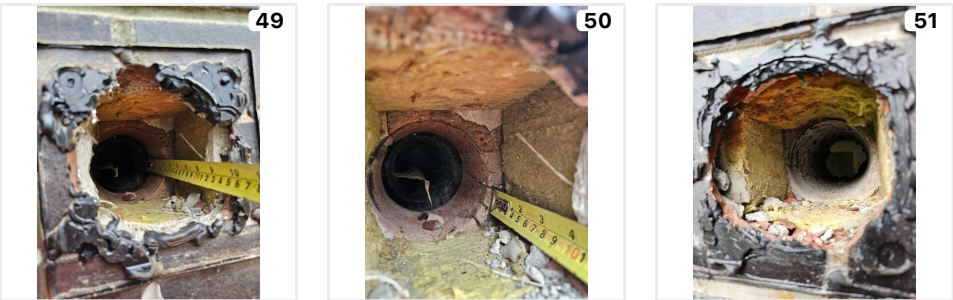
# Inspection: YXVMCR

Wall Type 2 - Brick slip system over mineral wool insulation

| 2 Elements | Thickness/Depth | Material | Photo Ref. | Rating (BS EN13501) |
|---|---|---|---|---|
| Surface Finish | 15mm | Brick Slip / Brick Tile | | A1 - Non-Combustible |
| Insulation | 100mm | Mineral Wool Insulation | | A1 - Non-Combustible |

There is no external wall cavity

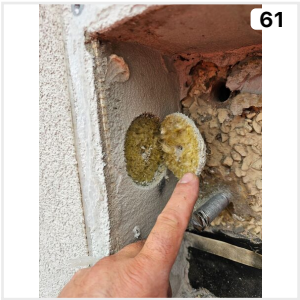
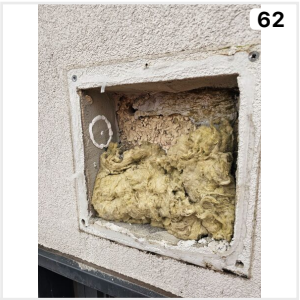
# Inspection: RBV159

Wall Type 3 - Render over mineral wool insulation

| 2 Elements | Thickness/Depth | Material | Photo Ref. | Rating (BS EN13501) |
|---|---|---|---|---|
| Surface Finish | 6mm | Render | | A1 - Non-Combustible |
| Insulation | 100mm | Mineral Wool Insulation | | A1 - Non-Combustible |

Floor Slab Abuts The Backing Wall
