Document Version 4  
Survey Date 08/11/2024  
Suggested Review Date 08/11/2029

# FIRE RISK APPRAISAL EXTERNAL WALLS

## HACKWOOD HOUSE

Hackwood House  
Hartlebury Road  
Oldbury  
West Midlands  
B69 1EG

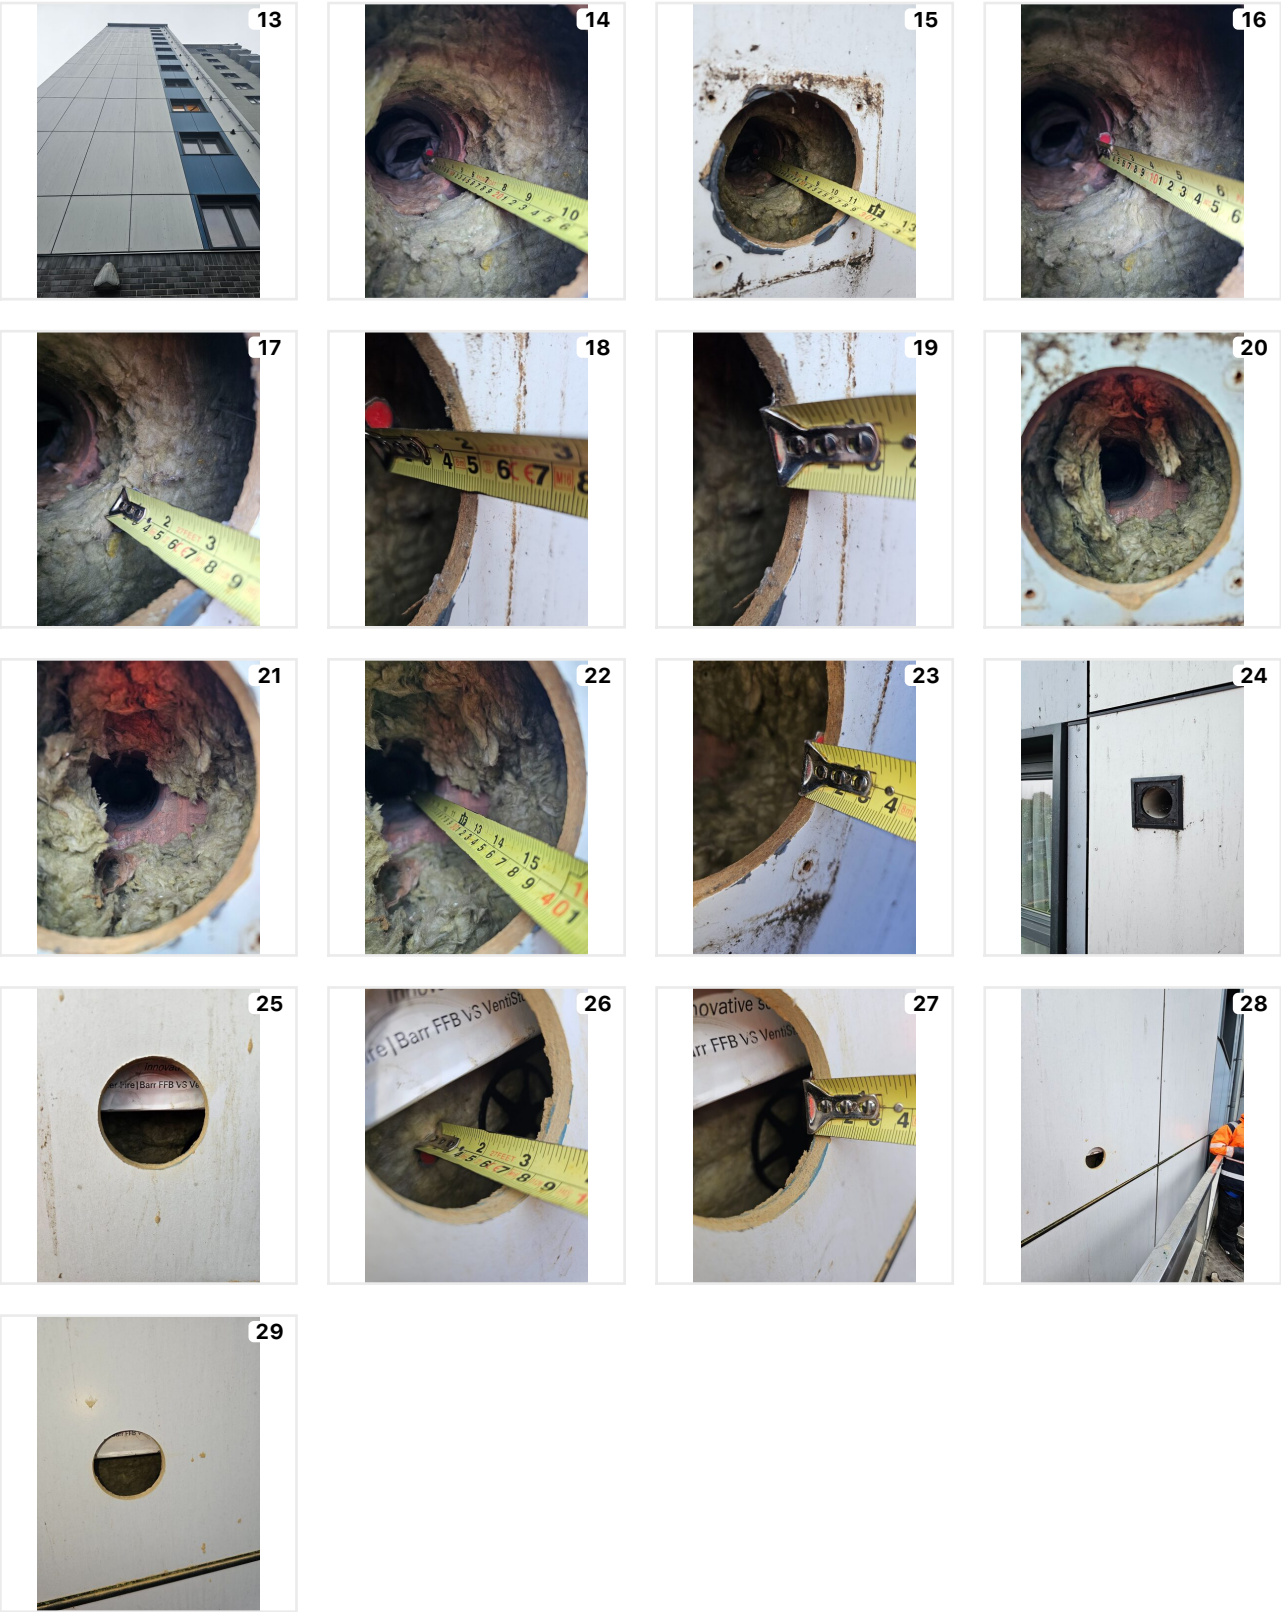
# Inspection Photos

Floor Slab Abuts The Backing Wall

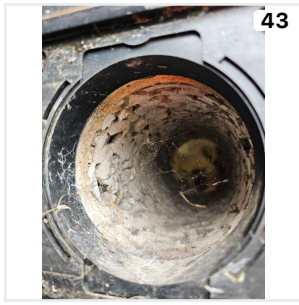
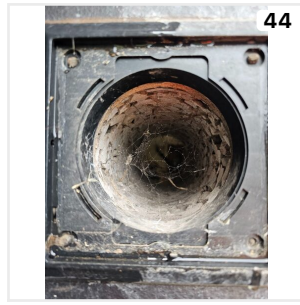
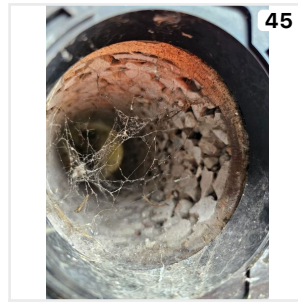
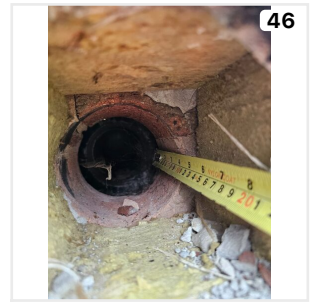
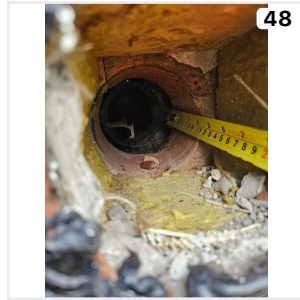
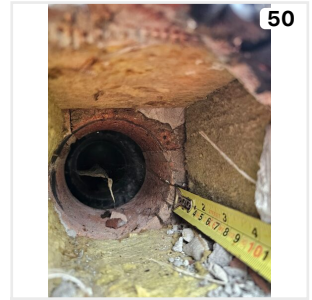
## Inspection Photos

Elevation • Location  
Wall Type 1 - Rainscreen Cladding • Accessible wall

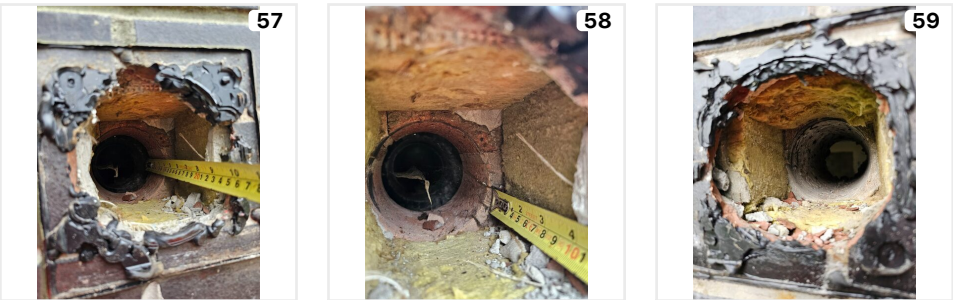
## Inspection Photos

Elevation • Location  
Wall Type 2 - Brick slip over mineral wool • Accessible wall

There is no external wall cavity

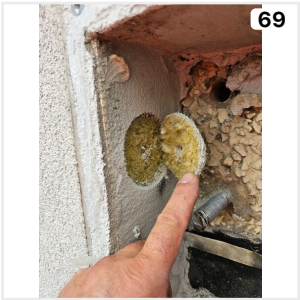
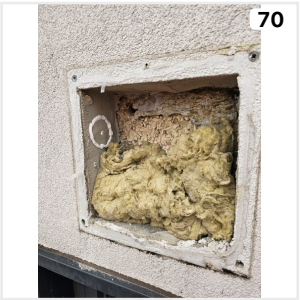
# Inspection Photos

Elevation • Location  
Wall Type 1 - Rainscreen Cladding • Accessible wall

Floor Slab Abuts The Backing Wall
