Document Version 6

# EXTERNAL WALL SURVEY

## HAMSTEAD HOUSE

Hamstead House  
Coniston Crescent  
Hamstead  
West Midlands  
B43 5NU

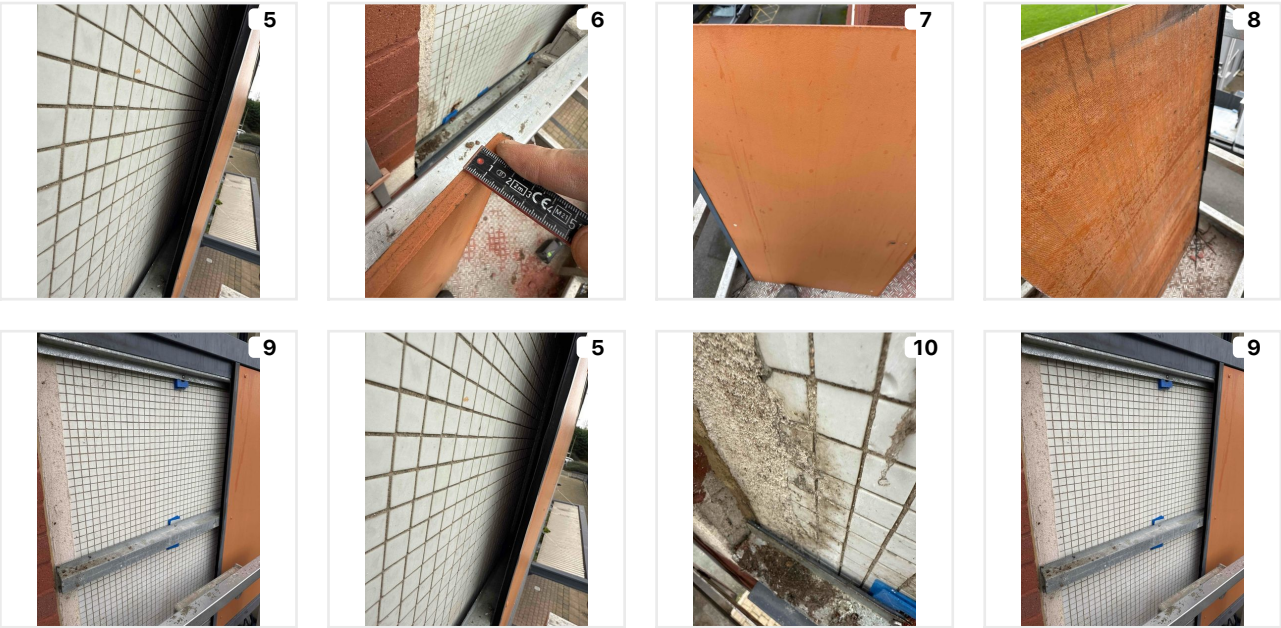
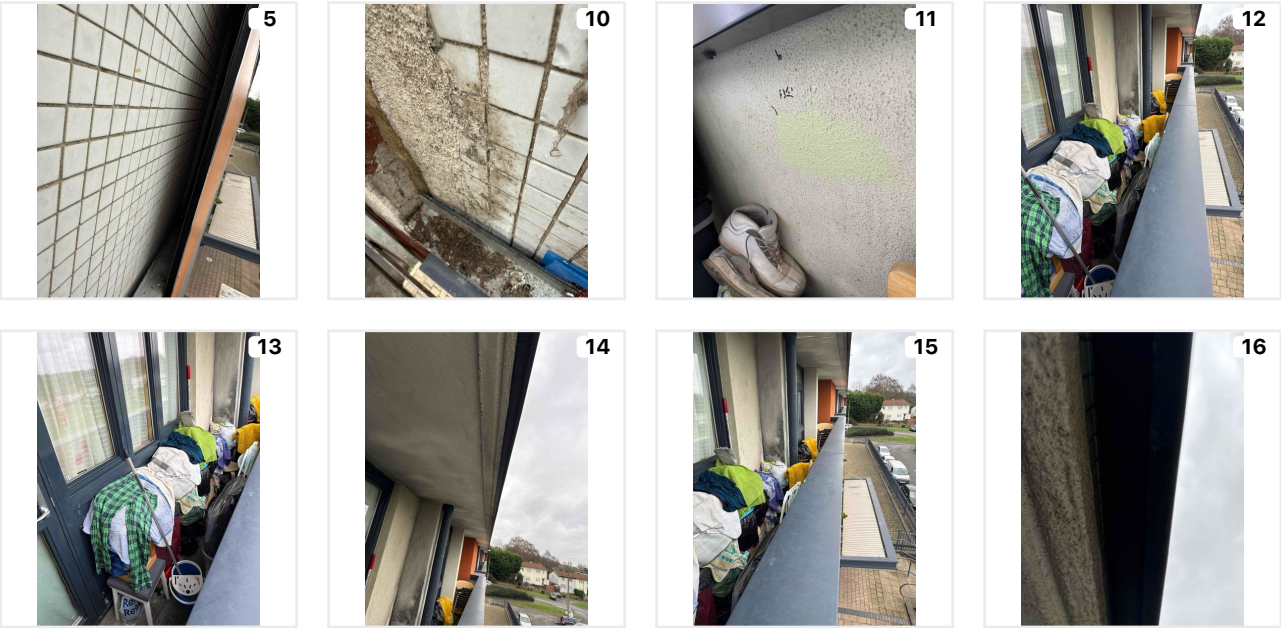
# Inspection: 4UWETN

Balcony is concrete and over clad  
Cement board fixed to steel brackets what are fixed to concrete parapet wall  
All balconies are concrete up stand parapet wall and all covered with cement board in 2 colours  
Concrete parapet is sat on slab edge

| 3 Elements | Thickness/Depth | Material | Photo Ref. | Rating (BS EN13501) |
|---|---|---|---|---|
| Surface Finish | 10mm | Cement board | 5, 6, 7, 8, 9 | A1 - Non-Combustible |
| Inner Leaf | | Reinforced concrete finished with ceramic tiles | 10, 9 | A1 - Non-Combustible |

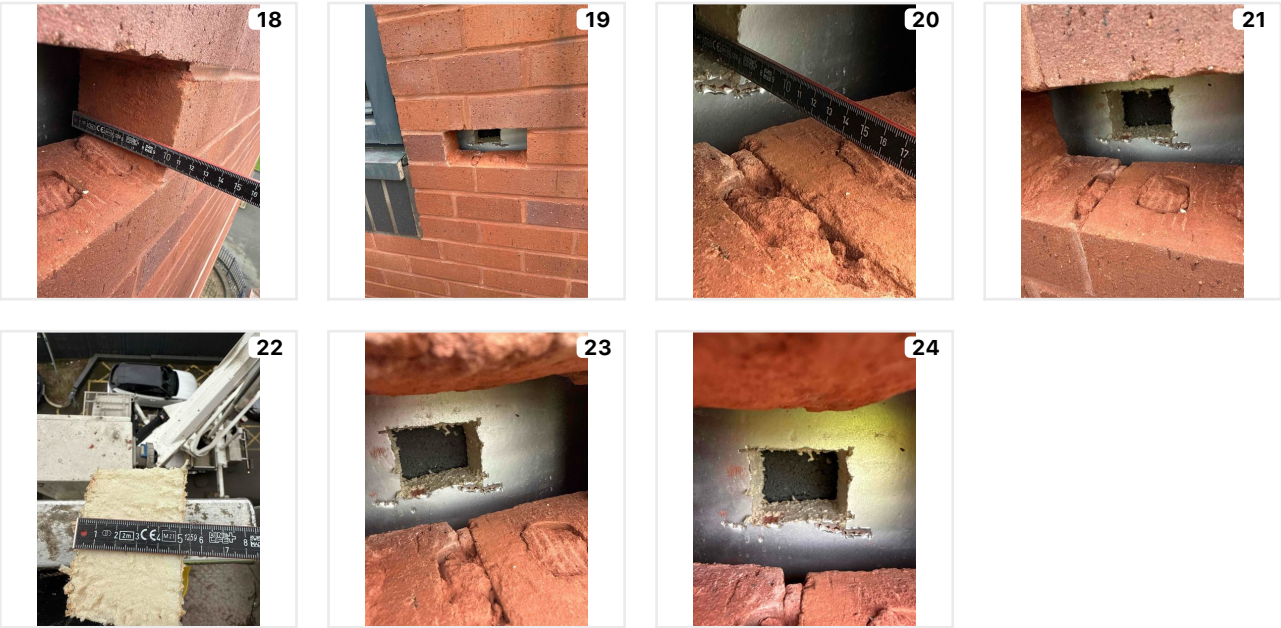
# Inspection: EAQZI5

Plastic cavity closer to window jam at bottom expanding foam in corner joint

| 4 Elements | Thickness/Depth | Material | Photo Ref. | Rating (BS EN13501) |
|---|---|---|---|---|
| Insulation | 50mm | PIR Insulation | 22, 23 | C - Combustible |

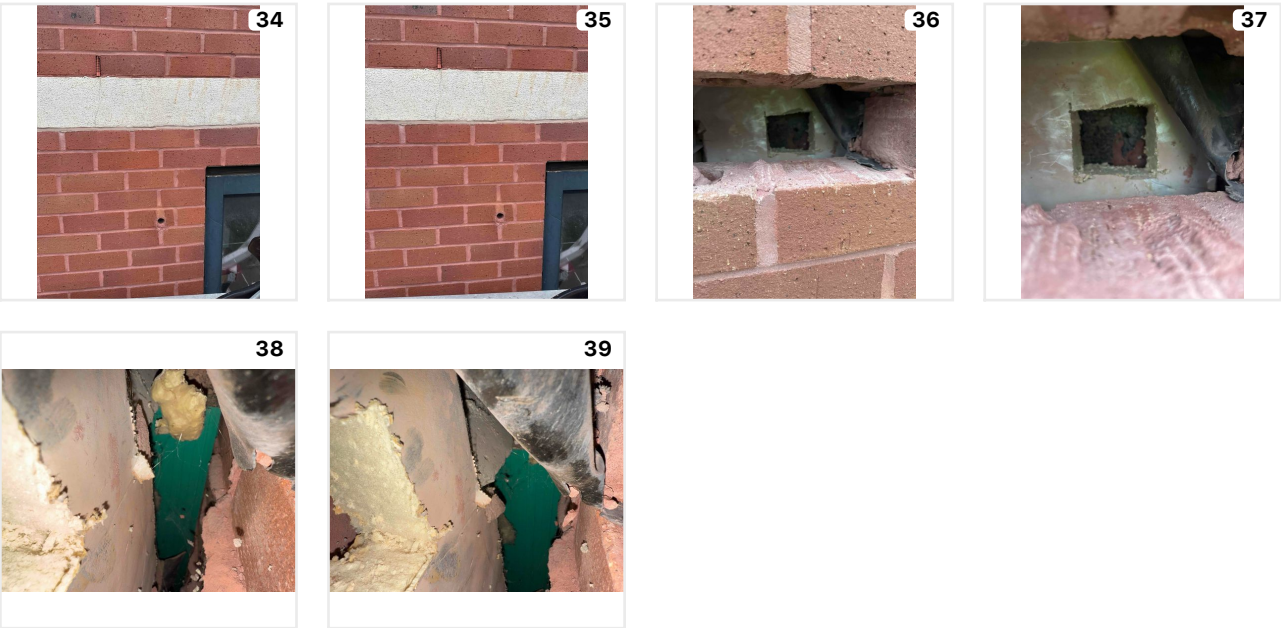
# Inspection: YF5545

Slab comes to front edge of brick  
Plastic cavity closer around window

| 4 Elements | Thickness/Depth | Material | Photo Ref. | Rating (BS EN13501) |
|---|---|---|---|---|
| Insulation | 50mm | PIR Insulation | 30, 31 | C - Combustible |

None

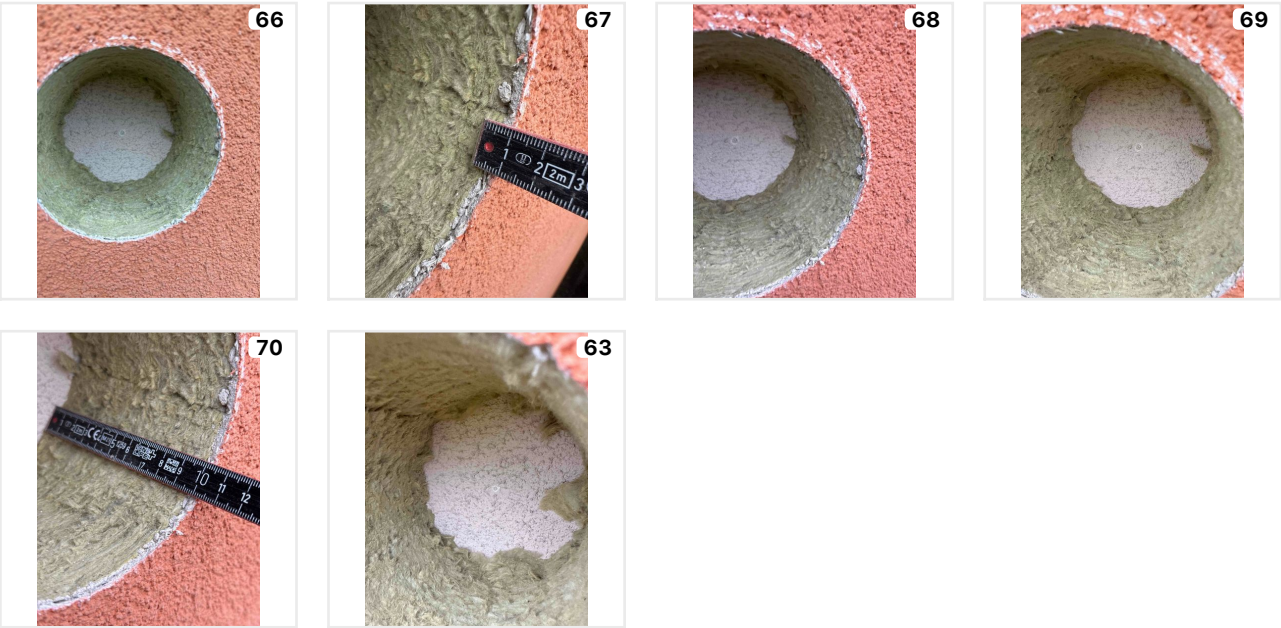
# Inspection: XHBA1E

| 3 Elements | Thickness/Depth | Material | Photo Ref. | Rating (BS EN13501) |
|---|---|---|---|---|
| Render on rockwool then at slab level<br>No gap behind rockwool | | | | |

| 1 Cavity Barrier | Material | Photo Ref. |
|---|---|---|
| Horizontal Cavity Barrier | Mineral Wool | |
