Document Version 3  
Survey Date 19/02/2025  
Suggested Review Date 19/02/2030

# FIRE RISK APPRAISAL EXTERNAL WALLS

## HAMSTEAD HOUSE

Hamstead House  
Coniston Crescent  
Hamstead  
West Midlands  
B43 5NU

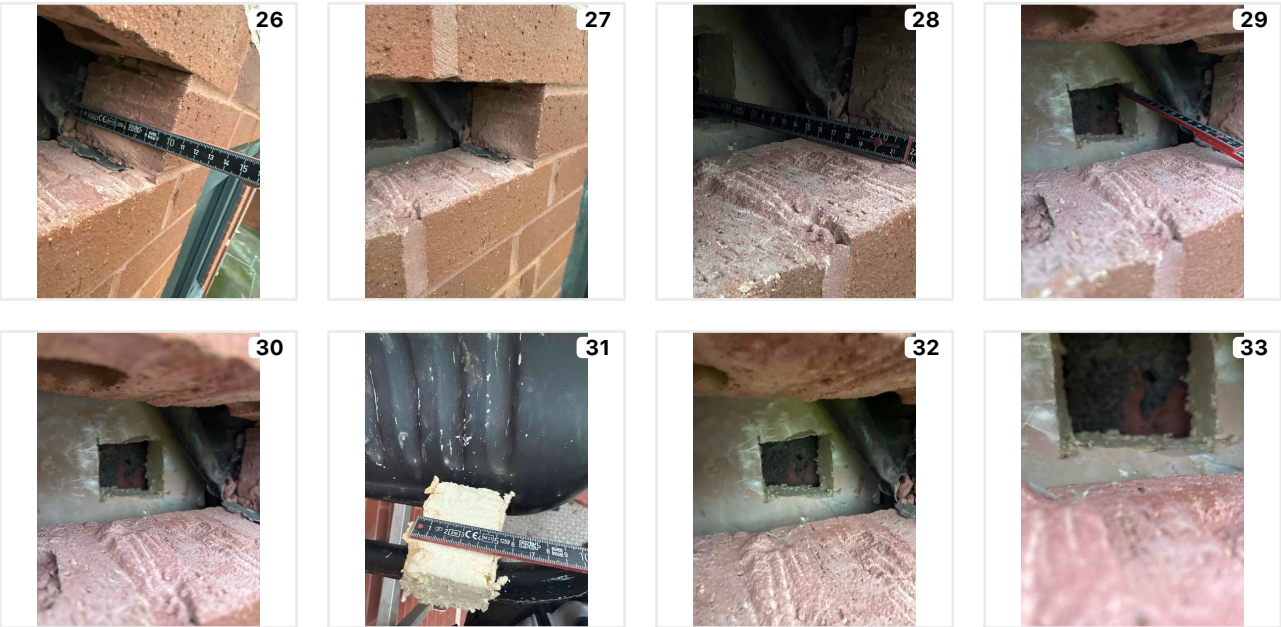
## Build-up Photos

Outside and backing walls sit on the floor slab

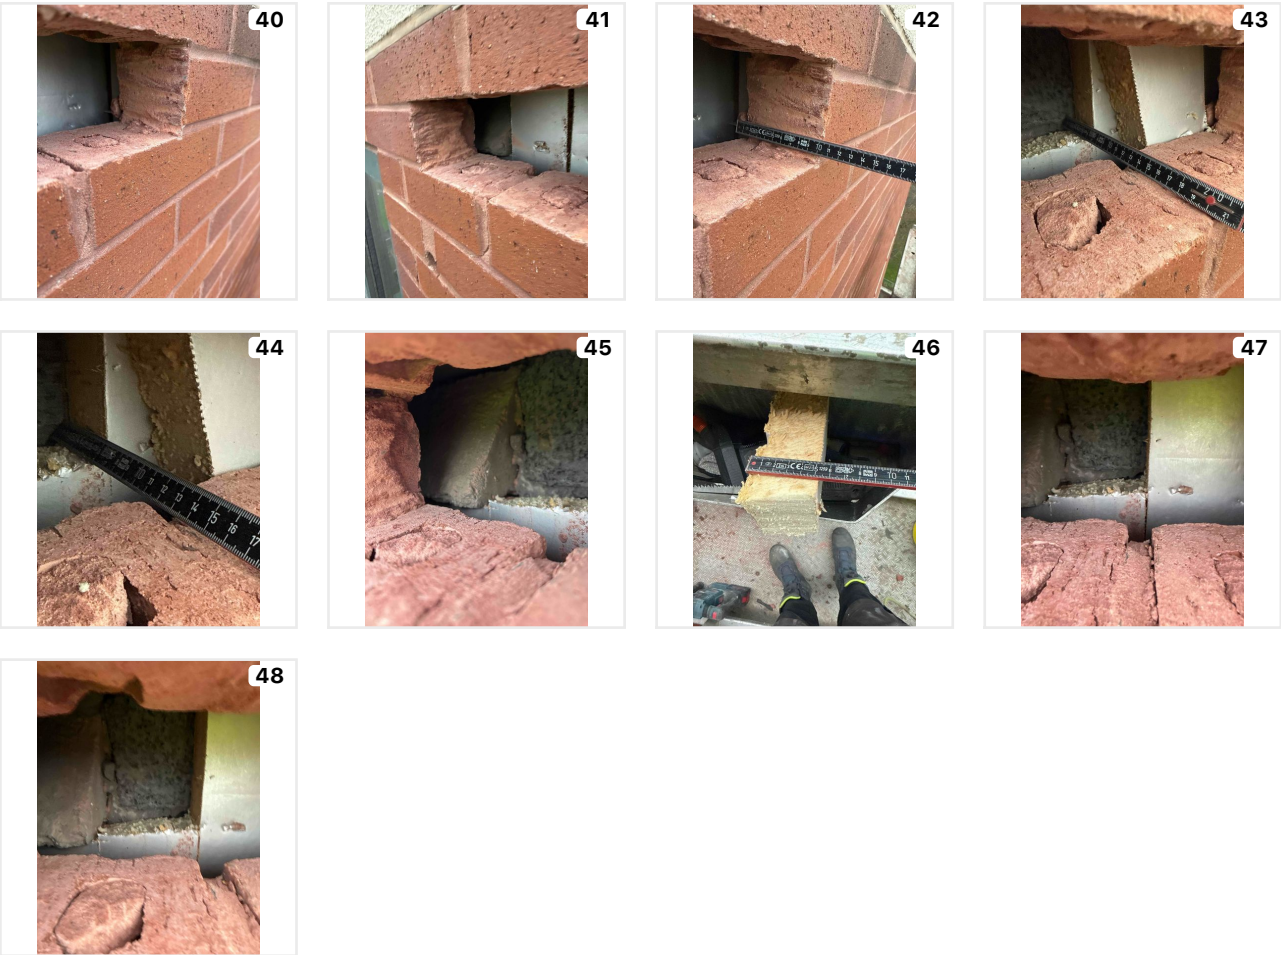
## Build-up Photos

Outside and backing walls sit on the floor slab

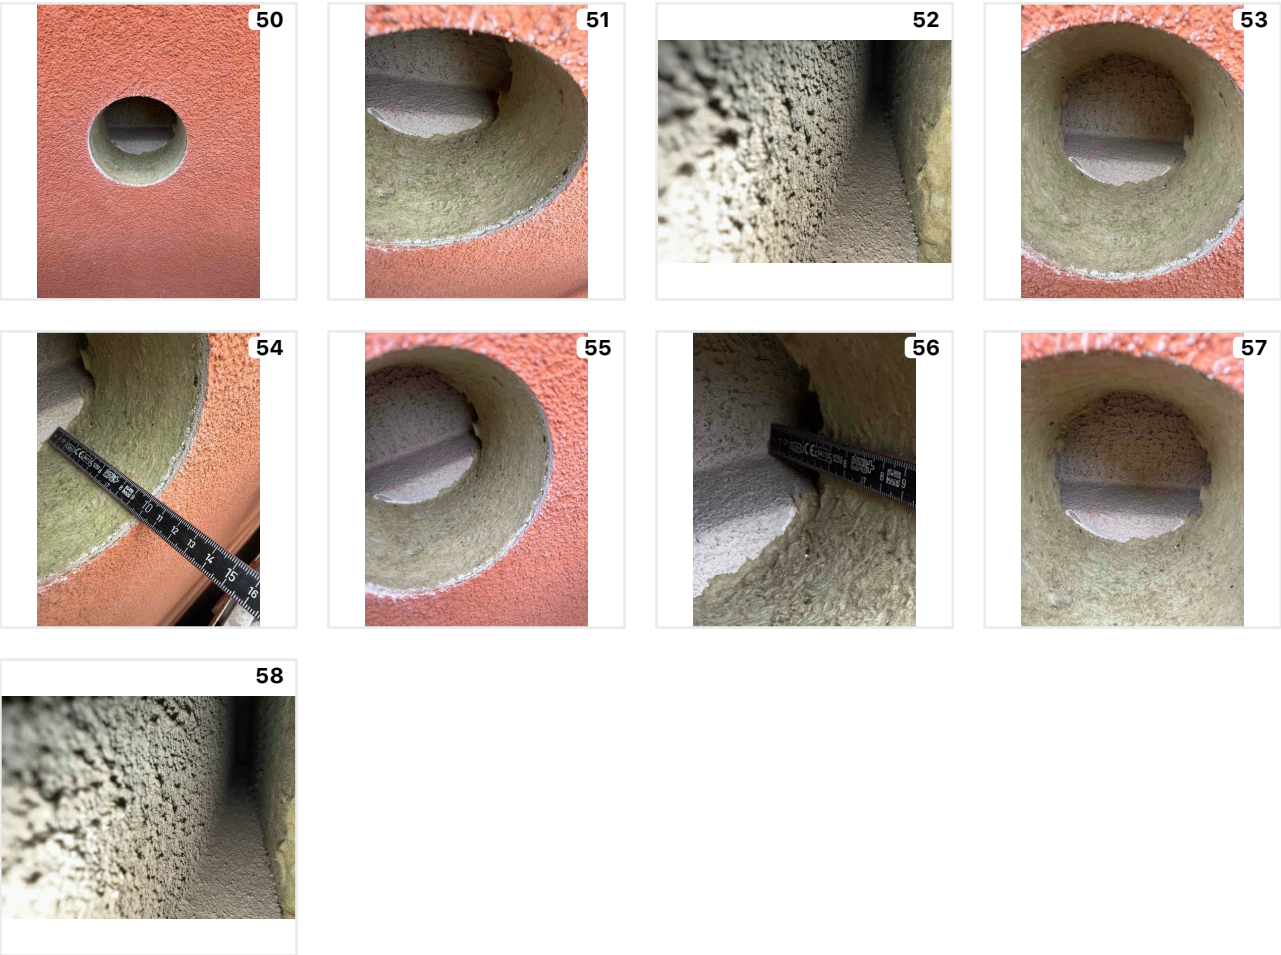
## Build-up Photos

Backing Wall Sits On The Floor Slab

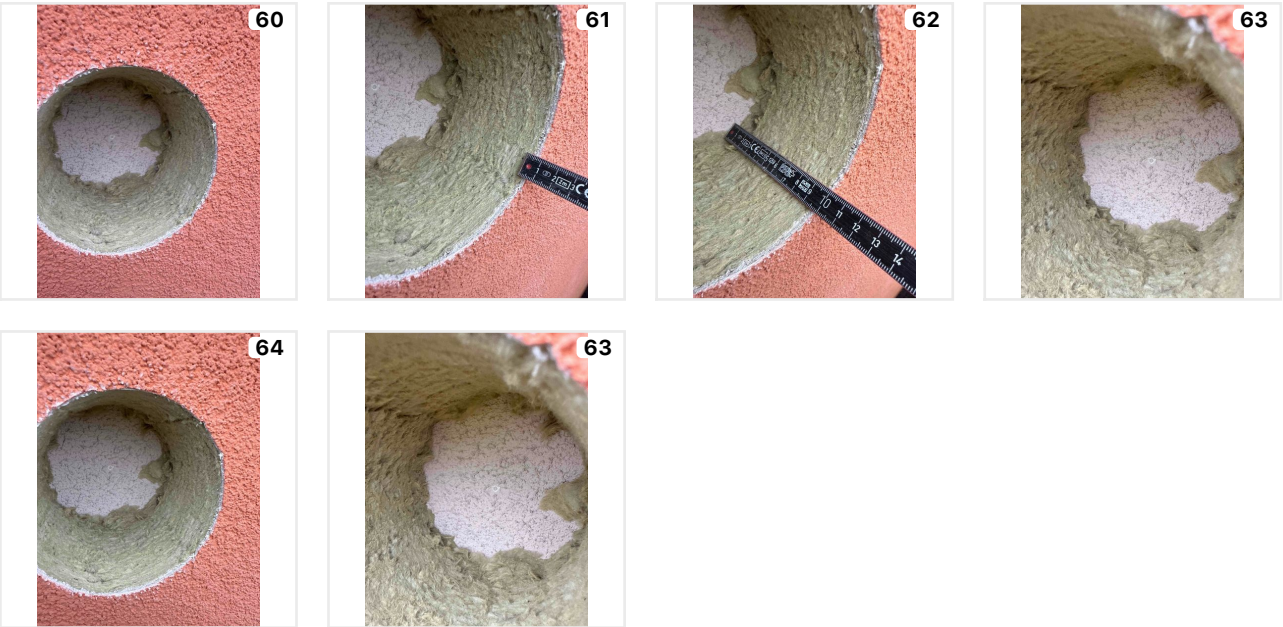
## Build-up Photos

Backing Wall Sits On The Floor Slab

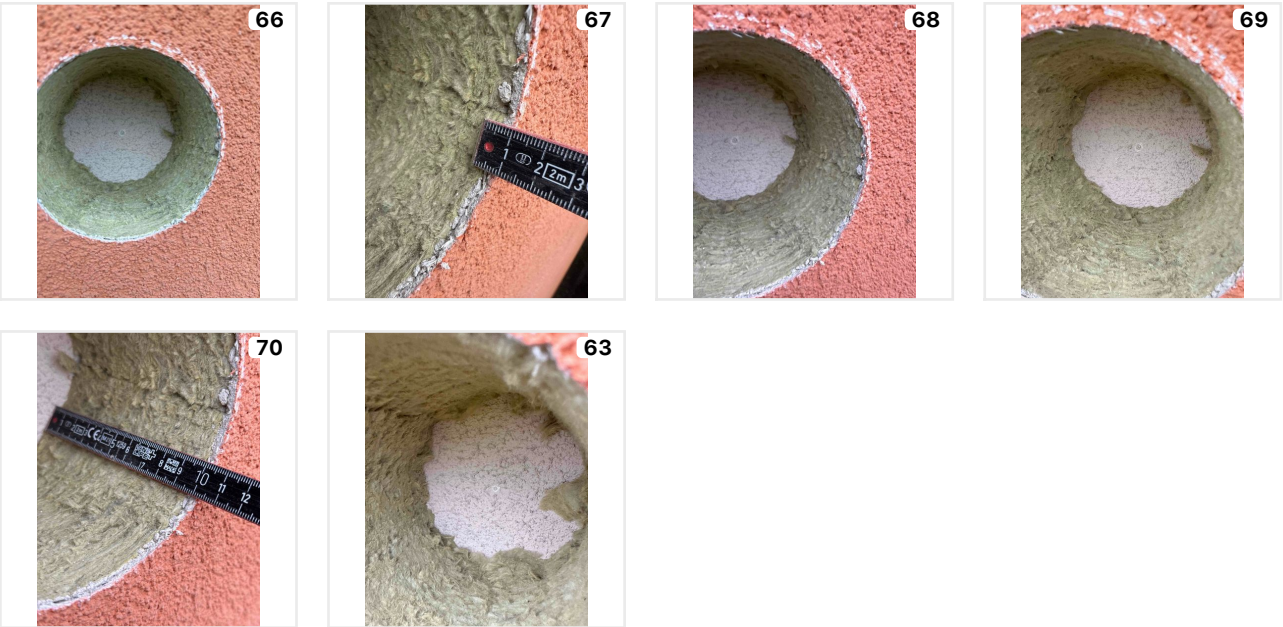
## Build-up Photos

Floor Slab Abuts The Backing Wall
