Document Version 3  
Survey Date 05/11/2024  
Suggested Review Date 05/11/2029

# EXTERNAL WALL SURVEY

## HARRY PRICE HOUSE

Hartlebury Road  
Oldbury  
B69 1EQ

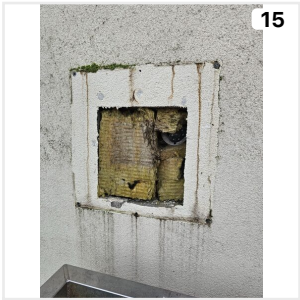
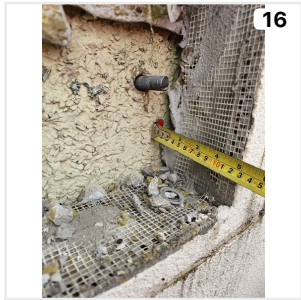
# Inspection: 6D865D

## Name/Summary

Wall Type 3 - Render over mineral wool insulation

| 3 Elements | Thickness/Depth | Material | Photo Ref. | Rating (BS EN13501) |
|---|---|---|---|---|
| Surface Finish | 15mm | Brick Slip / Brick Tile | | A1 - Non-Combustible |
| Insulation | 100mm | Mineral Wool Insulation | | A1 - Non-Combustible |
| The insulation has the appearance of Rockwool Duo Slab | | | | |
| Inner Leaf<br>Support (Backing<br>Wall) | 102mm | Original brickwork | | A1 - Non-Combustible |

There is no external wall cavity

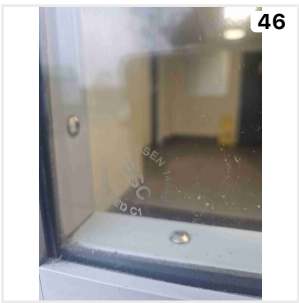
Kite marking indicates laminated glass EN 14449
