Survey Date 01/07/2025

# EXTERNAL WALL SURVEY

## HERONVILLE HOUSE

Sedgeley Road East  
Tipton  
DY4 7TX

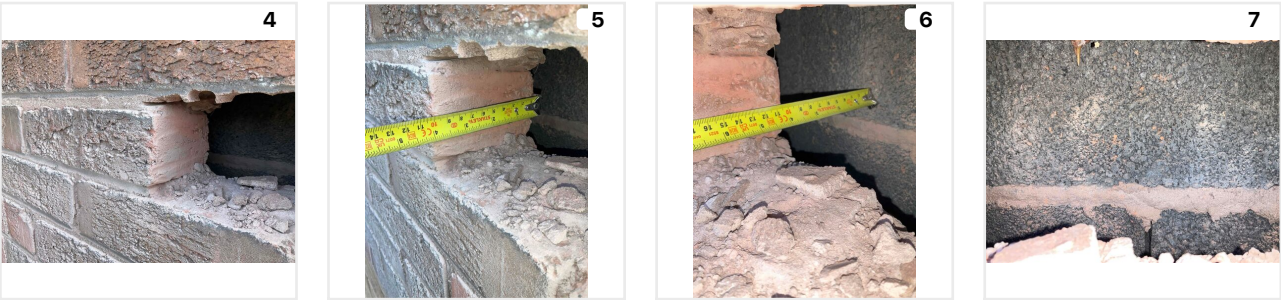
# Build-up Photos

| 3 Elements | Thickness/Depth | Material | Photo Ref. | Rating (BS EN13501) |
| External Surface Material | 102mm | Brickwork | 4, 5 | A1 - Non-Combustible |
| Cavity | 100mm | | 6 | |
| Substrate | | Original blockwork | 7 | A1 - Non-Combustible |

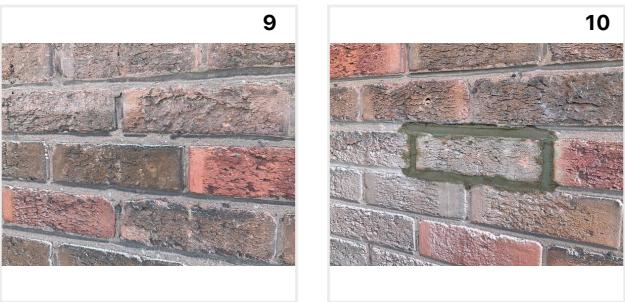
# Inspection Photos

Cavity closed horizontally by the concrete floor slab
