# FIRE RISK APPRAISAL EXTERNAL WALLS

## HERONVILLE HOUSE

Sedgeley Road East  
Tipton  
DY4 7TX

RB-H4KUCU

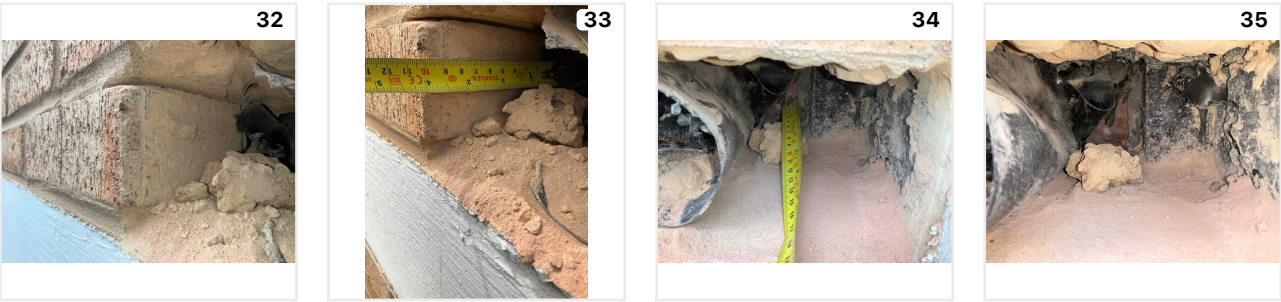
# Build-up Photos

**Conclusion:** This wall system is comprised of a double-leaf masonry system that was observed to contain no insulation. The outer leaf was formed of 102mm brickwork, and the inner leaf was formed of 100mm blockwork.

| 3 Elements | Thickness/Depth | Material | Rating (BS EN13501) |
|---|---|---|---|
| External Surface Material | 102mm | Brickwork | A1 - Non-Combustible |
| Substrate | | Original blockwork | A1 - Non-Combustible |

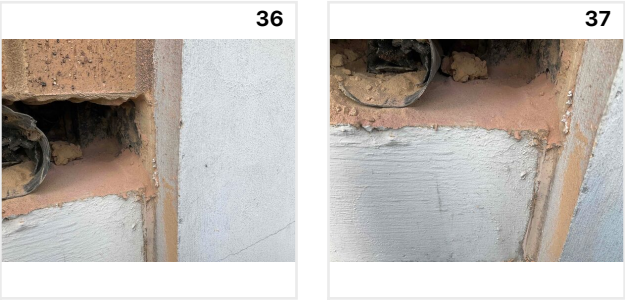
# Cavity Barrier Photos

No dedicated cavity barriers were identified within the wall system however it was observed that the floor slab extends to the external surface effectively disrupting the mechanism for vertical fire spread within the cavity.

Floor slabs extend to external surface, providing horizontal compartmentation.
