# FIRE RISK APPRAISAL EXTERNAL WALLS

## HOLLY COURT

Holly Court  
Acacia Avenue  
West Bromwich  
West Midlands  
WS5 4HB

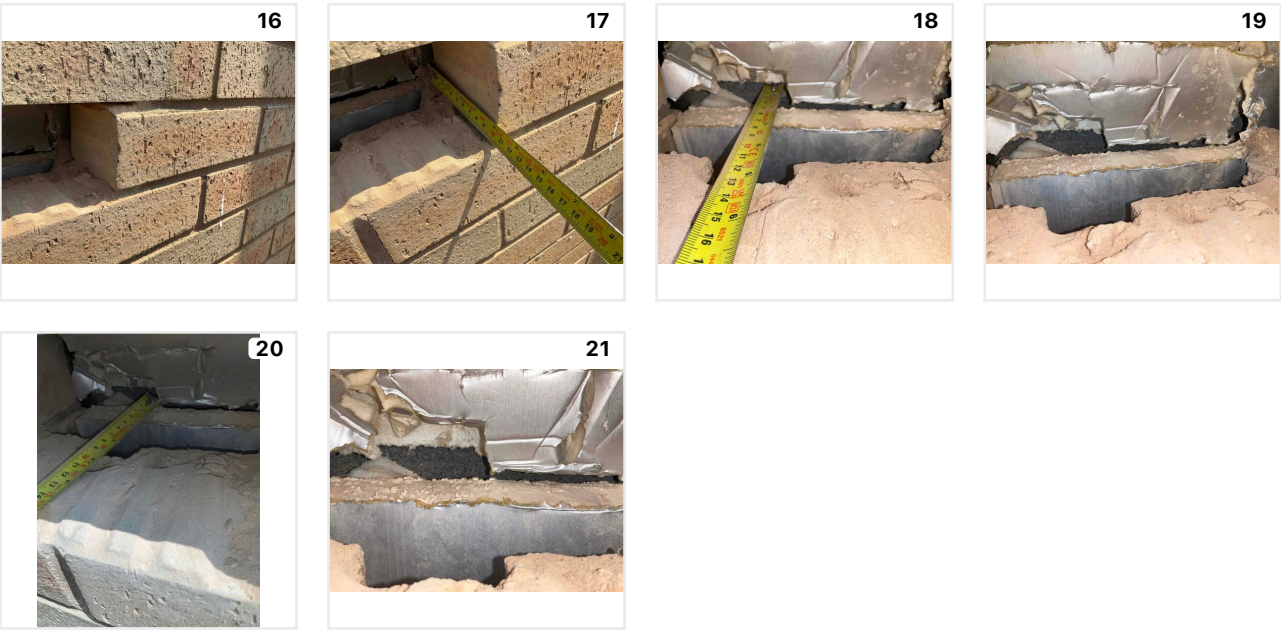
# Build-up Photos

Reinforced concrete

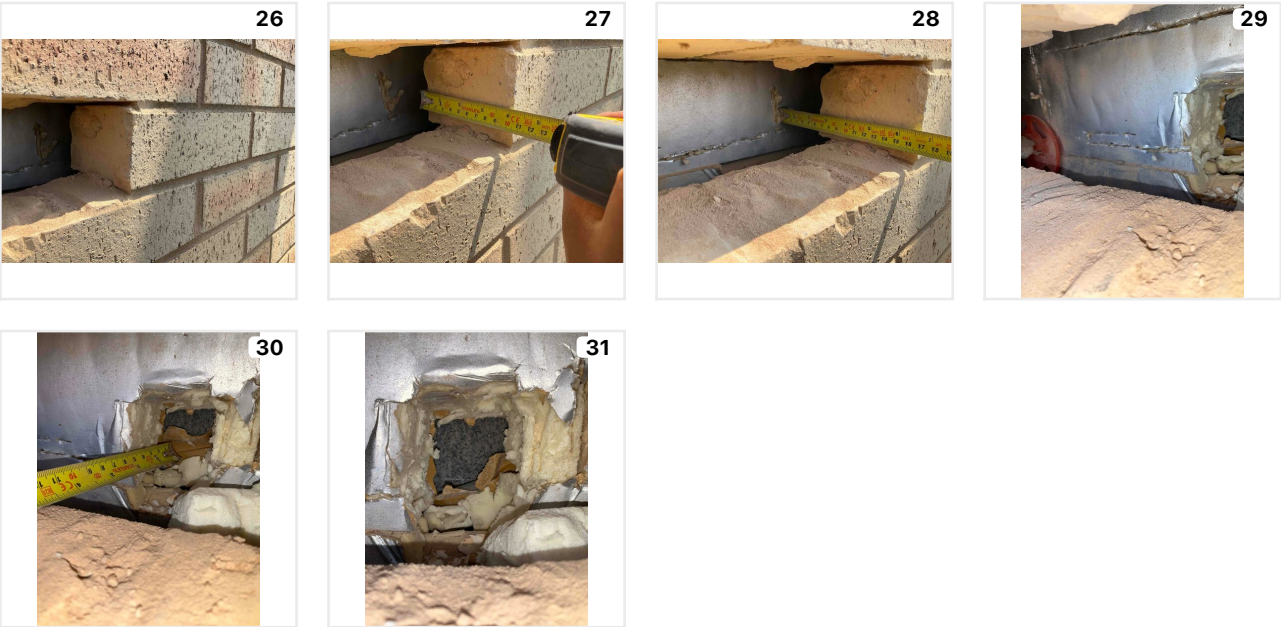
Build-up Photos

Reinforced concrete

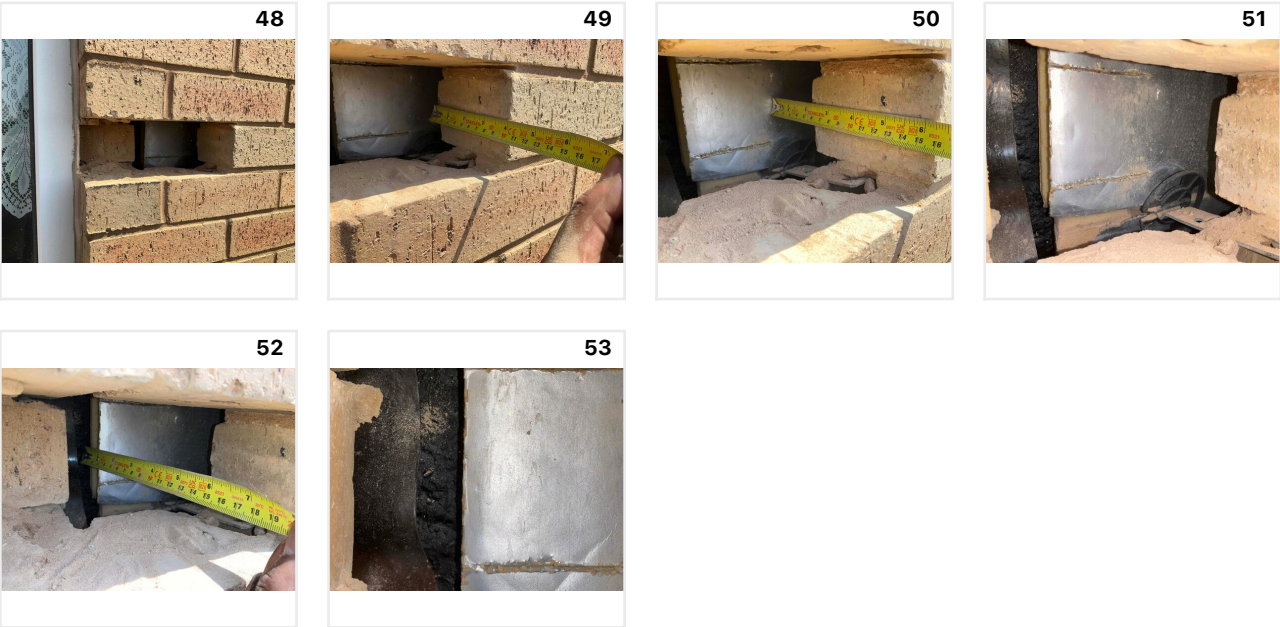
Build-up Photos

Reinforced concrete

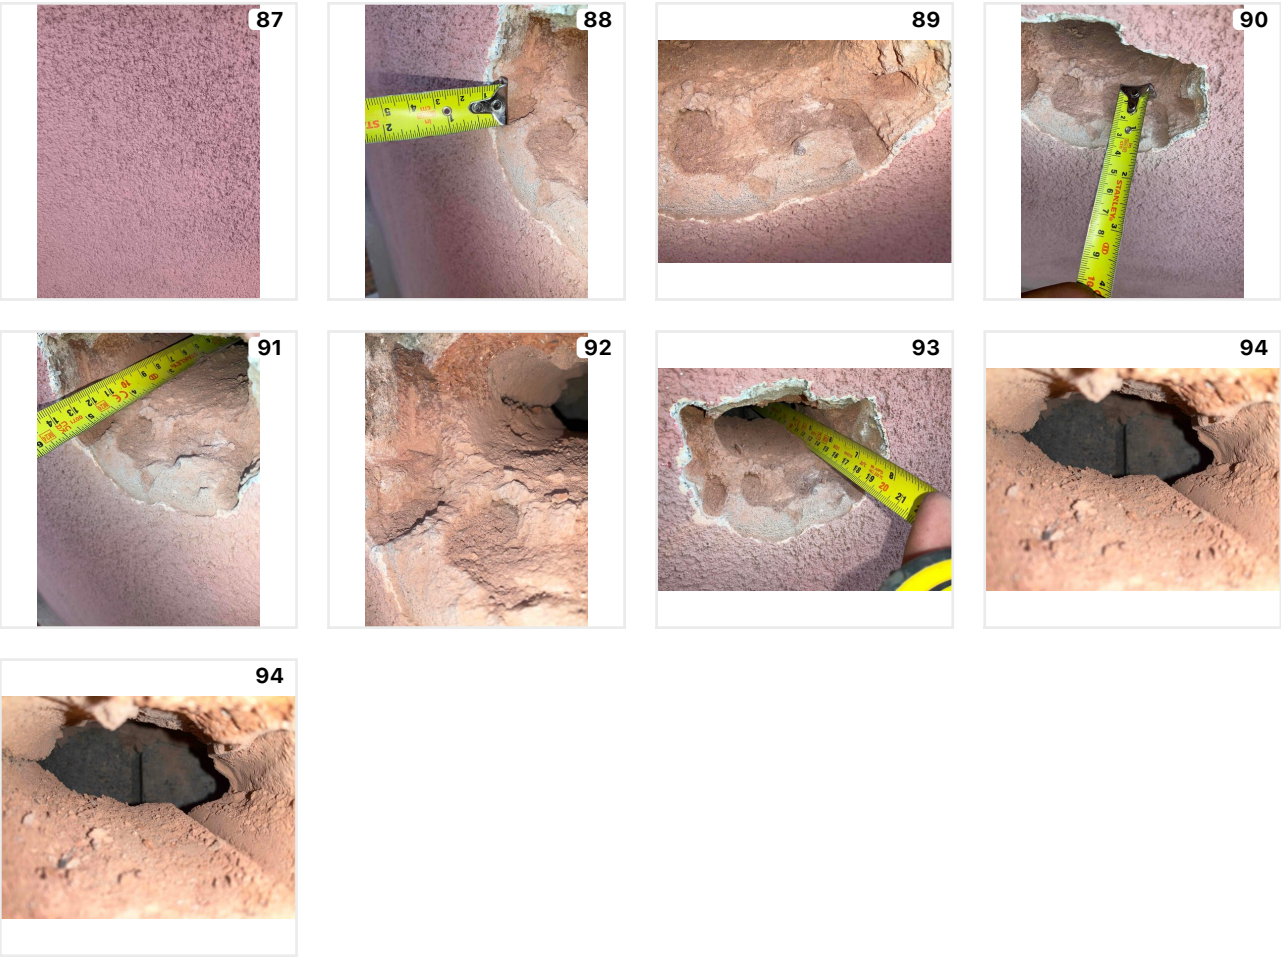
## Build-up Photos

No cavity barrier identified at this inspection location
