**FIRNTEC**  
BUILDING COMPLIANCE

# EXTERNAL WALL SURVEY

## 1-32 HORTON STREET

1-32 Horton Street  
Tipton  
DY4 7JW

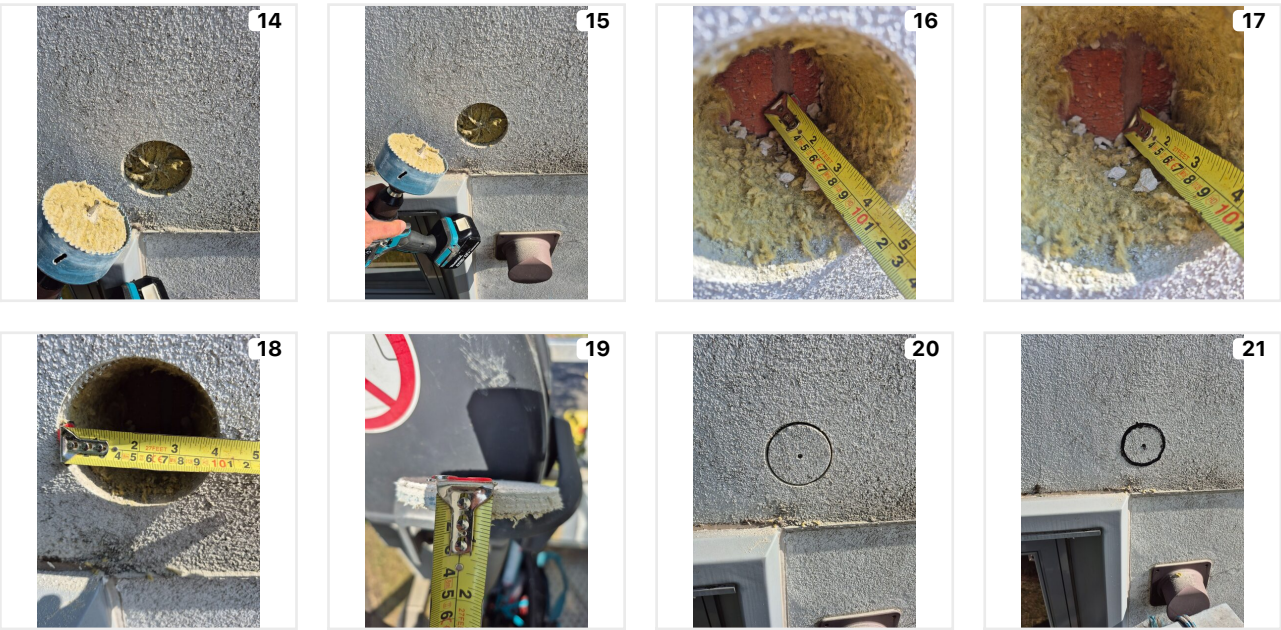
Inspection Photos

**Substrate**  
The render is applied directly to a solid masonry wall—specifically blockwork inner leaf with brick outer leaf and cavity insulation.  
No evidence of any carrier board, EPS insulation, or framing behind the render was observed.

**2. Render Type and Build-Up**  
The render is a cementitious or acrylic-based system, likely composed of the following layers:  
Base coat: A thick, grey cementitious layer providing mechanical adhesion.  
Mesh-reinforced scratch coat: Not exposed, but presumed typical for crack resistance.  
Finish coat: A coarse-textured acrylic or polymer-modified topcoat, cream/grey in colour.

**3. Fire Performance**  
The render system appears to be direct-to-substrate with no combustible backing.  
Combined with mineral wool cavity insulation and masonry substrate, this system is non-combustible (Euroclass A1–A2-s1,d0).  
No combustible detailing, intumescent trims, or polymeric expansion joints were observed.

**4. Condition**  
Localised weathering and surface staining observed, but no visible detachment or cracking indicative of structural failure.  
The drilled inspection confirmed continuous mineral wool insulation behind render.

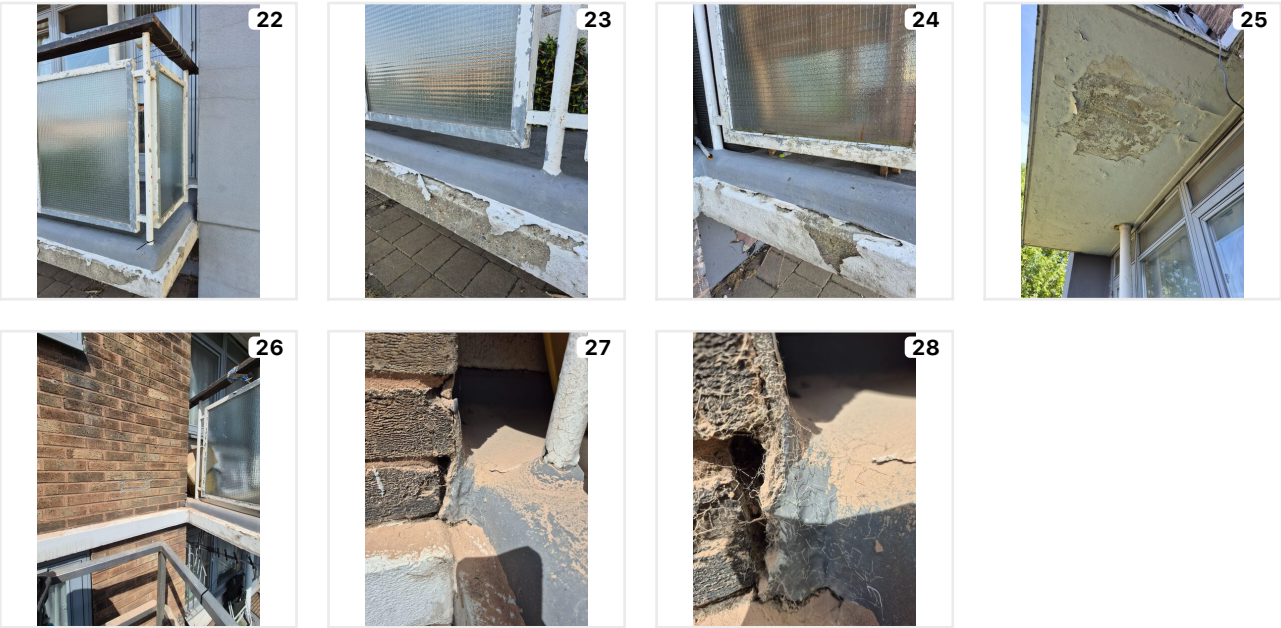
Elevation • Location  
West Elevation • Stacked Balcony

The balconies are constructed from solid, predominantly non-combustible materials and do not incorporate combustible cladding or screening. Current condition is aged but does not significantly increase external fire spread risk.

| 2 Elements | Thickness/Depth | Material | Photo Ref. | Rating (BS EN13501) |
|---|---|---|---|---|
| Waterproof Membrane | | Void: Coated concrete (possibly bituminous or painted waterproof layer); aged/worn. | | B - Combustible |

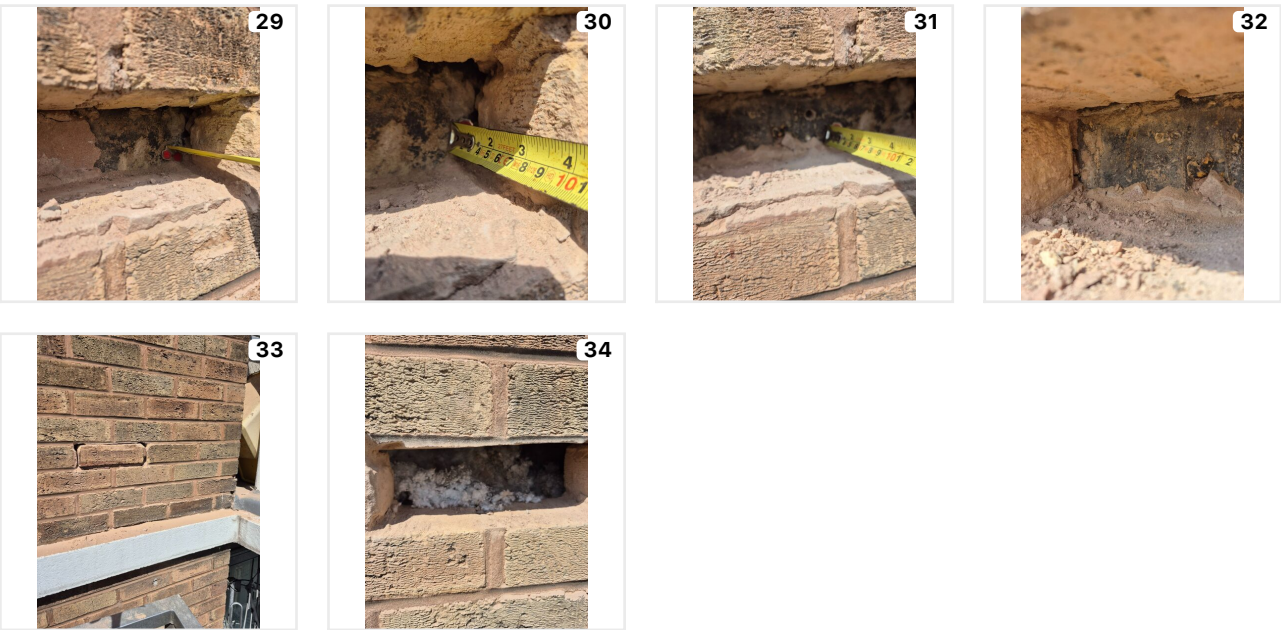
Location  
Compartment Floor and Wall Junction Interface

Masonry construction appears original and robust but lacks modern cavity fire barrier provision. Localised brick removal (as seen in investigative openings) confirms presence of mineral wool-type insulation, but continuity and integrity not fully verified. Surface spalling and mortar degradation observed in some areas, particularly under balconies and near service penetrations. No cladding, rainscreen systems or panelised façades present.

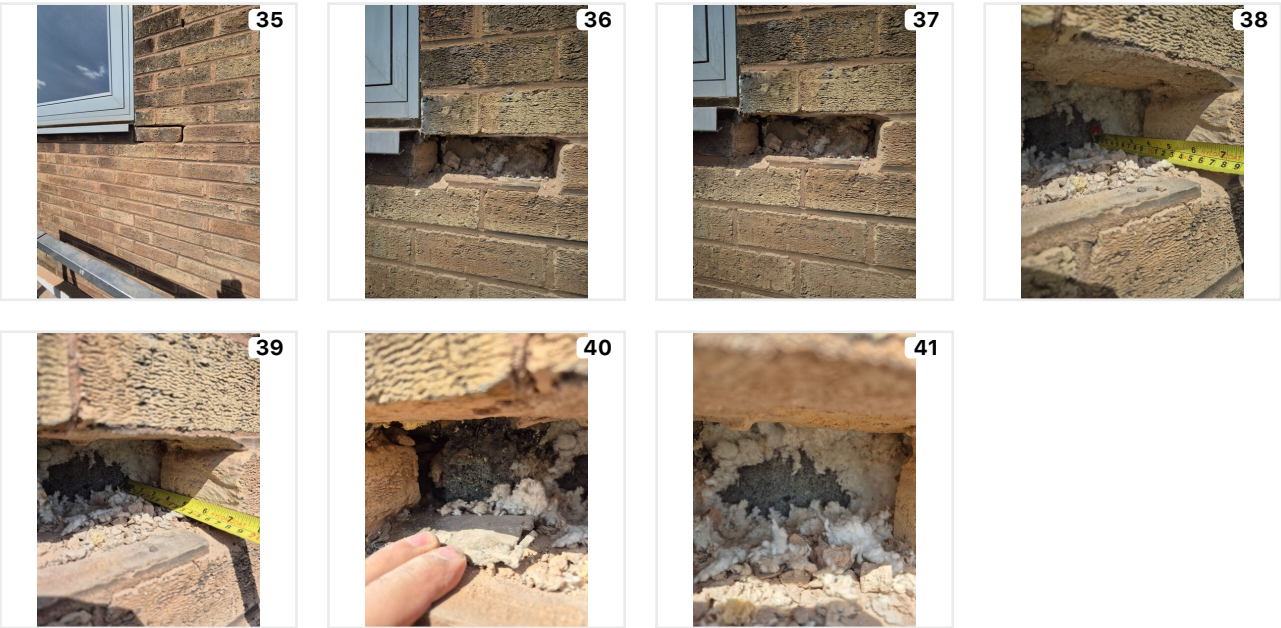
Location  
Aperture Opening

Masonry construction appears original and robust but lacks modern cavity fire barrier provision. Localised brick removal (as seen in investigative openings) confirms presence of mineral wool-type insulation, but continuity and integrity not fully verified. Surface spalling and mortar degradation observed in some areas, particularly under balconies and near service penetrations. No cladding, rainscreen systems or panelised façades present.

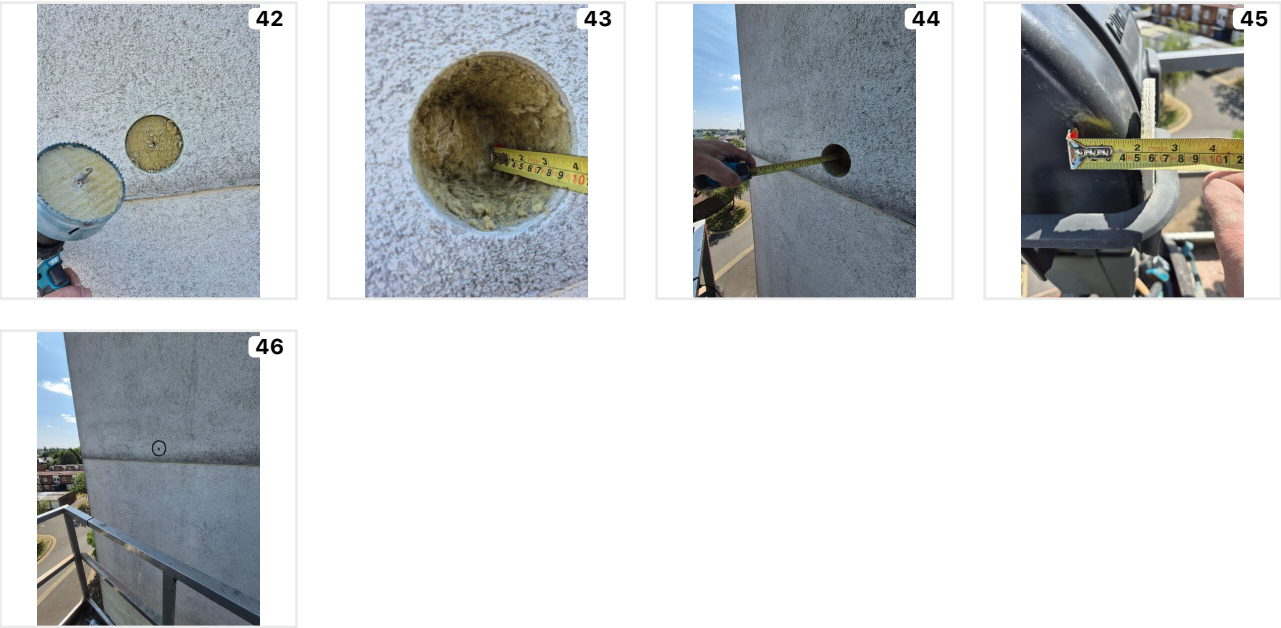
Location  
Compartment Floor Junction

**Substrate**  
The render is applied directly to a solid masonry wall—specifically blockwork inner leaf with brick outer leaf and cavity insulation.  
No evidence of any carrier board, EPS insulation, or framing behind the render was observed.

**2. Render Type and Build-Up**  
The render is a cementitious or acrylic-based system, likely composed of the following layers:  
Base coat: A thick, grey cementitious layer providing mechanical adhesion.  
Mesh-reinforced scratch coat: Not exposed, but presumed typical for crack resistance.  
Finish coat: A coarse-textured acrylic or polymer-modified topcoat, cream/grey in colour.

**3. Fire Performance**  
The render system appears to be direct-to-substrate with no combustible backing.  
Combined with mineral wool cavity insulation and masonry substrate, this system is non-combustible (Euroclass A1-A2-s1,d0).  
No combustible detailing, intumescent trims, or polymeric expansion joints were observed.

**4. Condition**  
Localised weathering and surface staining observed, but no visible detachment or cracking indicative of structural failure.  
The drilled inspection confirmed continuous mineral wool insulation behind render.

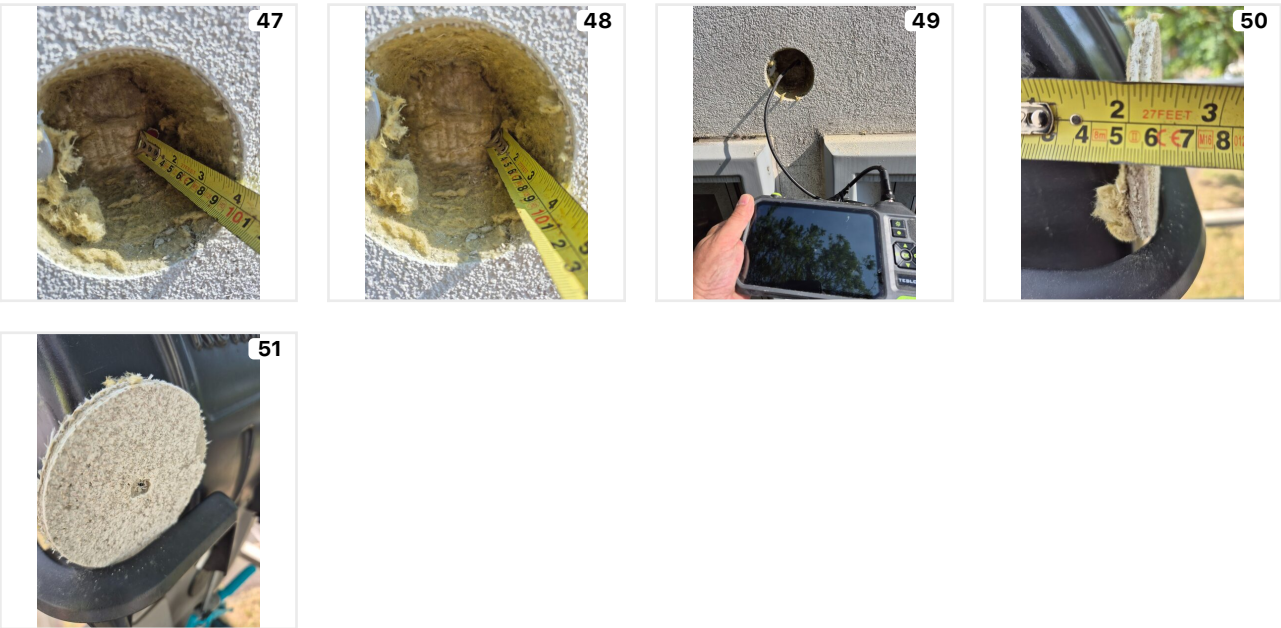
Location  
Aperture Opening

**Substrate**  
The render is applied directly to a solid masonry wall—specifically blockwork inner leaf with brick outer leaf and cavity insulation.  
No evidence of any carrier board, EPS insulation, or framing behind the render was observed.

**2. Render Type and Build-Up**  
The render is a cementitious or acrylic-based system, likely composed of the following layers:  
Base coat: A thick, grey cementitious layer providing mechanical adhesion.  
Mesh-reinforced scratch coat: Not exposed, but presumed typical for crack resistance.  
Finish coat: A coarse-textured acrylic or polymer-modified topcoat, cream/grey in colour.

**3. Fire Performance**  
The render system appears to be direct-to-substrate with no combustible backing.  
Combined with mineral wool cavity insulation and masonry substrate, this system is non-combustible (Euroclass A1-A2-s1,d0).  
No combustible detailing, intumescent trims, or polymeric expansion joints were observed.

**4. Condition**  
Localised weathering and surface staining observed, but no visible detachment or cracking indicative of structural failure.  
The drilled inspection confirmed continuous mineral wool insulation behind render.

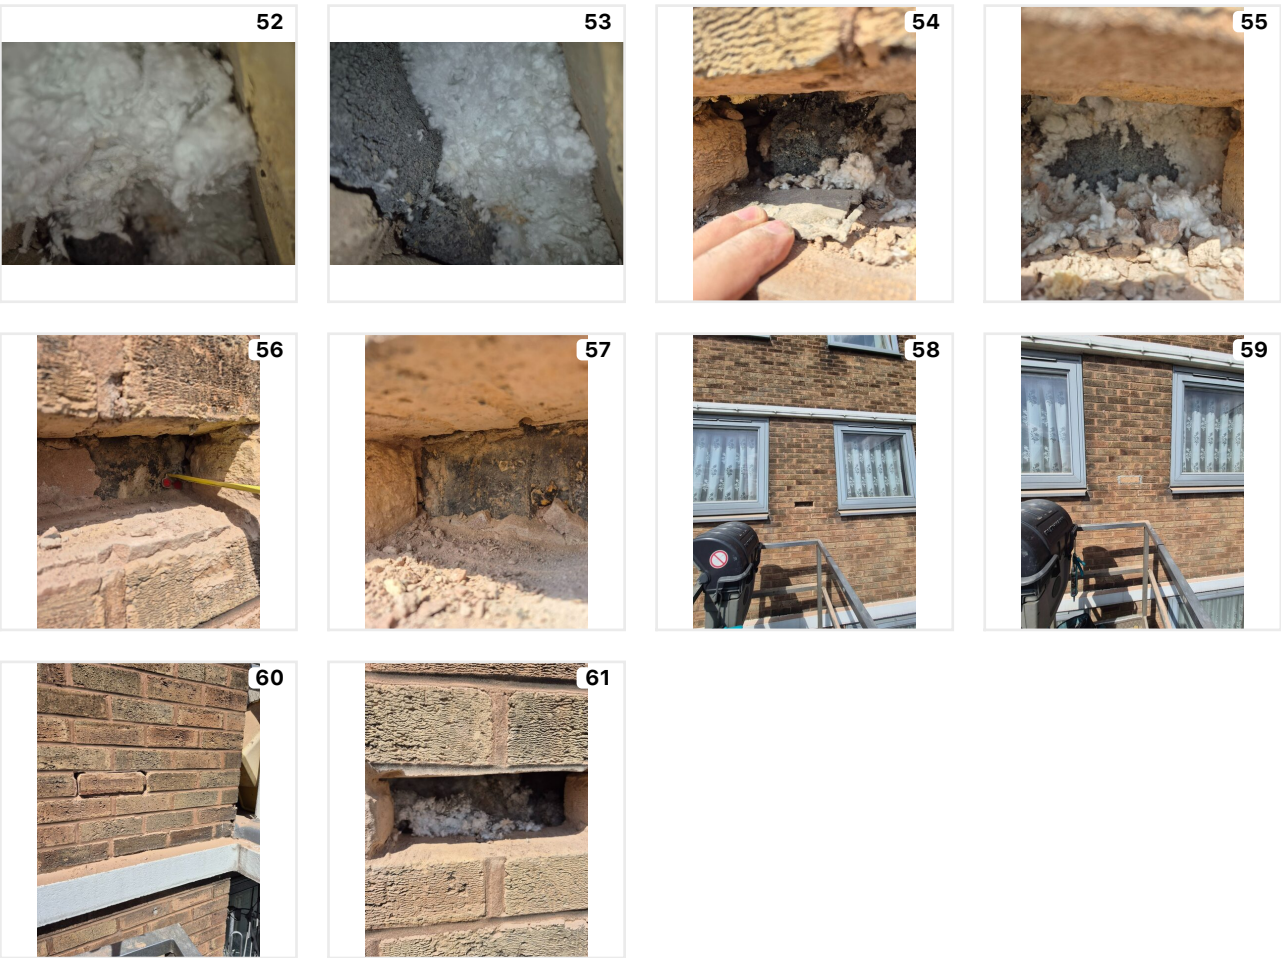
Location  
Compartment Floor and Wall Junction Interface

Masonry construction appears original and robust but lacks modern cavity fire barrier provision. Localised brick removal (as seen in investigative openings) confirms presence of mineral wool-type insulation, but continuity and integrity not fully verified. Surface spalling and mortar degradation observed in some areas, particularly under balconies and near service penetrations. No cladding, rainscreen systems or panelised façades present.

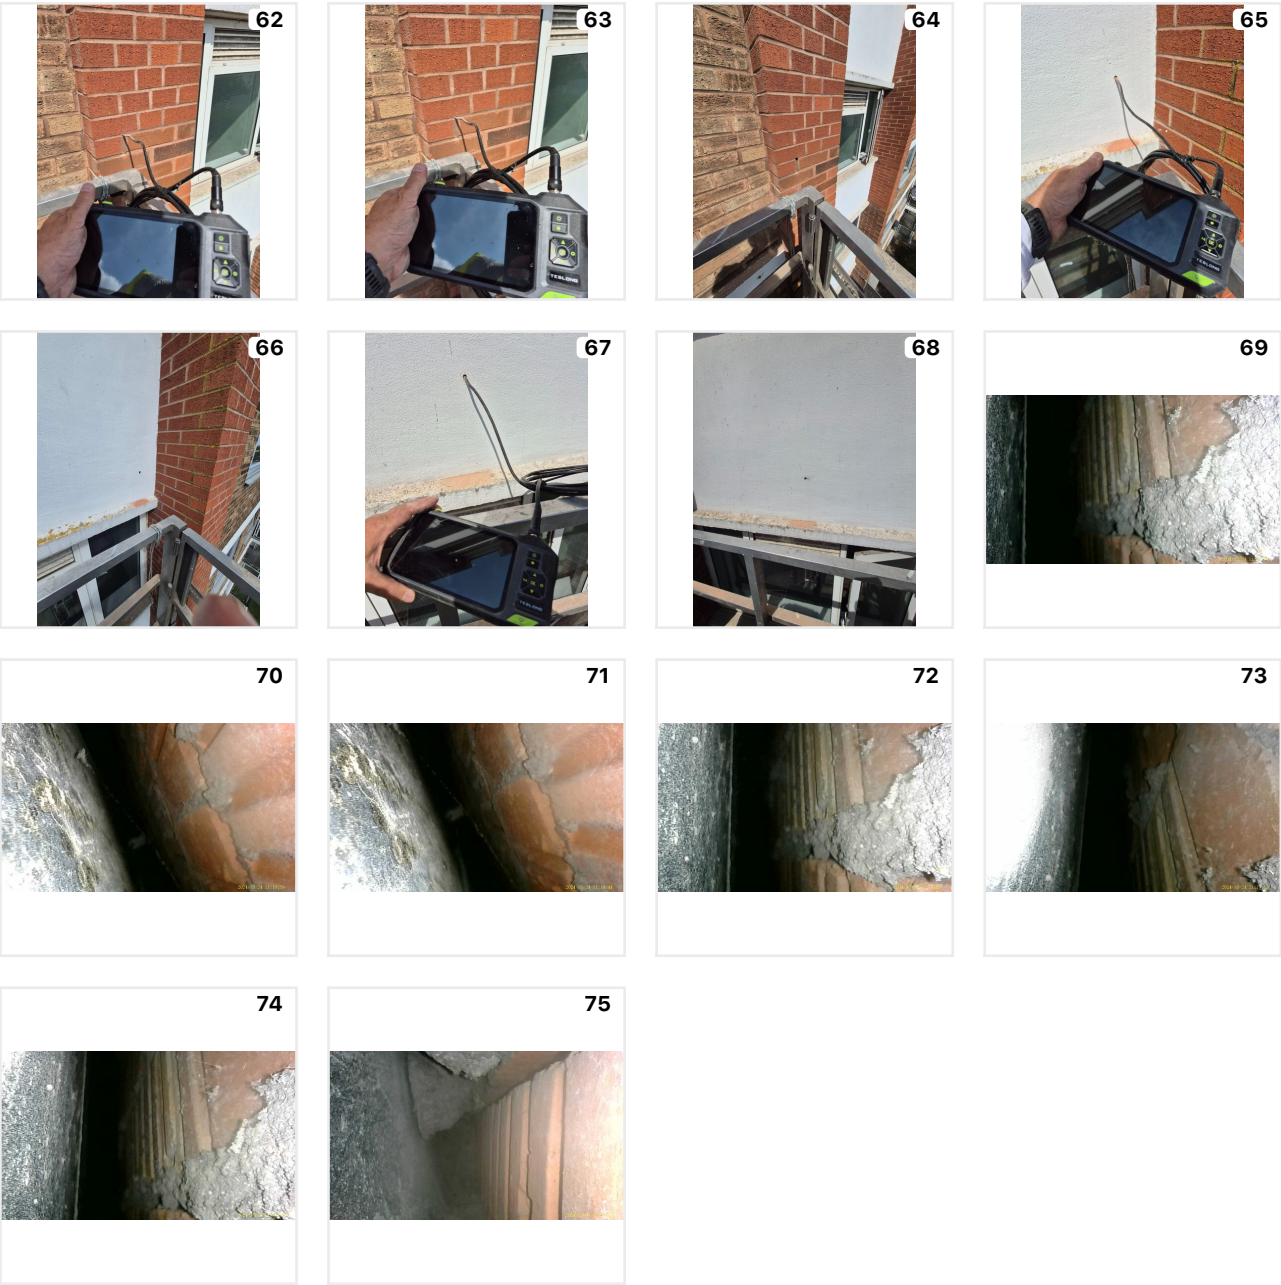
Location  
Vertical section external to staircore

Masonry construction appears original and robust but lacks modern cavity fire barrier provision.  
Localised borescope confirms no insulation within cavity at survey location  
Surface spalling and mortar degradation observed in some areas, particularly under windows.  
No cladding, rainscreen systems or panelised façades present.

| 3 Elements | Thickness/Depth | Material | Photo Ref. | Rating (BS EN13501) |
|---|---|---|---|---|
| Cavity | 75mm | Void: no cavity fill was found | | |
