Survey Date 13/08/2025

# FIRE RISK APPRAISAL EXTERNAL WALLS

## 1-32 HORTON STREET

1-32 Horton Street  
Tipton  
DY4 7JW

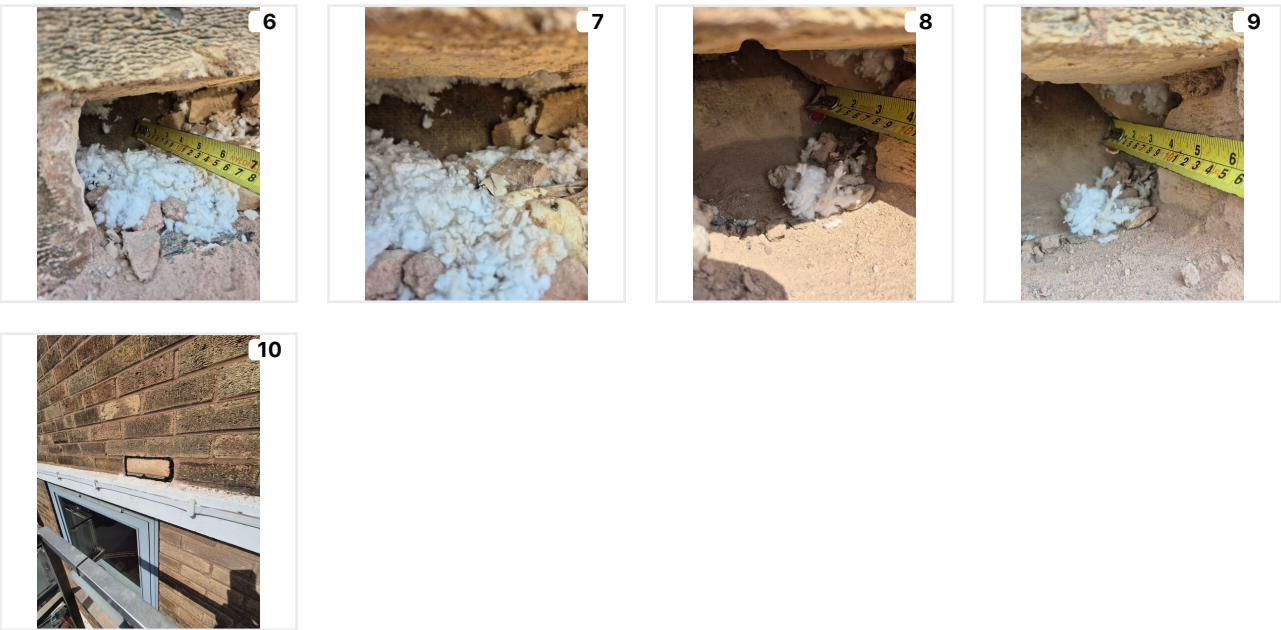
Masonry construction appears original and robust but lacks modern cavity fire barrier provision. Localised brick removal (as seen in investigative openings) confirms presence of mineral wool-type insulation, but continuity and integrity not fully verified. Surface spalling and mortar degradation observed in some areas, particularly under balconies and near service penetrations. No cladding, rainscreen systems or panelised façades present.

Backing Wall Sits On The Floor Slab

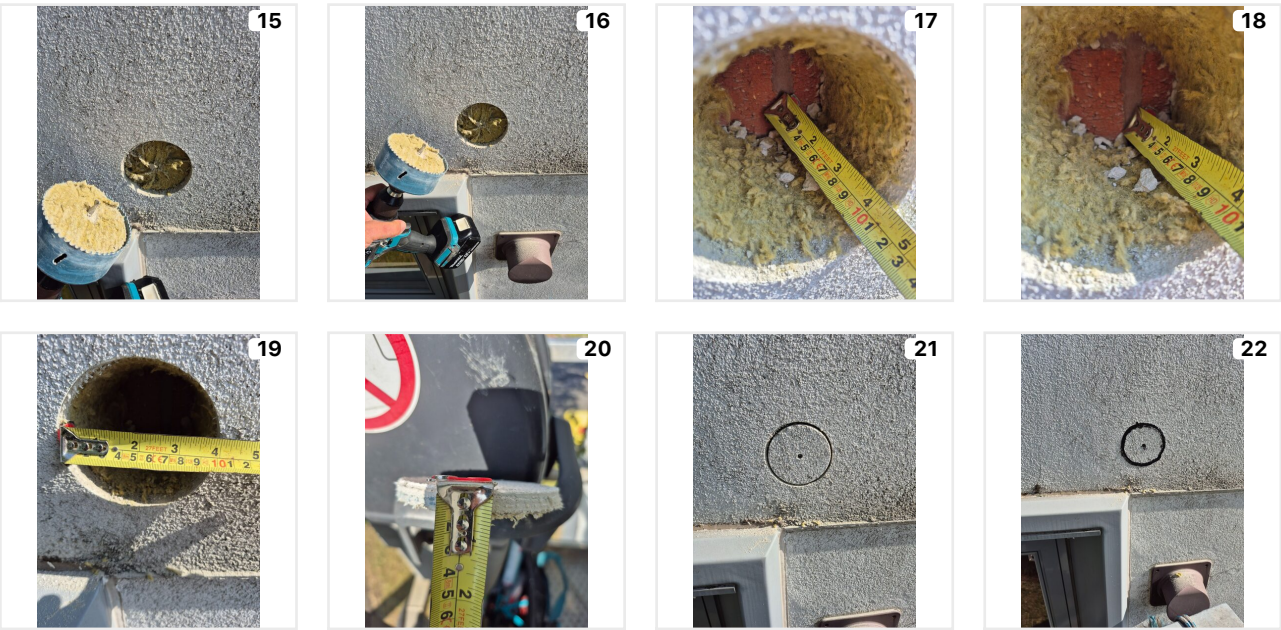
**Substrate**  
The render is applied directly to a solid masonry wall—specifically blockwork inner leaf with brick outer leaf and cavity insulation.  
No evidence of any carrier board, EPS insulation, or framing behind the render was observed.

**3. Fire Performance**  
The render system appears to be direct-to-substrate with no combustible backing.  
Combined with mineral wool cavity insulation and masonry substrate, this system is non-combustible (Euroclass A1–A2-s1,d0).  
No combustible detailing, intumescent trims, or polymeric expansion joints were observed.

**4. Condition**  
Localised weathering and surface staining observed, but no visible detachment or cracking indicative of structural failure.  
The drilled inspection confirmed continuous mineral wool insulation behind render.

Backing Wall Sits On The Floor Slab

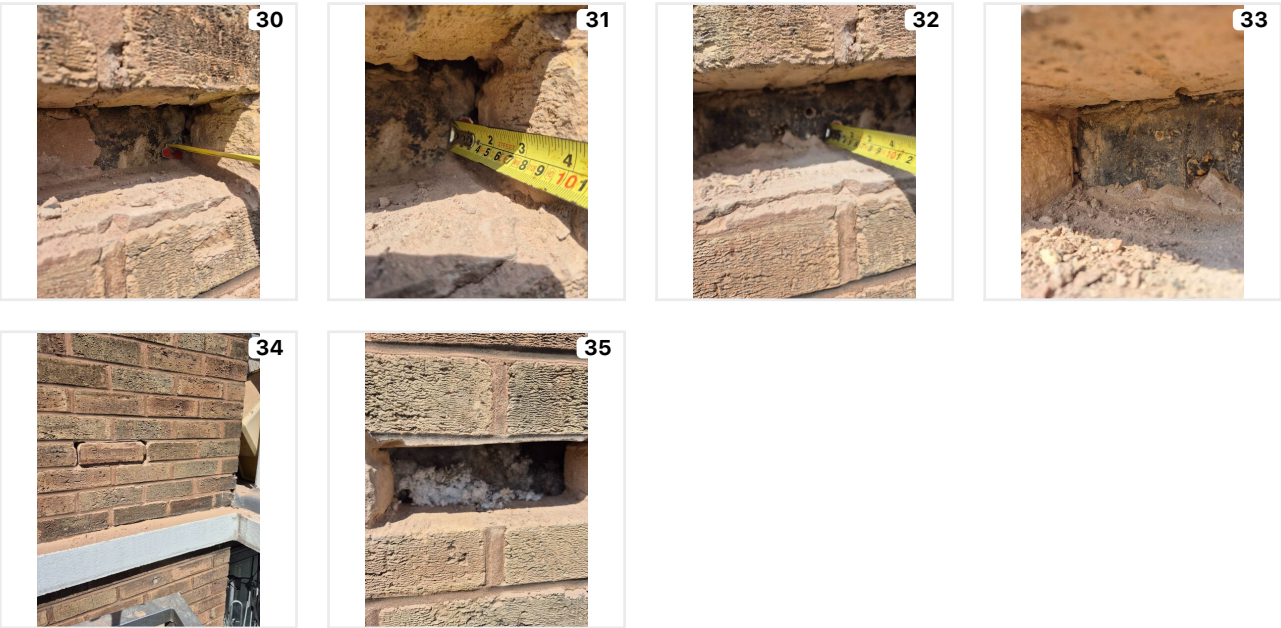
# Inspection: MTL1UD

Masonry construction appears original and robust but lacks modern cavity fire barrier provision. Localised brick removal (as seen in investigative openings) confirms presence of mineral wool-type insulation, but continuity and integrity not fully verified. Surface spalling and mortar degradation observed in some areas, particularly under balconies and near service penetrations. No cladding, rainscreen systems or panelised façades present.

Backing Wall Sits On The Floor Slab

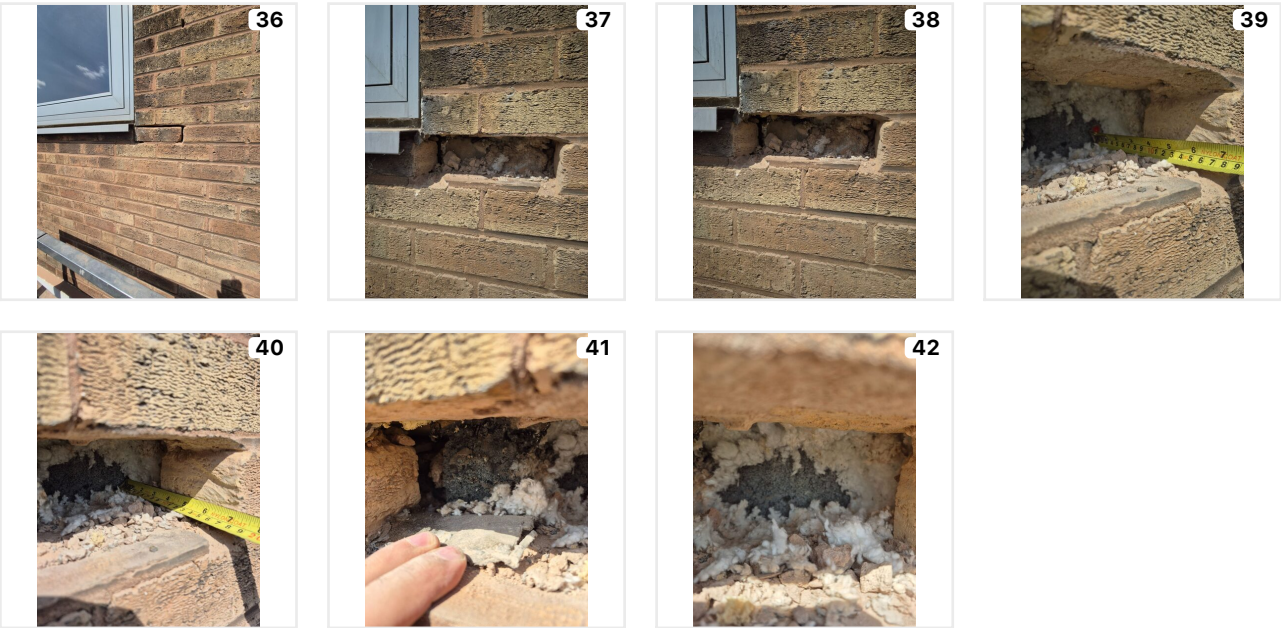
# Inspection: 7AHY8Q

Masonry construction appears original and robust but lacks modern cavity fire barrier provision. Localised brick removal (as seen in investigative openings) confirms presence of mineral wool-type insulation, but continuity and integrity not fully verified. Surface spalling and mortar degradation observed in some areas, particularly under balconies and near service penetrations. No cladding, rainscreen systems or panelised façades present.

Backing Wall Sits On The Floor Slab

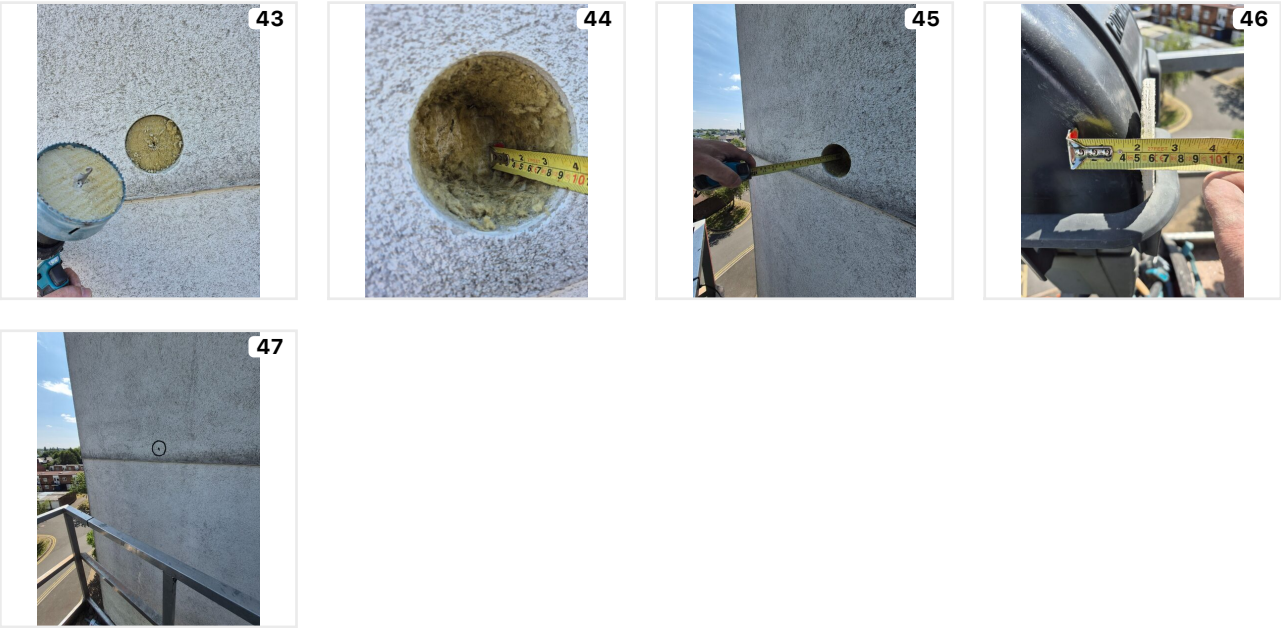
# Inspection: 3ST48B

**Substrate**  
The render is applied directly to a solid masonry wall—specifically blockwork inner leaf with brick outer leaf and cavity insulation.  
No evidence of any carrier board, EPS insulation, or framing behind the render was observed.

**3. Fire Performance**  
The render system appears to be direct-to-substrate with no combustible backing.  
Combined with mineral wool cavity insulation and masonry substrate, this system is non-combustible (Euroclass A1-A2-s1,d0).  
No combustible detailing, intumescent trims, or polymeric expansion joints were observed.

**4. Condition**  
Localised weathering and surface staining observed, but no visible detachment or cracking indicative of structural failure.  
The drilled inspection confirmed continuous mineral wool insulation behind render.

Backing Wall Sits On The Floor Slab

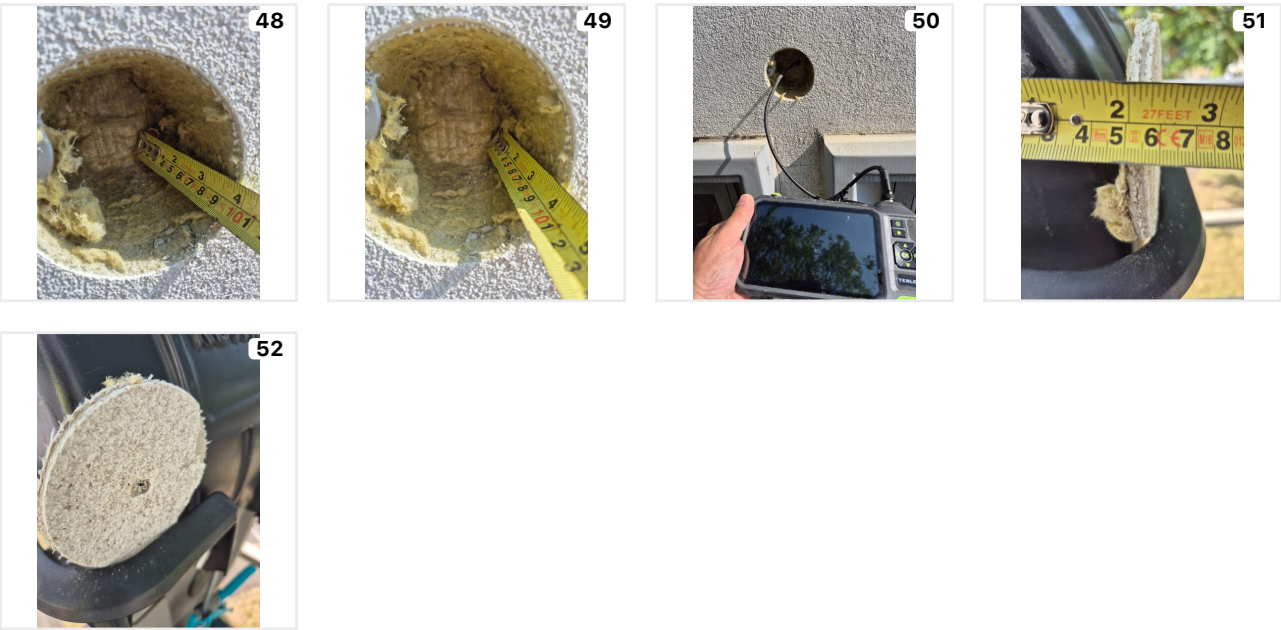
# Inspection: CTNZYE

**Substrate**  
The render is applied directly to a solid masonry wall—specifically blockwork inner leaf with brick outer leaf and cavity insulation.  
No evidence of any carrier board, EPS insulation, or framing behind the render was observed.

**3. Fire Performance**  
The render system appears to be direct-to-substrate with no combustible backing.  
Combined with mineral wool cavity insulation and masonry substrate, this system is non-combustible (Euroclass A1-A2-s1,d0).  
No combustible detailing, intumescent trims, or polymeric expansion joints were observed.

**4. Condition**  
Localised weathering and surface staining observed, but no visible detachment or cracking indicative of structural failure.  
The drilled inspection confirmed continuous mineral wool insulation behind render.

Backing Wall Sits On The Floor Slab

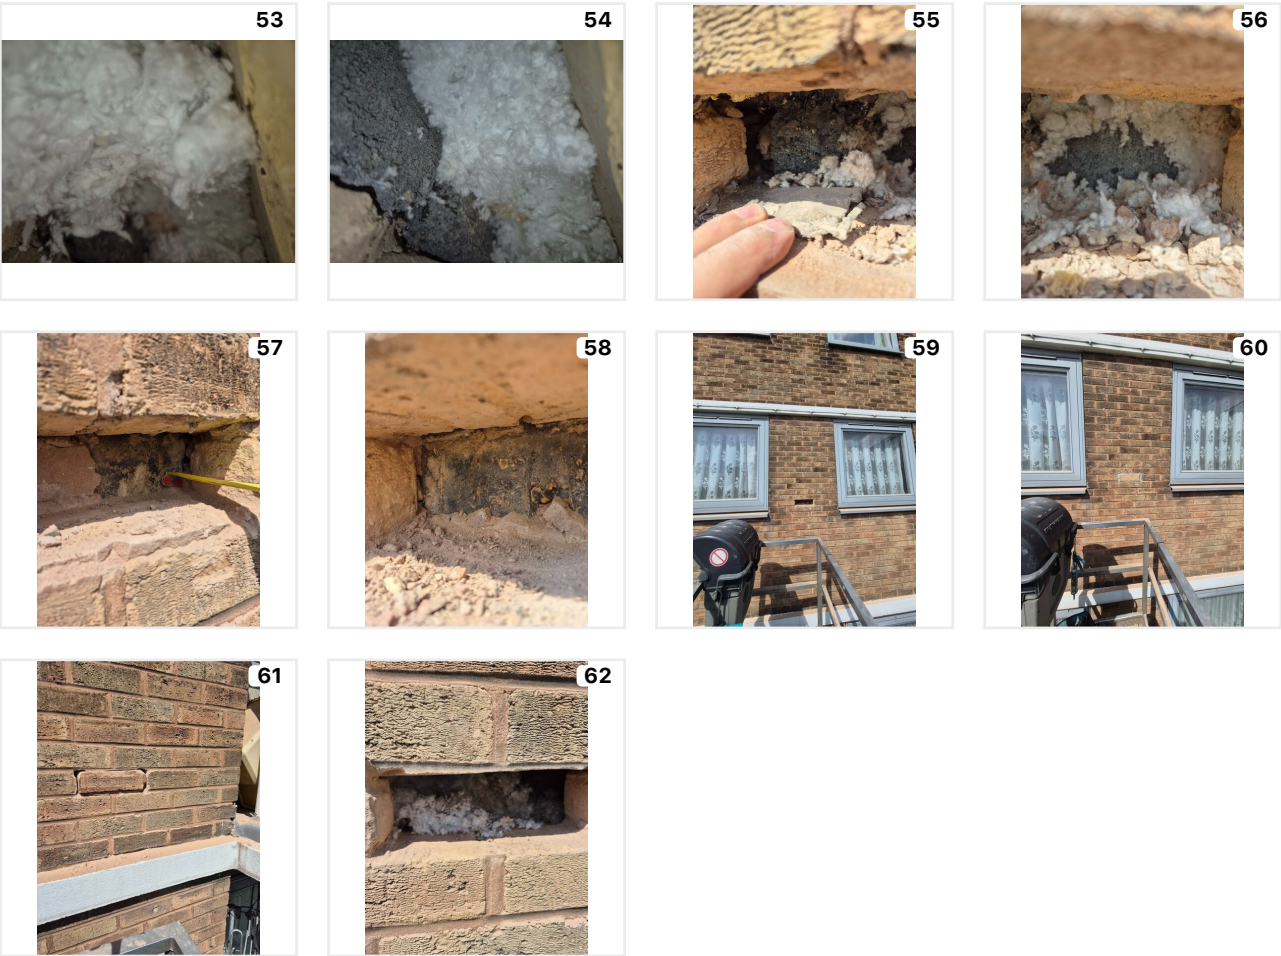
# Inspection: IUFT8X

Masonry construction appears original and robust but lacks modern cavity fire barrier provision. Localised brick removal (as seen in investigative openings) confirms presence of mineral wool-type insulation, but continuity and integrity not fully verified. Surface spalling and mortar degradation observed in some areas, particularly under balconies and near service penetrations. No cladding, rainscreen systems or panelised façades present.

Backing Wall Sits On The Floor Slab

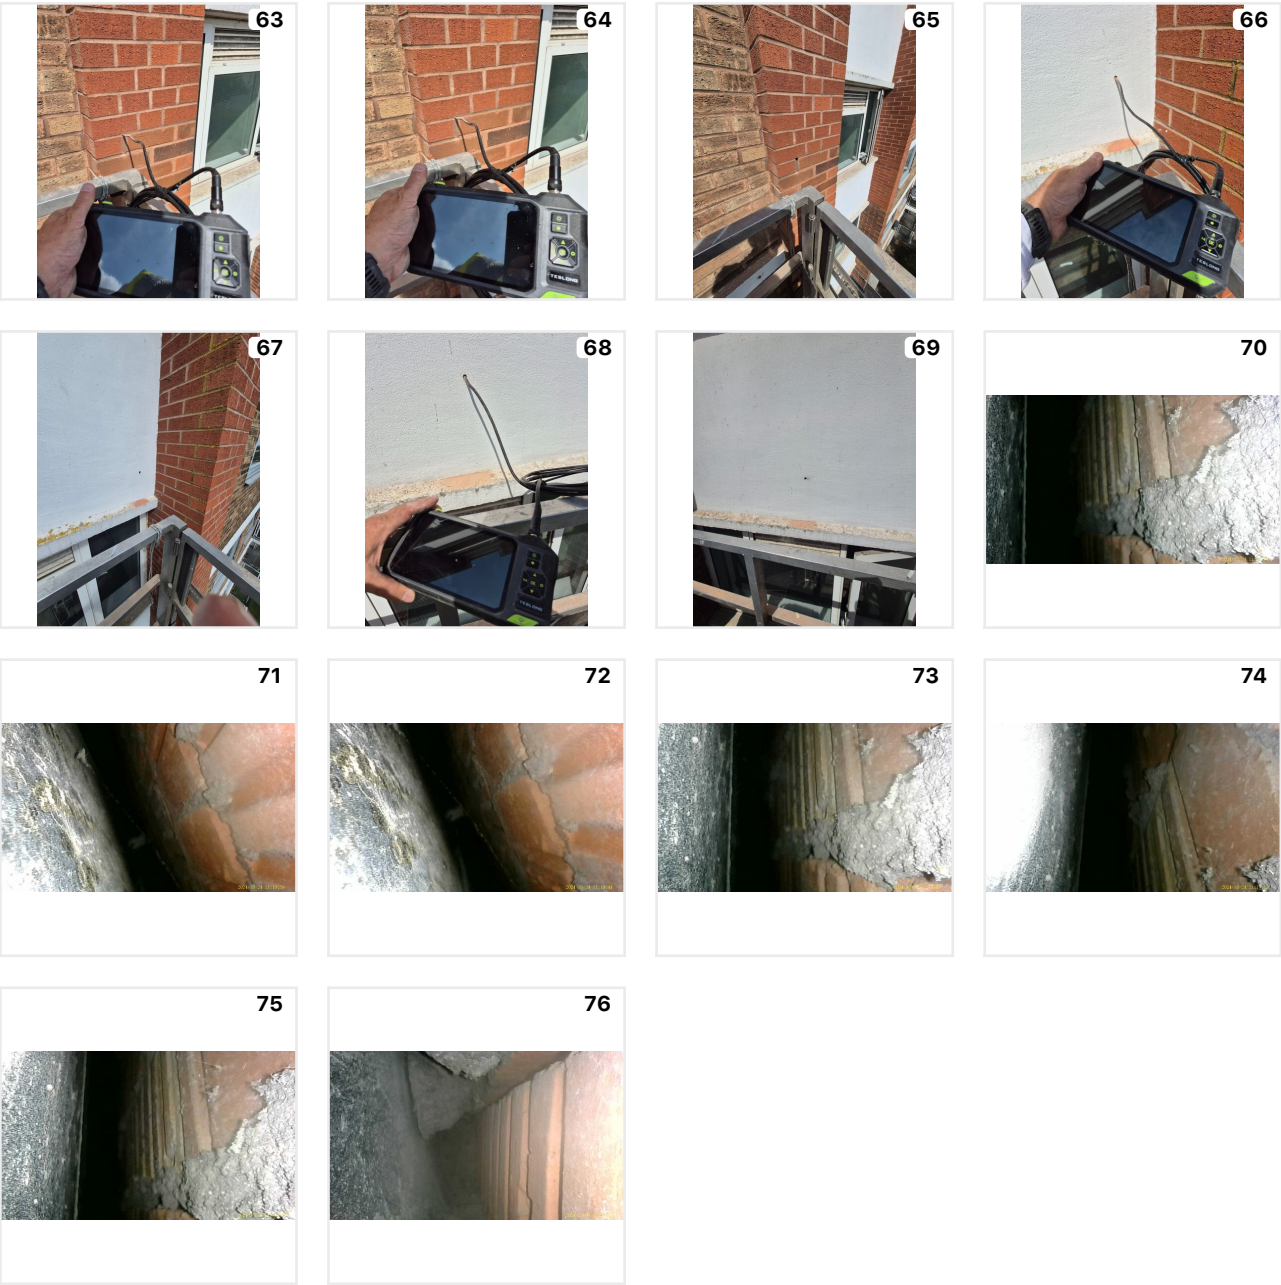
# Inspection: M3MYW7

Masonry construction appears original and robust but lacks modern cavity fire barrier provision.  
Localised borescope confirms no insulation within cavity at survey location  
Surface spalling and mortar degradation observed in some areas, particularly under windows.  
No cladding, rainscreen systems or panelised façades present.

| 3 Elements | Thickness/Depth | Material | Photo Ref. | Rating (BS EN13501) |
|---|---|---|---|---|
| Cavity | 75mm | Void: no cavity fill was found | | |

Backing Wall Sits On The Floor Slab
