Document Version 1  
Survey Date 13/08/2025  
Suggested Review Date 13/08/2030

# FIRE RISK APPRAISAL EXTERNAL WALLS

## 33-64 HORTON STREET

Great Bridge  
DY4 7JW

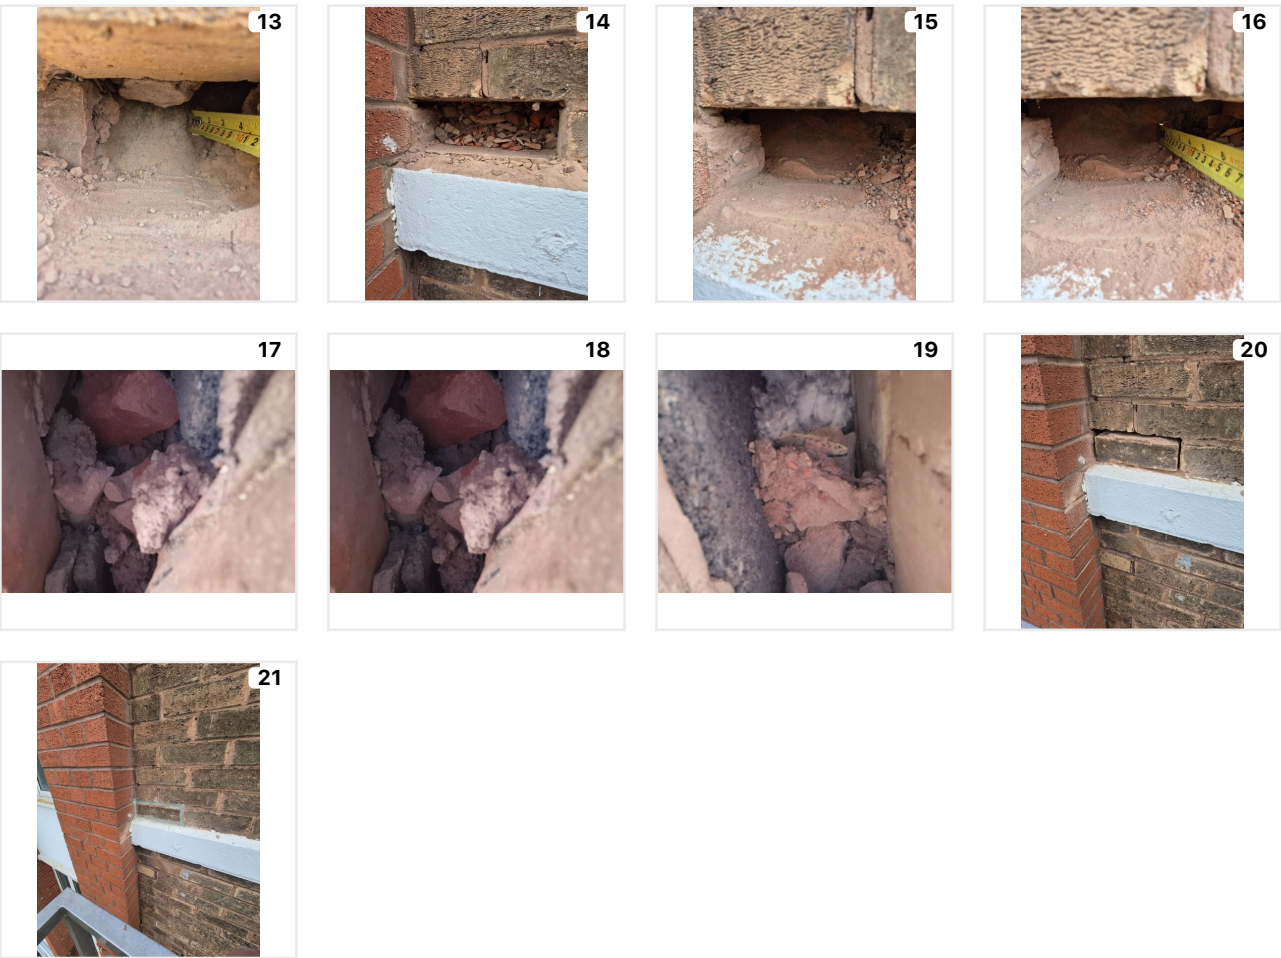
Backing Wall Sits On The Floor Slab

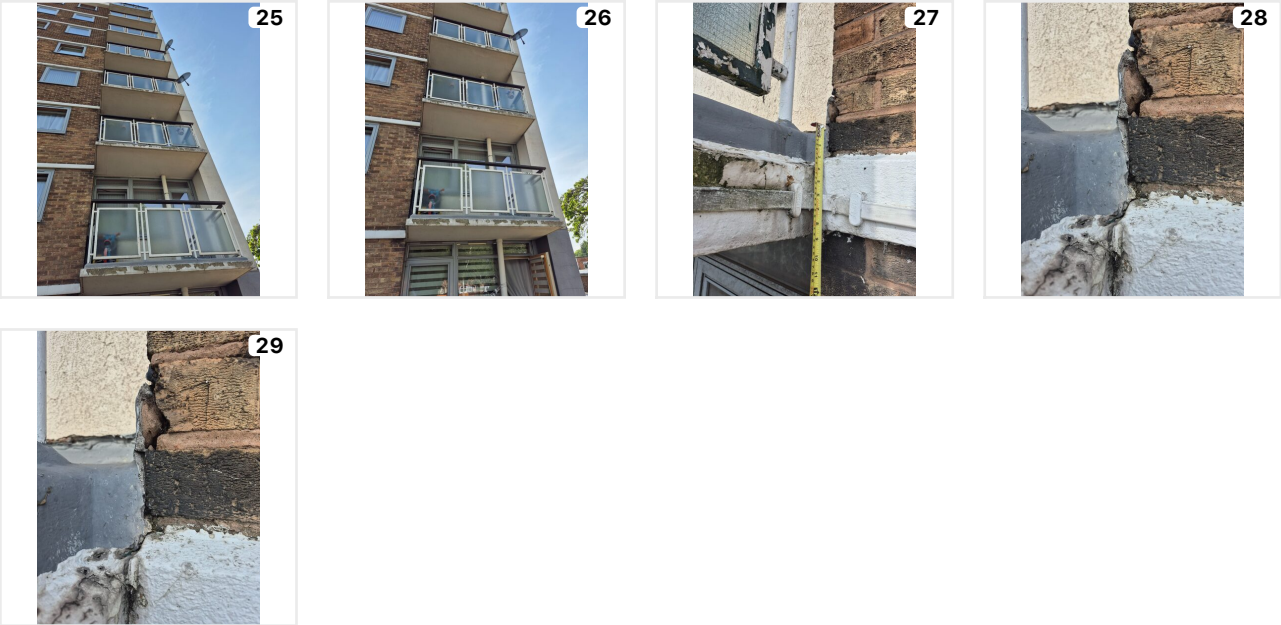
All visible elements are non-combustible or low-risk, with no evidence of timber decking, combustible screening, or cladding.  
General surface degradation (paint flaking, corrosion) was noted but does not presently constitute a fire risk.  
Fixings and materials appear to pre-date modern balcony design requirements (e.g. BS 8579:2020) but do not pose significant concern under PAS 9980.

| 3 Elements | Thickness/Depth | Material | Photo Ref. | Rating (BS EN13501) |
|---|---|---|---|---|
| External Surface Material | | Coated concrete (possibly bituminous or painted waterproof layer); aged/worn. | | B - Combustible |

Painted steel posts and horizontal rails; noted corrosion to surface coating.  
Infill Panels           Wired/obscured glass or patterned polycarbonate in aluminium framing.  
Top Rail               Steel or aluminium; unprotected edge corrosion visible in some locations.  
Fixing Method           Mechanically fixed into slab edge and upstand; no combustible packers evident.  
Combustible Materials       None observed. No timber, ACM, HPL or PVC-based infills or finishes present.

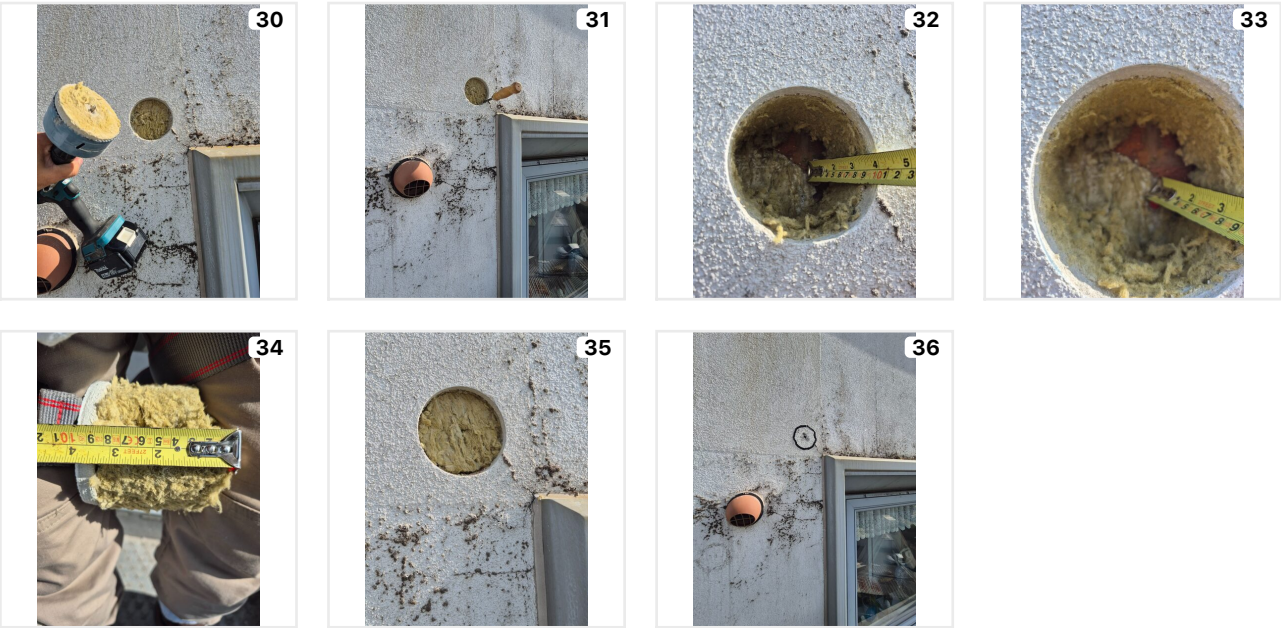
# Inspection: 8HNM5U

Backing Wall Sits On The Floor Slab

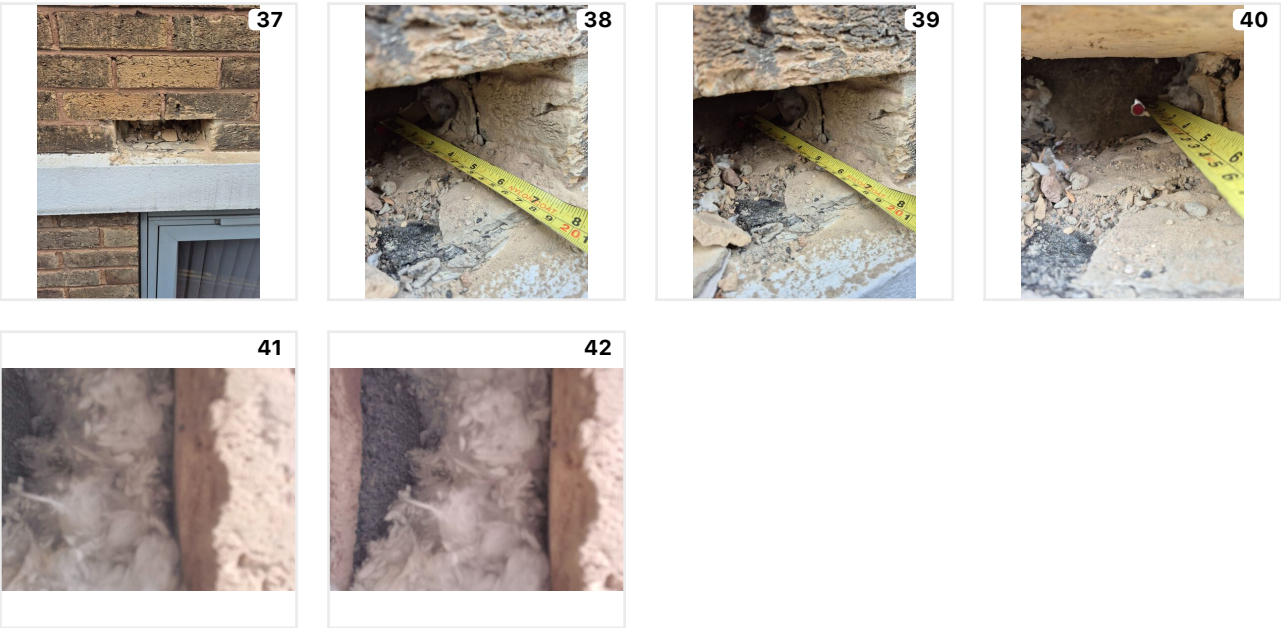
Masonry construction appears original and robust but lacks modern cavity fire barrier provision. Localised brick removal (as seen in investigative openings) confirms presence of mineral wool-type insulation, but continuity and integrity not fully verified. Surface spalling and mortar degradation observed in some areas, particularly under balconies and near service penetrations.

Backing Wall Sits On The Floor Slab

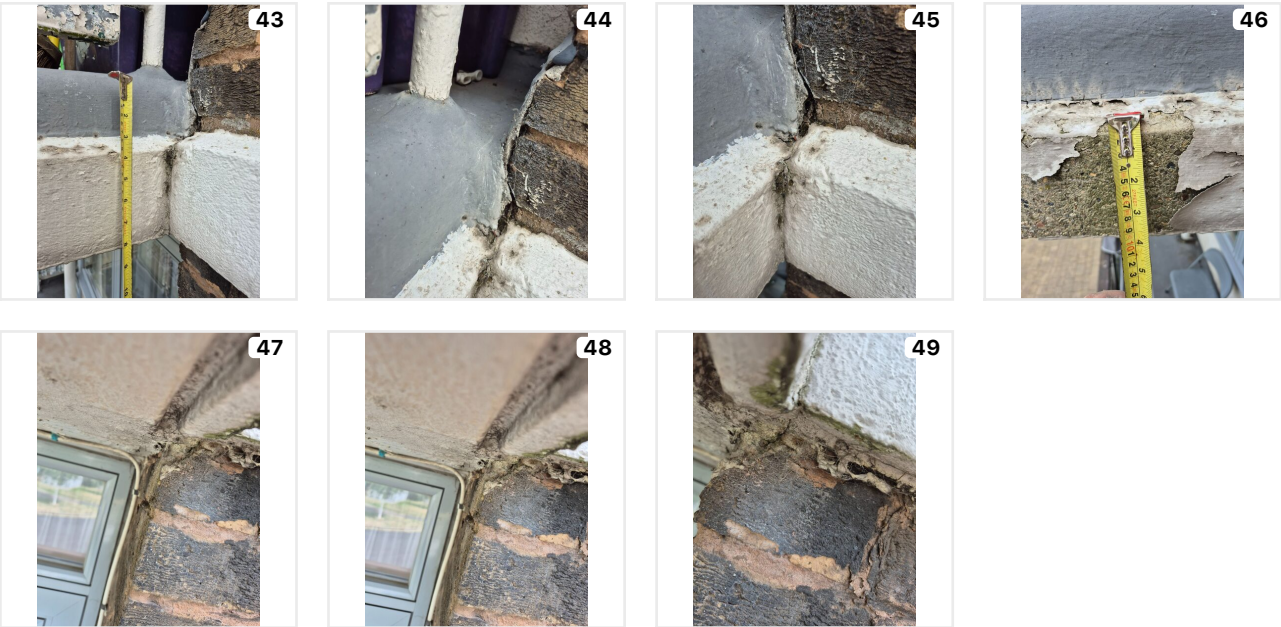
# Inspection: YIQ8DZ

All visible elements are non-combustible or low-risk, with no evidence of timber decking, combustible screening, or cladding.  
General surface degradation (paint flaking, corrosion) was noted but does not presently constitute a fire risk.  
Fixings and materials appear to pre-date modern balcony design requirements (e.g. BS 8579:2020) but do not pose significant concern under PAS 9980.

| 3 Elements | Thickness/Depth | Material | Photo Ref. | Rating (BS EN13501) |
|---|---|---|---|---|
| External Surface Material | | Coated concrete (possibly bituminous or painted waterproof layer); aged/worn. | | B - Combustible |

Painted steel posts and horizontal rails; noted corrosion to surface coating.  
Infill Panels           Wired/obscured glass or patterned polycarbonate in aluminium framing.  
Top Rail               Steel or aluminium; unprotected edge corrosion visible in some locations.  
Fixing Method           Mechanically fixed into slab edge and upstand; no combustible packers evident.  
Combustible Materials       None observed. No timber, ACM, HPL or PVC-based infills or finishes present.

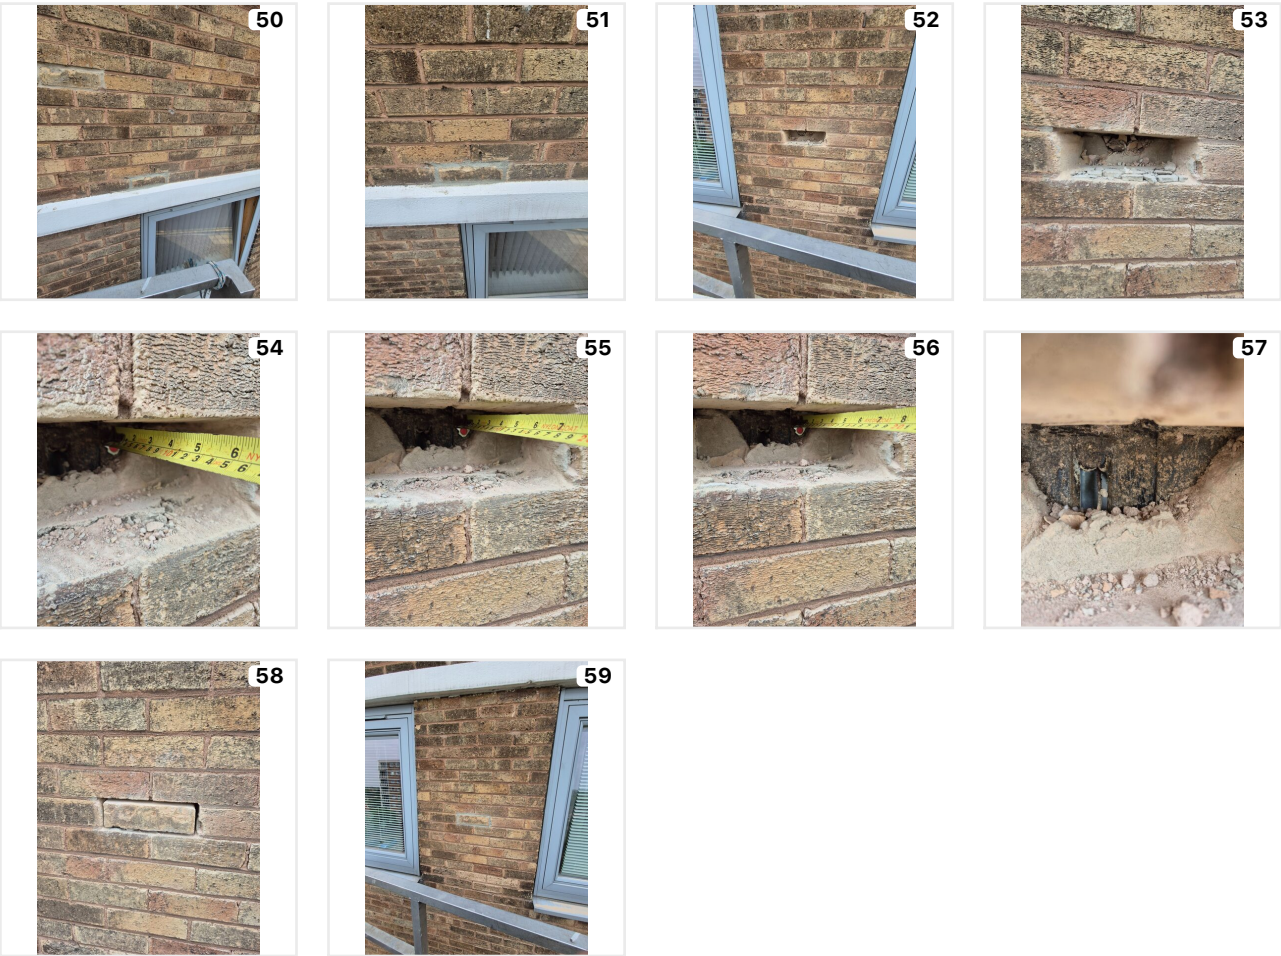
# Inspection: SWMN33

Masonry construction appears original and robust but lacks modern cavity fire barrier provision. Localised brick removal (as seen in investigative openings) confirms presence of mineral wool-type insulation, but continuity and integrity not fully verified. Surface spalling and mortar degradation observed in some areas, particularly under balconies and near service penetrations.

Backing Wall Sits On The Floor Slab

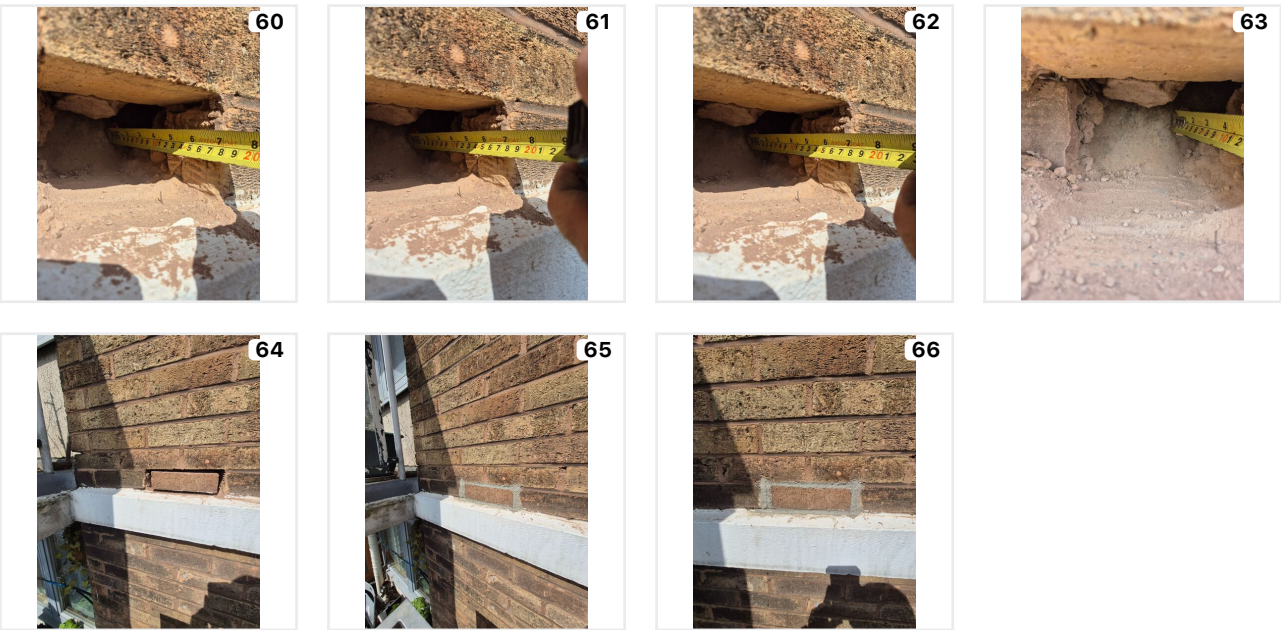
# Inspection: 1PBNQX

Masonry construction appears original and robust but lacks modern cavity fire barrier provision. Localised brick removal (as seen in investigative openings) confirms presence of mineral wool-type insulation, but continuity and integrity not fully verified. Surface spalling and mortar degradation observed in some areas, particularly under balconies and near service penetrations.

Backing Wall Sits On The Floor Slab

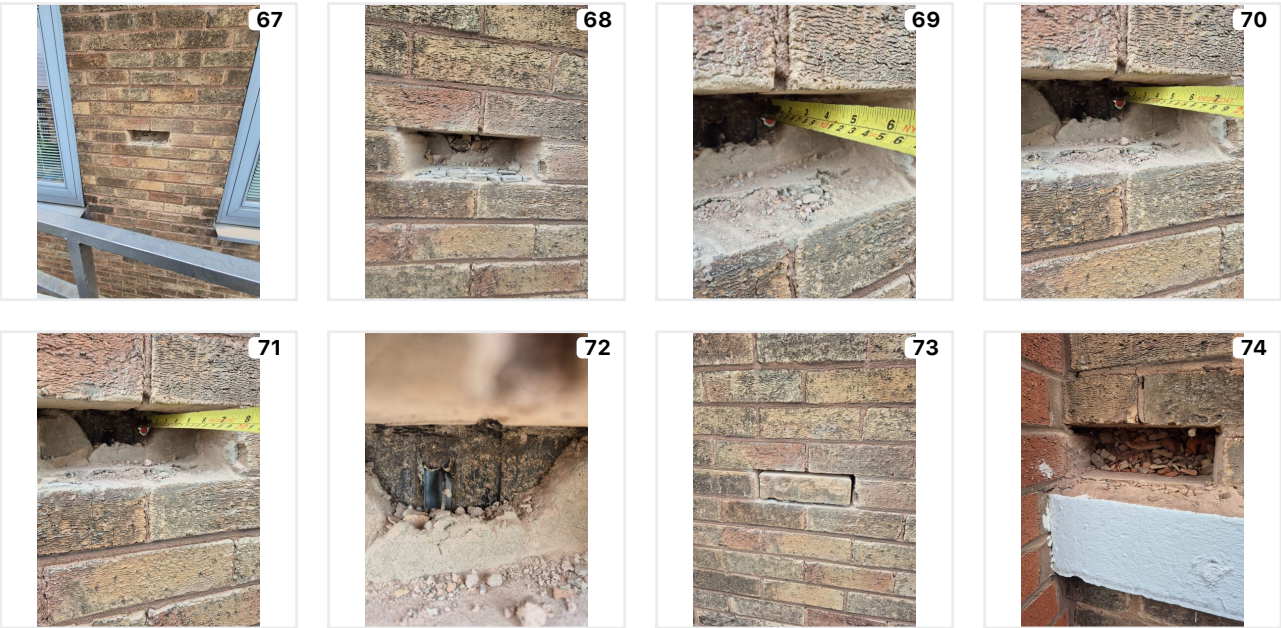
# Inspection: 8C6ZGS

Masonry construction appears original and robust but lacks modern cavity fire barrier provision. Localised brick removal (as seen in investigative openings) confirms presence of mineral wool-type insulation, but continuity and integrity not fully verified. Surface spalling and mortar degradation observed in some areas, particularly under balconies and near service penetrations.

Backing Wall Sits On The Floor Slab
